22 ST SAVIOURGATE YORK

A Report on an Archaeological Watching Brief

January 2006

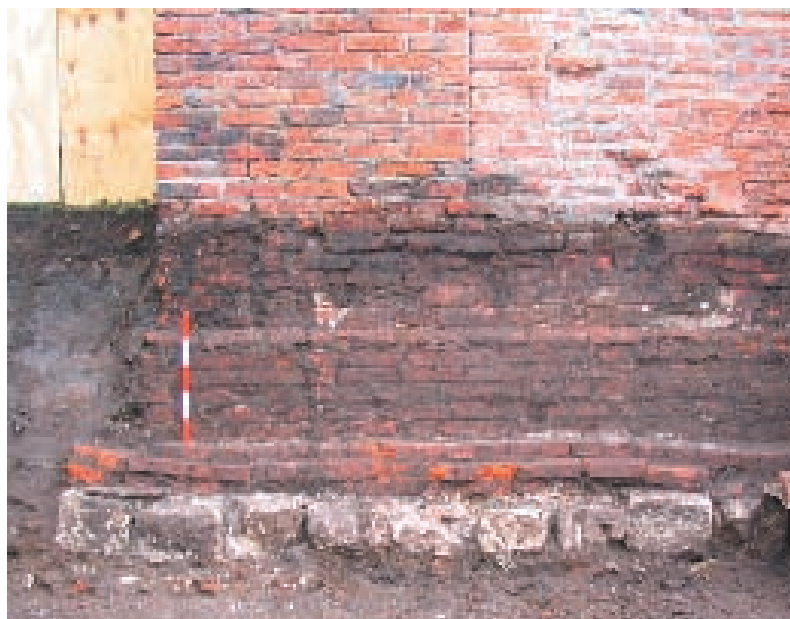
Plate 1 Exposed wall foundations, south-east facing section

corner was apparent. Cutting into 1032 was 1034, the poorly defined construction cut for the wall. The cut was at least 0.50 m deep and as much as 0.35m wide beyond the lower courses of the structure. In the base of 1034 was a single course of re-used limestone blocks (1035) up to 0.22m deep and including at least one sculptured block. The blocks had been bonded, or packed, with lumps of very pale brown mortar. Set over 1035 were three courses of horizontal bricks, c. 0.2m deep in total, bonded with a hard white mortar (1036). They were stepped in, to the north-west, some 0.15m from the south-east edge of 1035. These bricks measured c.245mm x 120mm x 50mm. It was felt that contexts 1035 and 1036 were both within construction cut 1034 which had been backfilled with a firm, mid brown silt (1033).

foundations, 1035 and 1036, in the south-east facing section also strongly suggest a post-medieval date.
