AREAS A, B and C  
HUNGATE DEVELOPMENT  
YORK

A Report on an  
Archaeological  
Watching Brief

February 2007

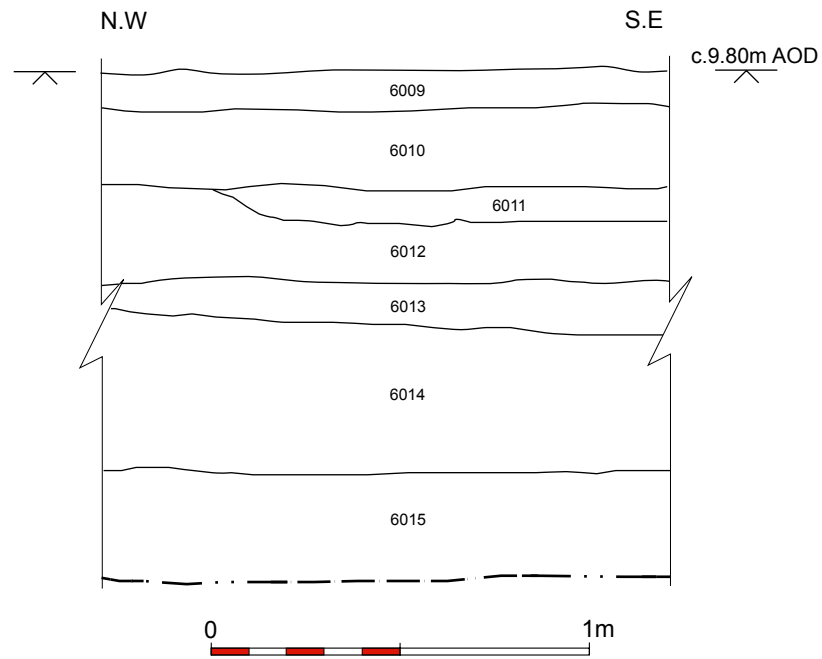
**Figure 5** Section 3, south-west facing

In this section the earliest deposit recorded was a loose, black silt containing frequent clinker and moderate gravel (6015) which was seen between c.1.1m BGL and the base of the section at c.1.4m BGL. Overlying this there was a mid greyish-brown silt with a moderate amount of limestone fragments (6014) and above this a deposit of very pale grey concrete (6013). 6013 was sealed by a light to mid brown slightly clayey silt (6012) and above this was a mid brown silt with occasional flecks of pale brown mortar (6011). Overlying 6011 was a deposit of pale yellow crushed limestone (6010). All of these except for 6013 were almost certainly levelling deposits and 6013 was probably the concrete casing for a ceramic drain. The uppermost context was of black tarmac (6009) which formed the current modern ground surface at c.9.8m OD.

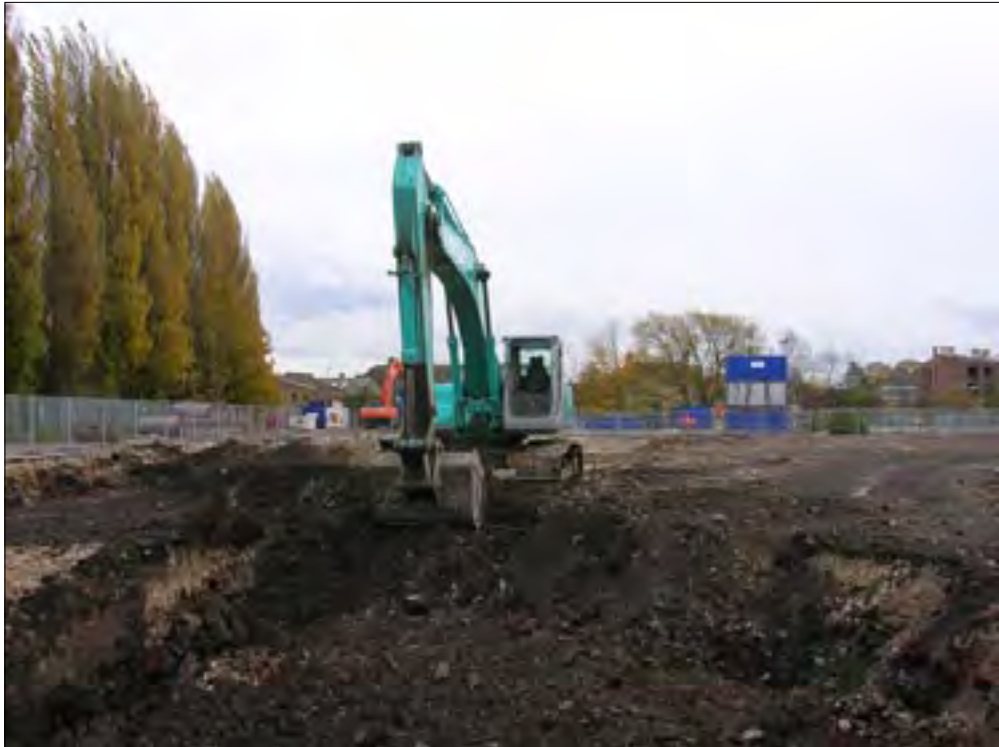
**Plate 1** Initial site stripping, central Block A, looking south east

Much of the breaking-out and clearance work was carried out using 30 ton 360° mechanical tracked excavators with toothed buckets, (Plates 1-2) although at formation level more

delicate work was carried out using a 1.8m wide toothless ditching bucket. The breaking-out and stripping was undertaken by Moorhead Excavations Ltd of Leeds and the work was monitored when machine excavation was in progress.

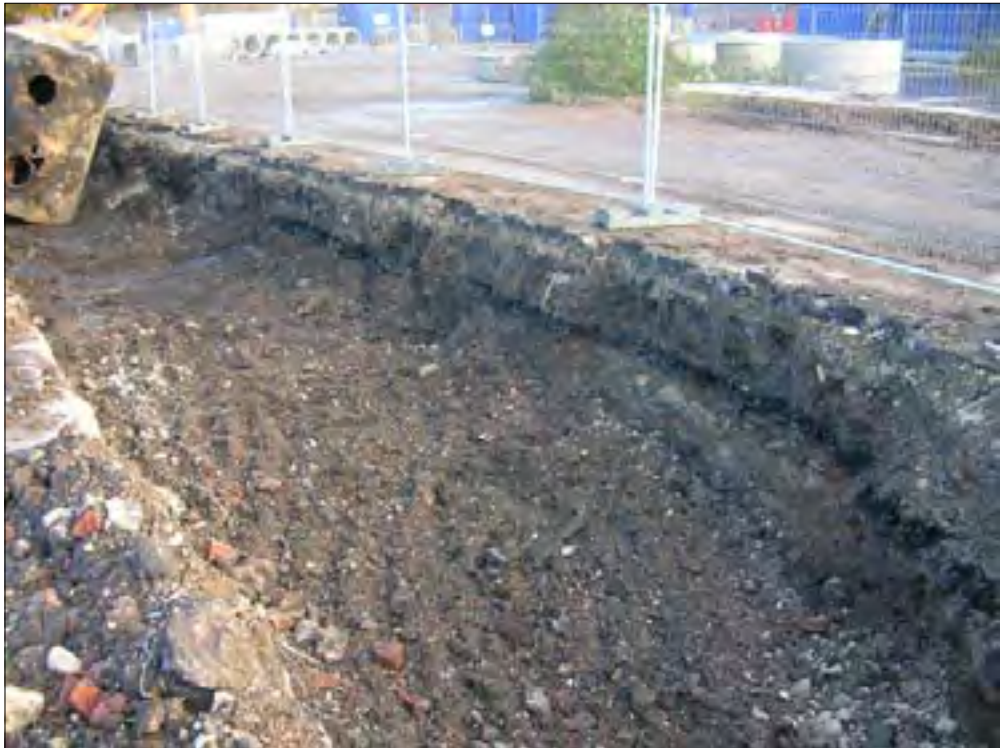
**Plate 3** *Levelling deposits, north-west end of Block C, looking south-east*

At all locations where stripping was observed, all of Blocks A, B and C, it was very clear that the deposits encountered were all 20<sup>th</sup> century levelling deposits (Plate 3). Little trace of any of the 19<sup>th</sup> century housing towards the eastern extents of Palmer Lane depicted on the 1852 O.S. map, (fig, 11) remained although a small piece of brick wall and a number of drains were noted within the area of Block C. The drains had only survived by being below parts of Palmer Lane (formerly Pound Lane), the line of which was retained for the later 20<sup>th</sup> century development of the site. It would appear that the construction works for the Northern Electric depot had removed most of any remaining walls of the 19<sup>th</sup> century housing before the ground level was raised by more than 1.5m using domestic and building waste. This raising of the ground level was probably carried out to alleviate flooding problems, known to have affected the 19<sup>th</sup> century housing in the vicinity.

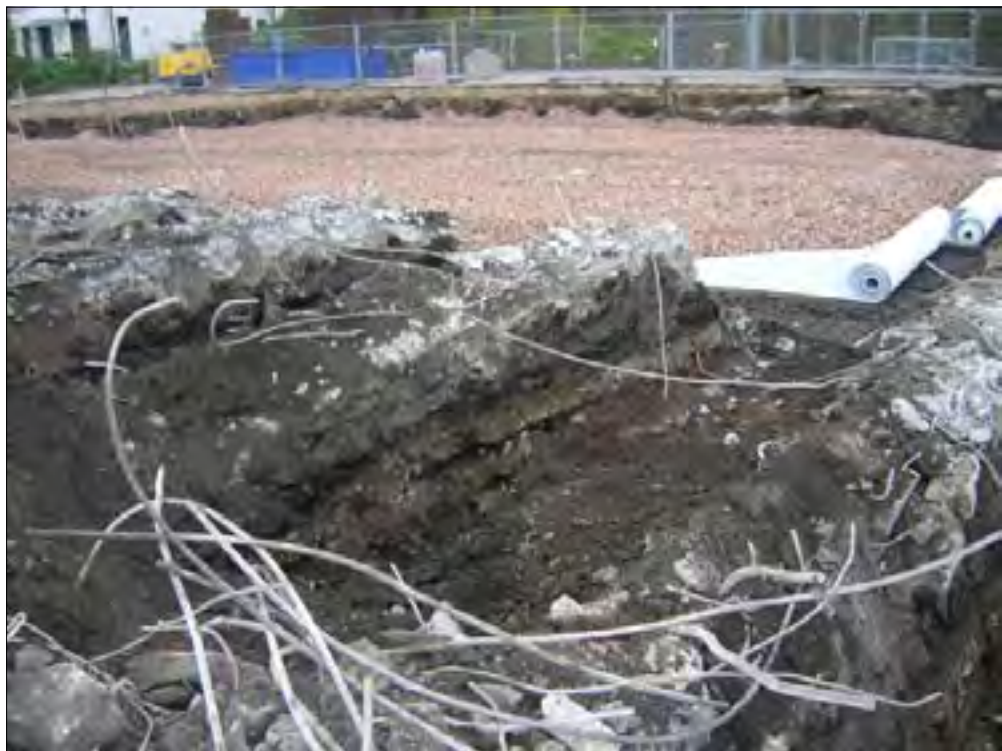
**Plate 4** *Levelling deposits and concrete raft, Block C, looking north-east*

Due to the somewhat greater depth of 20<sup>th</sup> century levelling deposits (Plate 4) across the blocks than was expected it was not possible to realise any of the research objectives as defined in the Research Design. It is therefore not possible, at this point in time, to shed much light on the history and development of Blocks A, B and C and monitoring of the pre-pile probing and the hand excavation of the lift pits in these areas may constitute the only viable source of archaeological information for Blocks A, B and C.
