CHARLIE BROWN GARAGE BOOTHAM

YORK

HISTORIC BUILDINGS ASSESSMENT

HISTORIC BUILDINGS ASSESSMENT
CHARLIE BROWN GARAGE
BOOTHAM YORK

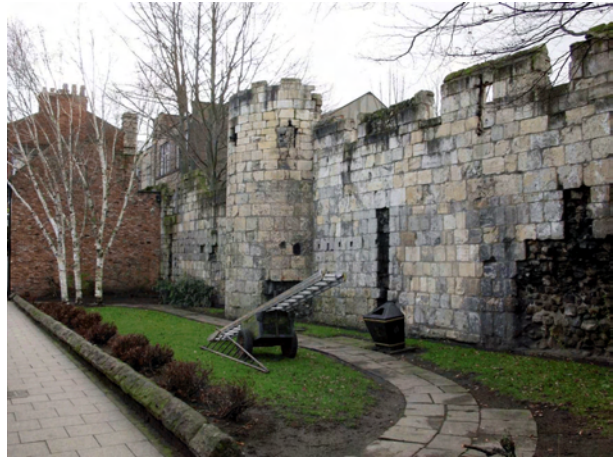
Plate 2 St Mary's Abbey precinct wall opposite the Charlie Brown garage

Much of the history of Bootham during the medieval period is interlaced with that of St Mary's Abbey, founded in 1089 and rebuilt during the Abbacy of Simon de Warwick (1258-96). The precinct walls of the abbey were first built in *c.*1266 and heightened in *c.*1318, separated from Bootham by a ditch and strip of land (Plate 2); St Mary's Tower, at the junction of Bootham and Marygate, was built in *c.*1324 (Pevsner and Neave 1995, 237). The site of proposed development would therefore have overlooked the abbey during the medieval period, a

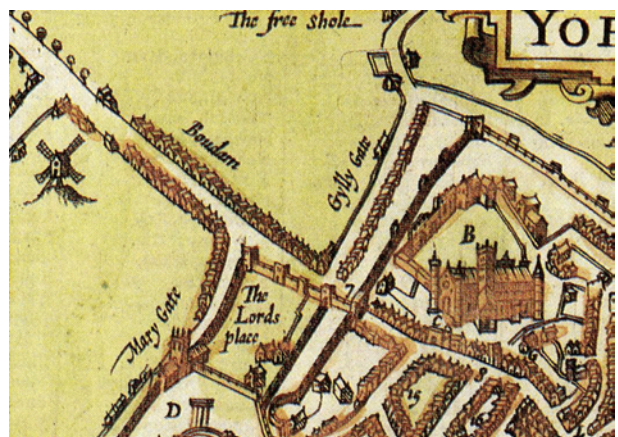
Plate 3 Extract from Speed's map of 1610

A sketch of York, c.1545 depicts 'housis' along the street frontage of Bootham finishing level with Marygate. It may be supposed that many of these buildings were medieval in origin but it is clear that during the 16th and 17th centuries the suburb of Bootham grew with new buildings constructed to the west. Indeed, Speed's map of 1610 (Plate 3), appears to show buildings along Bootham to what is now Bootham School. The nature of these buildings is unknown, but during Elizabethan times a report that a minor cleric was accused of giving 6s to people who saw him resorting to

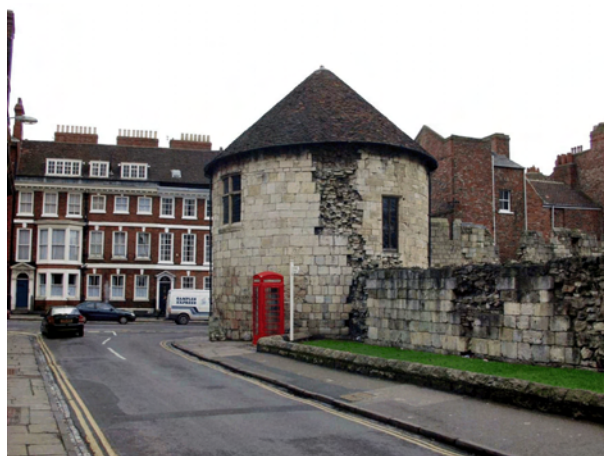
Plate 4 St Mary’s Tower from Marygate

Following the Civil War, rebuilding work was undertaken in the Bootham area to make good the damage inflicted during the siege. The upper sections of Bootham Bar were rebuilt (Wilson and Mee 2005, 48), St Mary’s Tower was hastily repaired resulting in the rather awkward looking structure that survives today (Plate 4), whilst in excess of 5,000 bricks were ordered for the repair of Ingram’s Hospital (Tillott 1961). The extent of damage to other structures on the street is difficult to ascertain, but from the late 17th century, Bootham began to develop as a fashionable suburb and, superficially at least, buildings surviving on the street date from this time onwards (RCHME 1975, 54). The growth of the suburb is captured on a several late 17th and 18th century maps. Archer’s map, c.1680 depicts buildings and large gardens along the length of Bootham; buildings are also shown built up against the abbey precinct walls and opposite the site of the proposed development (Plate 5). Curiously, Archer shows buildings built around small ‘squares’, but as these are not shown on any later maps, this may be the result of artistic licence rather than a true reflection of

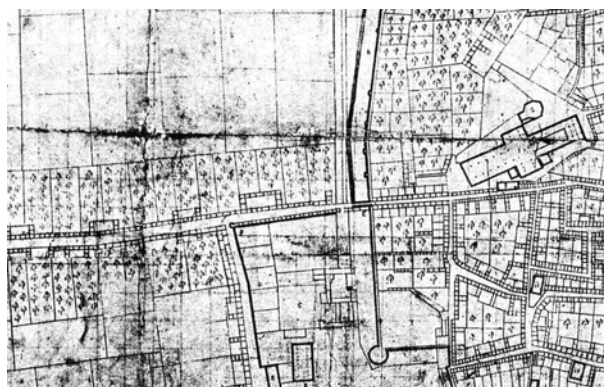
Plate 5 Extract from Archer’s map of c.1680

the built environment of Bootham at this time. Archer shows no buildings along Gillygate, reflecting the firing of properties on this street during the Siege of York. The fact that buildings along Bootham had been rebuilt or repaired by *c.*1680 probably owes as much to the fact that the suburb was not fired during the siege.

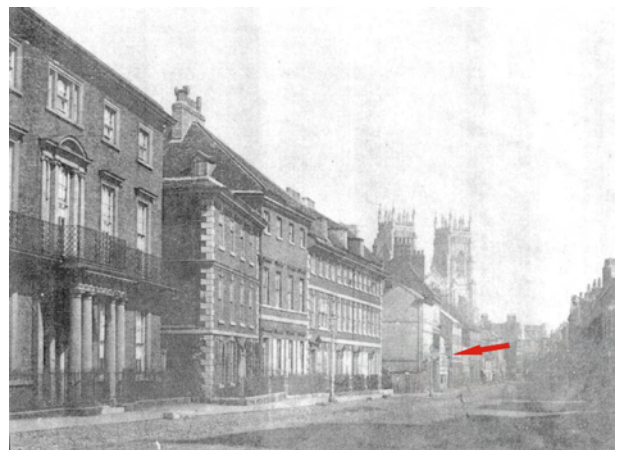
Plate 10 Historic photograph of Bootham, *c.*1853

Because the function of two of the buildings on the site are given on the 1852 OS map it is possible to identify them in early trade directories. The Black Horse Inn is first recorded in 1830 (Parson and White 1830, 8) as 10 Bootham and owned by Joseph Leetall. In the same directory, William Wilks is named as 'Blacksmith & Iron Dealer, 38, Bootham Row. Wilks & Son, Ironmongers, Bootham, are also recorded in 1809-11 (Holden 1809-11, 440) and it is reasonable to equate this firm with the later Blacksmith's and Iron Dealer, William Wilks. A tantalising glimpse of the Black Horse Inn is offered by an historic photograph of Bootham taken *c.*1853 (Plate 10). The gable of No. 33 Bootham is visible on the photograph, and beyond it can be seen a smaller building with at least one double-height bay window, which concurs with the footprint of the Black Horse Inn shown on the 1852 OS map. Because of the angle of the photograph, little more can be said about the building except that there appears to have been a second storey and beyond it, shown in shadow, is a narrow building of possibly two storeys, which is probably the smithy.

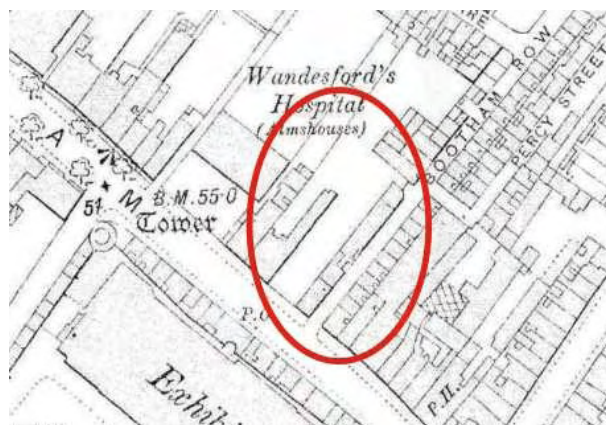
Plate 12 Extract from the 1909 OS map

After 1909, the four buildings on Providence Square cease to be listed in the trade directories, although Providence Square itself is still recorded. There is no obvious explanation for this although it may be an omission (see, for instance, Cook 1909; Anon 1925; 1935). From then on, a variety of businesses are recorded on Bootham Row, including labourers, a joiner, a cabinet maker, a coal merchant and a motor engineer. As the system of numbering on Bootham Row at this time is not known, it is impossible to identify any of them with buildings on the site of proposed development. By 1955, only a single entry is made for the left-hand side of Bootham Row, and after 1965 the only business recorded is Robson and Knowles, architects and surveyors (Kelly 1955, 25; 1965, 27; 1975, 286). This suggests a gradual contraction of businesses and certainly on the 1909 OS map (Plate 12), the four buildings behind the fruiterers are shown as three structures, with and the remaining open yard filled in; Providence Square is shown as one open space contiguous with the garden of No. 33 Bootham. From the 1930s onwards, it is known that properties on Bootham Row were demolished, and this may account for the retraction of light industry and commercial activity on the street.

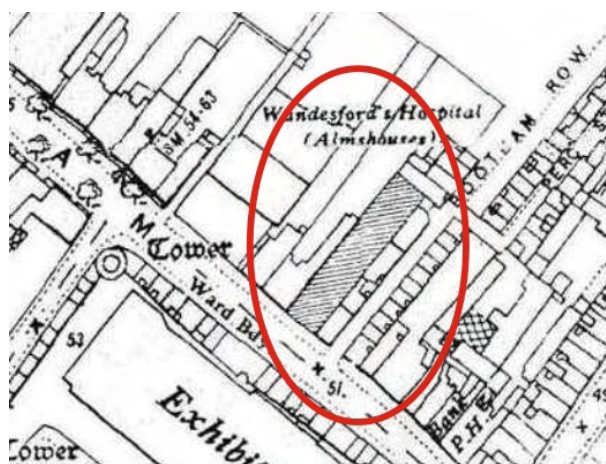
Plate 13 Extract from the 1937 OS map

From 1935 onwards, No. 33 Bootham, immediately adjacent to the site of proposed development, is listed as a mixture of tenants, indicating its division into flats. One of these tenants was a Ronald J.P. Scobey. Also listed under No. 33 from 1935 to 1949-50 is ‘Scobey’s Garage’, presumably a business belonging to R.J.P. Scobey. It is not clear on the 1937 OS map (Plate 13) where the garage listed as No. 33 Bootham was located, but it is reasonable to suppose that it occupied land in the former garden space to the rear of the property. The 1937 OS map also shows the former site of the Black Horse Inn and Providence Square as a shaded area. Comparison with other shaded areas on the map, including buildings at the far end of Sycamore Terrace (southwest of Bootham and known to have been built c.1936), suggests that the shaded area indicates land in the process of being developed. Certainly, the shaded area corresponds with the footprint of the central shed surviving at the site, slotted into the space between No. 33 Bootham and the buildings on Bootham Row. If it is accepted that the land was developed c.1937, then the entries for Scobey’s Garage, No. 33 Bootham must relate to this new structure and the site appears to have been

listed together with the adjoining property, rather than as a plot in its own right. By 1965 Scobey's Garage is listed as No. 31 Bootham and No. 33 solely as flats (Kelly 1965, 27). This corresponds with the absence of No. 31 Bootham as a fruiterers, and implies that this property had been bought, and subsumed into the greater mass of Scobey's Garage; the whole site had then been reallocated No. 31 Bootham. Given that one of the surviving buildings at the site, a low concrete-framed building fronting the main shed, probably dates from the 1960s (see below), it seems likely that when the fruiterers was purchased by Scobey's, it was demolished, and a forecourt and new reception for the garage were created. The buildings fronting Bootham Row may also have been subsumed into the garage complex at this time, or soon afterwards, resulting in the layout of the site as it survives today. Sometime after 1975, when the site was still known as Scobey's Garage (Kelly 1975, 28), the business became part of the 'Charlie Brown' garage group, later still to be bought out by Kwik-Fit Ltd. The garage closed in 2003 and has since stood empty, with the buildings facing Bootham Row left in a semi-derelict state.

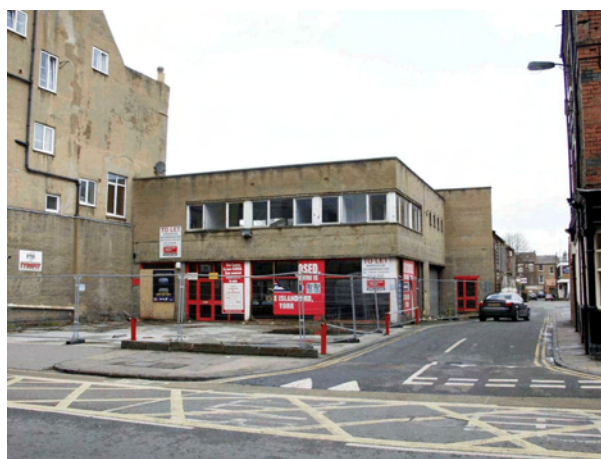
Plate 14 Southwest elevation and forecourt

The southwest elevation, fronting onto Bootham, forms the principal facade. A small forecourt, open to both Bootham and Bootham Row, leads to a low, two-storey reception building with a reinforced concrete frame, four bays by three bays with large areas of windows, particularly at ground-floor level where there is also a main entrance to the garage (Plate 14). Superficially, this building is typical of the 1960s. In places, the concrete frame is exposed, but elsewhere the exterior walls are built of buff-coloured brick and there is a flat roof. The buff-coloured brick is also used along the

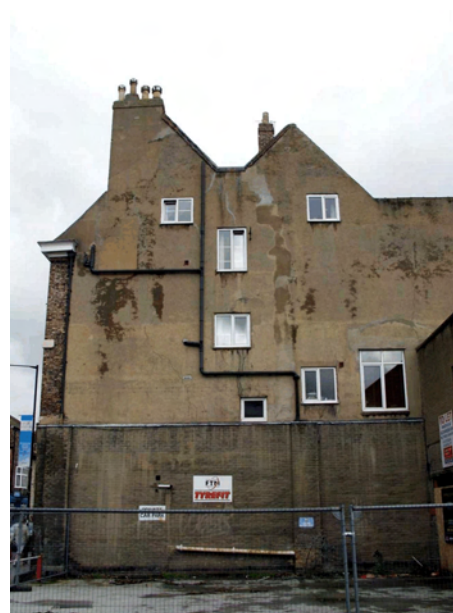
Plate 15 Southeast elevation of No. 33 Bootham

northwest side of the forecourt, forming an area of walling to first-floor level, built up against the southeast elevation of the adjoining property, No. 33 Bootham. The remainder of this elevation is rendered, but the fenestration is of interest, as its arrangement may reflect the existence of earlier, adjacent buildings on the Charlie Brown site. Of the window openings in this elevation (Plate 15), only the two gable windows are likely to be original, although they have modern frames. Given that a mid-19th century photograph appears to show the Black Horse Inn as a possibly two-storey building (see Plate 11), and the OS map of 1852 shows the square footprint to lie adjacent to No. 33, with long ranges to the rear (see Plate 10), the other windows on the elevation cannot be original. However, it is clear that the large, rectangular window to the northeast replaces an earlier window, the outline of which is just visible in the render. The outline suggests some sort of window with a gable; it was therefore likely to have been some sort of first-floor bay/oriel window with a lead roof. This would not have been original to No. 33 Bootham, but is a feature typical of the late 19th century.

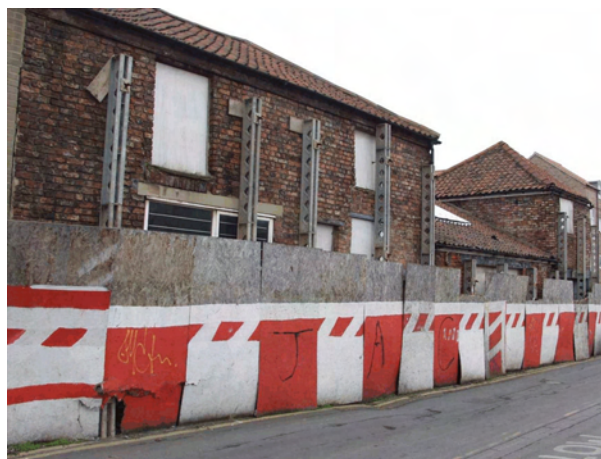
Plate 16 Southeast elevation of the site from the south

The southeast elevation of the site is the most complex of all the exterior elevations and includes a number of different structures built at various times, reflecting the evolution of the site throughout the 19th and 20th centuries (Plate 16). The southernmost end of this elevation forms part of the concrete-framed and buff-coloured brick reception building. This part of the reception building includes a large garage opening with a modern roller-shutter door and 3 small square windows above, perhaps lighting bathrooms. The southeast elevation of the reception building is set slightly back from the Bootham Row frontage and its northeast wall breaks forward from the rest of the elevation to meet the roadway and the front edge of structures to the northeast.

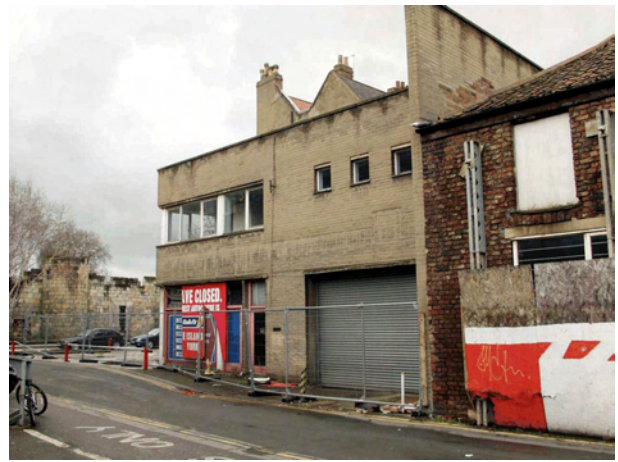
Plate 17 Southeast elevation of the reception building

The northeast elevation of the reception building also rises above the height of the rest of the building, compensating for the height of the main shed roof at the centre of the site. Of interest, a small section of red clamp brickwork survives at the eastern end of this wall, above the roofline of Structure 1 to the northeast (Plate 17). This is probably a survival from the rectangular building shown on 19th century OS maps at the corner of Bootham and Bootham Row, which was demolished some time during the mid- to late 20th century when the reception building and forecourt were constructed.

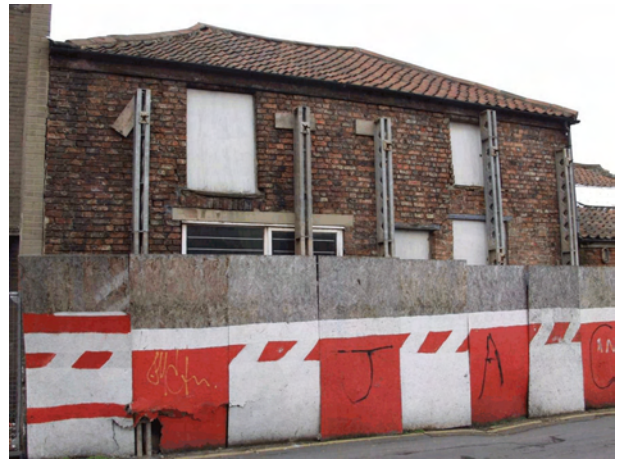
Plate 18 Southeast elevation of Structure 1

To the northeast of the reception building is Structure 1, a two-storey, approximately three-bay structure built of red clamp bricks, a timber fascia at eaves level with a basic moulding to its lower edge, and a hipped pantile roof (Plate 18). Although the ground floor of the elevation is largely concealed by modern hoarding, it is possible to make out a series of three openings: to the left, a large modern window opening with a concrete lintel, above which survives an earlier brick lintel for a narrower opening, and to the right, two small openings, both with narrow wooden lintels. The central opening may represent a doorway. The nature of the lintels and areas of disturbed and re-set brickwork around these two openings suggests that they too are modern insertions. At first floor level are two further openings. One, located directly above the larger of the three ground-floor openings and aligned with the redundant brick lintel, has the proportions of a taking-in door and appears to have a brick lintel and a thin stone sill. The second, smaller opening, also has a stone sill but apparently has a timber lintel. It seems likely that both of the first floor windows are original.

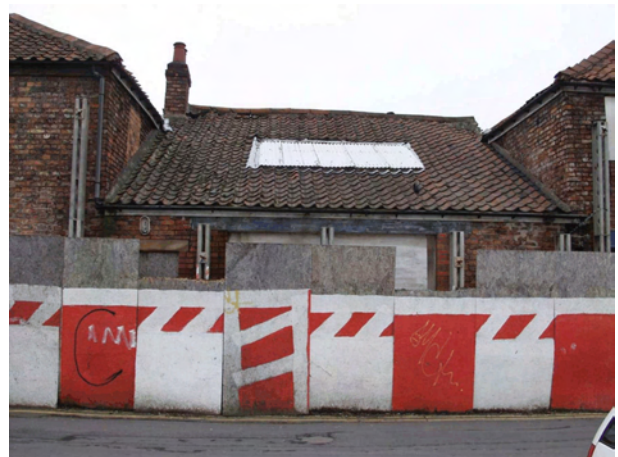
Plate 19 Southeast elevation of Structure 2

Moving northeast along the elevation is a single-storey structure (Structure 2), also built of red brick but only those at the northeast end of the building are clamps whilst to the southeast the brick has a smooth finish (Plate 19). There is a monopitch roof covered in pantiles, a large rectangular skylight of corrugated plastic sheeting (a modern feature, perhaps replacing an earlier skylight) and a small chimney stack rising out of the southwest gable. Stratigraphically, this structure is later than the building to the southwest, demonstrated by a ragged straight join between the two southeast walls, and the fact that the roof of this building cuts across a window in the northeast elevation of the building to the southwest. Openings in the ground floor of the elevation include, from left to right, a doorway with a stone lintel with chamfer detail, and a wide opening with a timber lintel. The use of some modern red brick in the northeast jamb of the wide opening suggests it is a later insertion. The southwest jamb probably reuses the edge of an earlier opening. The use of red clamp bricks to the northeast of the wide opening may indicate reuse of part of an earlier wall.

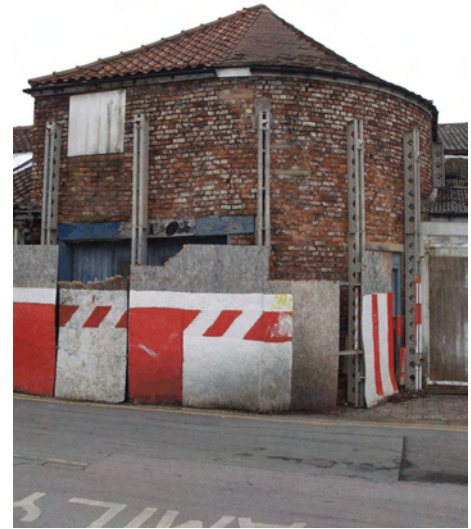
Plate 20 Southeast elevation of Structure 3

Next along the southeast elevation is a two storey structure (Structure 3), clearly the product of several phases

of structural activity. The building is of two bays, and has a rounded eastern corner (Plate 20). Although largely obscured by hoarding, the ground-floor section of both the southeast and northeast walls indicates that the building was raised on top of an existing boundary wall, the upper edge of which is marked by a row of bricks set on end. Inserted into this wall are two openings; one a wide opening in the southeast elevation, with a timber lintel and double wooden doors, the other a doorway with a stone lintel, the chamfer detail of which is stylistically similar to that observed in Structure 2 to the southwest. The first floor of the structure is built of red clamps; where the wall curves to meet the northeast elevation, a series of stone 'stitches' have been inserted, and some of the brickwork reset and repointed. These are undoubtedly modern repairs, probably reflecting the weak structural integrity of the building raised above a boundary wall, probably on insufficient foundations. The hipped roof is a combination of pantiles and small rosemary tiles, the latter used to follow the curve of the building. A single opening exists at first-floor level, in the southeast elevation; it is a small, square window which was formerly rectangular, the bottom of which has been filled in with five courses of reset clamps and a sill created out of bull-nosed red bricks, set on end. To the northeast of Structure 3 is a pair of wooden gates leading into a small covered passage and ultimately to the large shed at the centre of the site. The passage is roofed with corrugated sheeting, and its northeastern wall reuses clamp bricks, although the lower section may incorporate an *in situ* section of earlier walling. Of interest, this entrance is in the same position as the entrance to the former yard at the rear of the Black Horse Inn, therefore representing a continuity in access to the site from at least the early 19th century.

First, Structure 3, with the rounded corner, is clearly shown as a building on the 1852 OS map, but the surviving fabric suggests that, at some point, the lower sections of the wall formed a boundary wall and not a building. Thus, the incorporation of this boundary wall into Structure 3 must predate 1852. Second, there is no evidence in Structure 1 for it having been two separate buildings, as indicated on the 1852 OS map. This suggests either a cartographic error, or that the structure seen today is a rebuilding, which post-dates 1852. Third, the fact that the open yard between these two buildings is now occupied by Structure 2 concurs with the archaeological evidence from the site, which shows that the central of the three buildings is later than those to either side. Cartographic evidence suggests this building had been created by 1892.

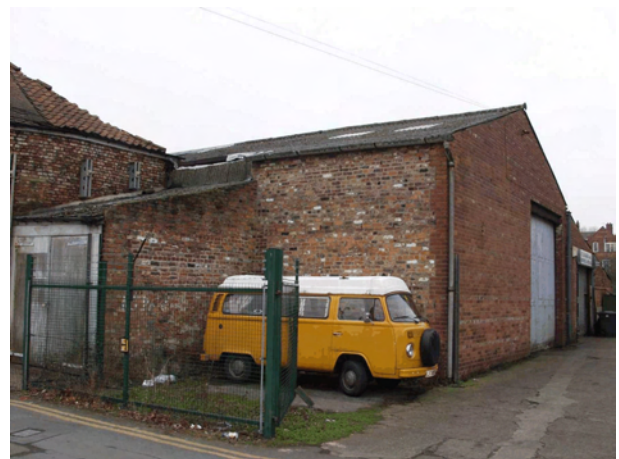
Plate 21 Northeast elevation of the site

To the northeast of the entrance, and set back from the Bootham Row frontage, is the only part of the southeast elevation of the central shed that can be seen from the exterior; it reuses clamps bricks and may be a recent rebuilding. The northeast corner of this elevation is built of the same modern red brick as that used on the northeast elevation of the shed (Plate 21). The northeast elevation has a single pitch gable and a large garage door opening in the western half, opening onto a small yard which also provides access to a second garage building directly behind No. 33 Bootham. The northeast elevation of this smaller garage building is also built of modern red brick, and may therefore be contemporary with the northeast wall of the Charlie Brown site. However, the join between the two structures is obscured by a downpipe, and could not be inspected closely. It may be that the smaller garage building behind No. 33 Bootham represents the site of the original Scobey's Garage.

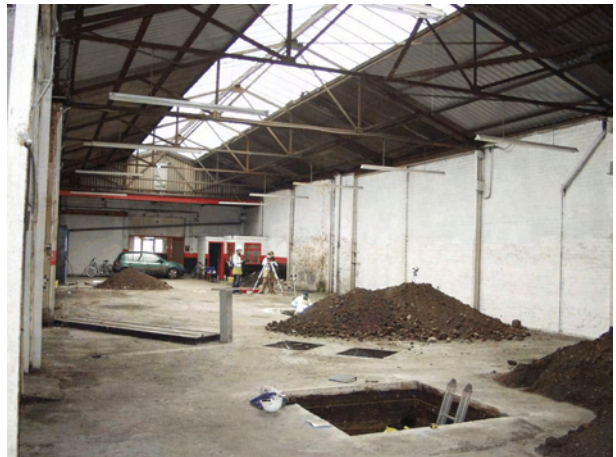
Plate 22 Internal view of the central shed looking south

A doorway in the northeast wall of the reception building communicates directly with a large shed, orientated northeast-southwest, forming the core of the site (Plate 22). The shed is eight bays long and the basic structure is composed of a steel and iron frame, with pairs of regularly spaced I-section stanchions supporting angle-iron or steel roof trusses; the trusses take the form of tie-beams with principal rafters and raking struts. The roof is covered in sheets of corrugated material, possibly asbestos, whilst the apex is glazed, providing the only source of natural light in the shed. The structural character of the steel-frame means that the northwest and southeast walls of the shed are non-load bearing, whilst

the southwest gable is constructed of panels of roofing material carried on an I-section steel beam (this gable includes a doorway providing access to a small area of flat roof over the reception building). To the northeast, the principal rafters are supported by the northeast gable wall which is constructed from modern red brick, and contains a full-height set of double doors, providing access to large vehicles. Further large doorways providing vehicular access to the shed are located in the southeast wall, one at the northeast end accessed via a short covered passageway, and a further set to the southwest and located immediately behind the reception building. At the southwest end of the shed, located in the western corner, are two small rooms constructed with concrete blocks. One was apparently used as a small office, with windows looking into the shed, whilst the other was used as a toilet.

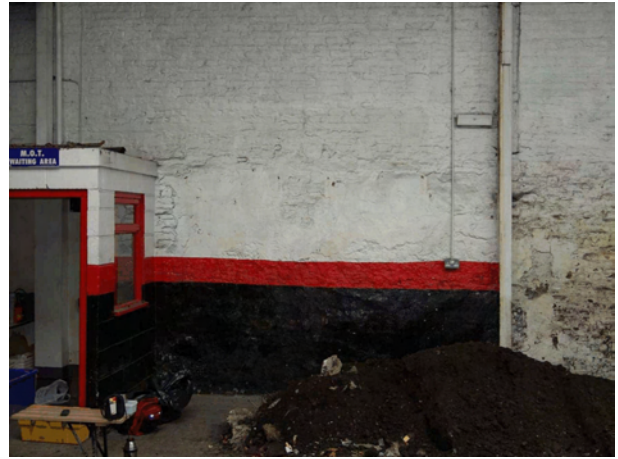
Plate 23 Area of earlier walling and plastered surfaces in the northwest elevation of the central shed

The northwest and southeast walls of the central shed are of considerable interest, as they contain sections of earlier walling, reflecting the fact that the structure of the shed was effectively 'slotted-in', between existing buildings and boundary walls to the northwest and southeast. The northwest wall comprises a number of distinct sections, but those towards the southwest clearly relate to structures on the adjoining plot, No. 33 Bootham. Here the bricks are narrow, probably dating from the 18th century, and appear to relate to the long range of

buildings extending from the rear of No. 33. The lower parts of this party wall retain a plastered surface which was undoubtedly once the interior of a structure built up against the party wall and predating the central shed (Plate 23). Cartographic evidence indicates that when the site was occupied by the Black Horse Inn, ranges of buildings extended from the rear of the inn along both the northwest and southeast boundaries of the site. These probably contained service buildings and stabling, and the rough character of the surviving plaster surface on the party wall would be consistent with a service room in the northwestern range. A number of straight joins in the northwest wall of the shed reflect the structural development of the range to the rear of No. 33, rather than evidence for earlier buildings on the Charlie Brown site. However, about halfway along the northwest wall, at the point where modern brickwork begins, an earlier feature can be identified (Plate 24). This comprises a section of brickwork, with bricks set on end and forming a curved edge. This must reflect the former extent of buildings to the rear of No. 33 Bootham, and the onset of what would appear to be a tall garden wall; the falling curved edge of the wall, with bricks set on end, is characteristic of the junction between a building and a garden wall. The fact that the garden wall is discontinued shortly after this point is consistent with the late 19th and early 20th century cartographic evidence, which suggests that the boundary between No. 33 and the Charlie Brown site was partially removed. The remainder of the northwest wall is built of modern brickwork, presumably contemporary with the shed structure, with the exception of the northeasternmost bay which is largely constructed of reused clamp bricks.

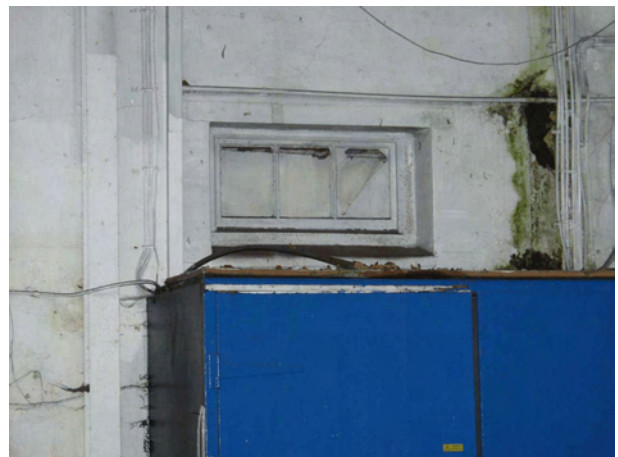
Plate 25 High level three-pane window in the southeast elevation of the central shed

The southeast wall of the central shed represents the rear, northwest wall of the series of small buildings fronting onto Bootham Row (Structures 1 to 3), and provides evidence for several phases of structural activity. Much of the southwestern end of this wall is obscured, but a high level, ground-floor window, comprising a three-pane casement window, survives apparently *in situ* (Plate 25). Without closer inspection, it is not possible to determine with any certainty why this window is set at such an unusually high level, but there are two possible explanations. First, the window may have been positioned above the height of an

existing wall, perhaps a boundary wall similar to that surviving in the northwest elevation; certainly, parts of the southeast wall contain earlier brickwork in its lower sections (see below). However, the 19th century cartographic evidence suggests that this building was originally constructed up against one of the rear ranges of the Black Horse Inn, in the early to mid-19th century. The window cannot, therefore, be original, and must post-date the demolition of the Black Horse Inn. Second, and perhaps most likely, the window represents the fanlight above a doorway, now blocked. This doorway, which must also post-date the demolition of the Black Horse Inn, would have led onto the open space known as 'Providence Square'. Upon construction of the central shed it would have become redundant, replaced by a modern doorway to the northeast. Incidentally, this modern doorway is fitted with a reused four-panel door, which may date from the late 18th to early 19th century.

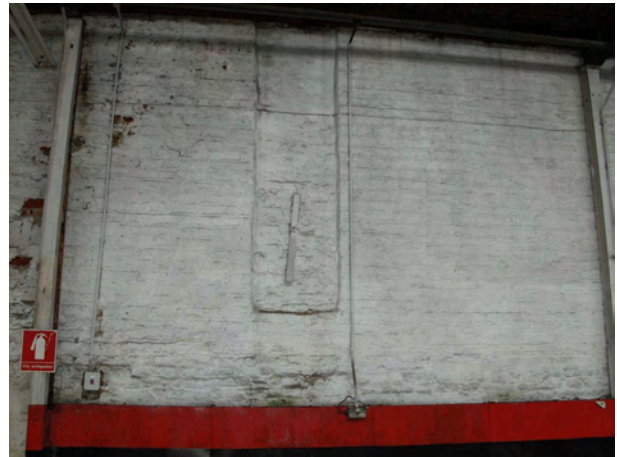
Plate 26 Rectangular feature in the southeast elevation of the central shed

Continuing northeast along the southeast elevation, it is apparent that the lower sections of the wall are earlier than the brickwork above, evidenced by the use of thin, probably 18th century bricks, as opposed to the wider clamps used higher up. This provides a stratigraphic sequence for the construction of the buildings along the southeastern edge of the site, which were partially constructed over an existing length of wall. This may represent the remains of an earlier boundary or structure, which was then incorporated into the later buildings. The brickwork above the earlier section of wall, and two unexplained recessed rectangular features (Plate 26), suggests that this elevation was at least partially built up against an existing structure to the northwest, identified using the cartographic evidence as the range of buildings to the rear of the Black Horse Inn. The evidence in the surviving elevation suggests that the range was at least two storeys high, at the point against which the buildings on Bootham Row were built.

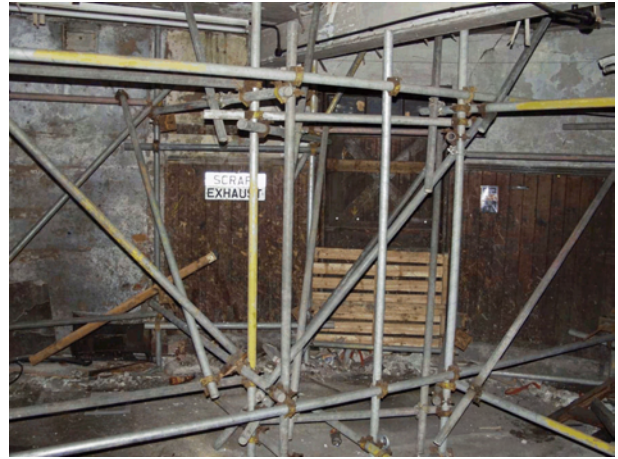
Plate 27 Incomplete panelling in the ground-floor room of Structure 3

The northeastern of the two ground floor rooms (Structure 3) retains areas of panelling to dado height and it is unclear without closer inspection whether the panelling originally continued all the way around the room or was always incomplete (Plate 27). The panelling itself is of tongue-and-grooved pine, on top of a plain skirting and finished with an architrave moulding in place of a proper dado moulding. The walls are plastered and in places retain a light green paint finish; the ceiling is of lath and plaster construction and the floor of concrete. A window in the northwest wall, now boarded up and containing a 4-pane, double casement window with a timber frame, must be original, predating the construction of the central shed to the northwest. To the southwest, the central room (Structure 2) is treated in a similar way to its neighbour to the northeast, but, in general, the quality of the internal treatment is of a higher standard (Plate 28). The floor level of the room, comprising narrow pine floorboards, is higher than that to the northeast, and the room is open to the underside of the monopitch roof and lit by a single skylight. The roof trusses, comprising a tie beam and a principal rafter braced by raking struts, have been 'boxed in' and the undersides of the tie beam have beaded edges. There is no evidence for a wall plate and it is therefore assumed that the tie beams are embedded in the walls to the northwest and southeast; indeed, the end of one of the tie beams is visible in the southeast wall of the central shed. All walls have wooden panelling to dado height with no skirtings and an architrave moulding used in place of a proper dado moulding. A strip of wood with a bevelled edge surviving on the southwest wall is probably the remains of a coat hook. Although undiagnostic, in terms of providing a date for the interior treatment of the room, the character of the woodwork and the mouldings are typical of the late 19th to early 20th century. Above the panelling, the walls are plastered and coloured with a

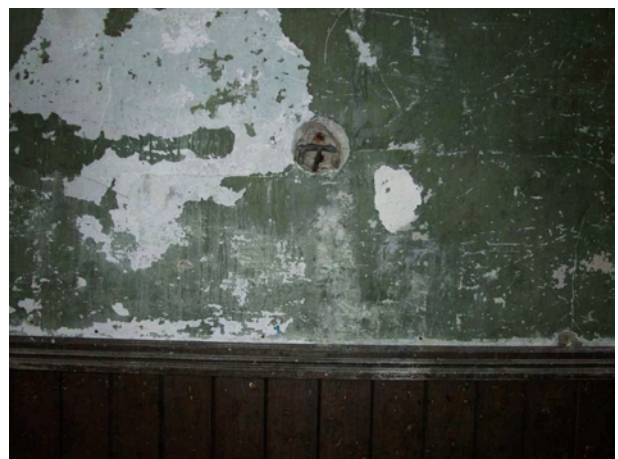
Plate 29 Position of former gas light fitting

dark green distemper paint, which may be the original treatment. Surviving within the plasterwork are sections of lead gas piping and the former siting of two gas lights can be seen on the northwest wall (Plate 29). In the western corner of the room, is a corner chimney stack; there is no evidence for any opening with the exception of a circular flue hole (Plate 30). This would seem to indicate the presence of a former stove, which would have stood on the stone hearth that survives *in situ*. The only other feature of note is a doorway leading to a first-floor room in Structure 3, which was probably accessed using a moveable ladder, the fixings for which survive in the plaster at the base of the door (Plate 31). This room was not available for close inspection, but it is open to the roof structure and contains at least one timber rack or shelving unit.

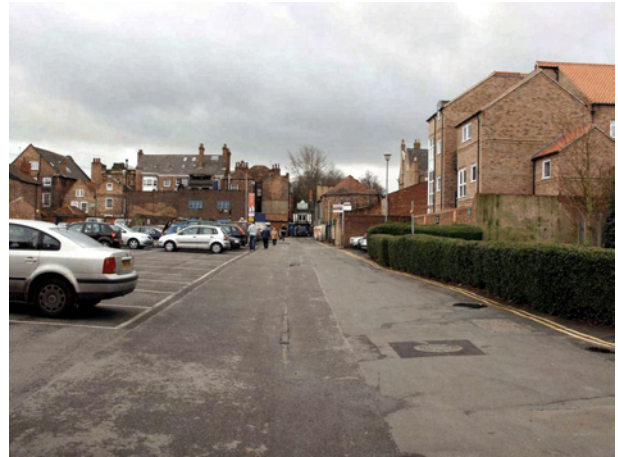
Plate 32 Bootham Row looking southeast

With the extensive demolition during the course of the 20th century, the 19th century streetscape that formerly existed on Bootham Row has all but disappeared, replaced with largely modern elements. The remaining earlier buildings on Bootham Row, forming part of the southeast side of the Charlie Brown garage, are the only 19th century surviving structures contemporary with the creation of the street. These buildings have received considerable alteration to their facades and, unfortunately, they now neither evoke the former character nor make a positive contribution to the modern character of the street. The buildings are hidden from the main Bootham street to the extent that they play no part in that streetscape, and it is therefore difficult to argue that these buildings make a positive contribution to the Conservation Area.
