**CHAINAGE 2500-2586,
CITY WALLS,
YORK**

**REPORT ON AN
ARCHAEOLOGICAL
WATCHING BRIEF**

**2000 FIELD REPORT
NUMBER 23**

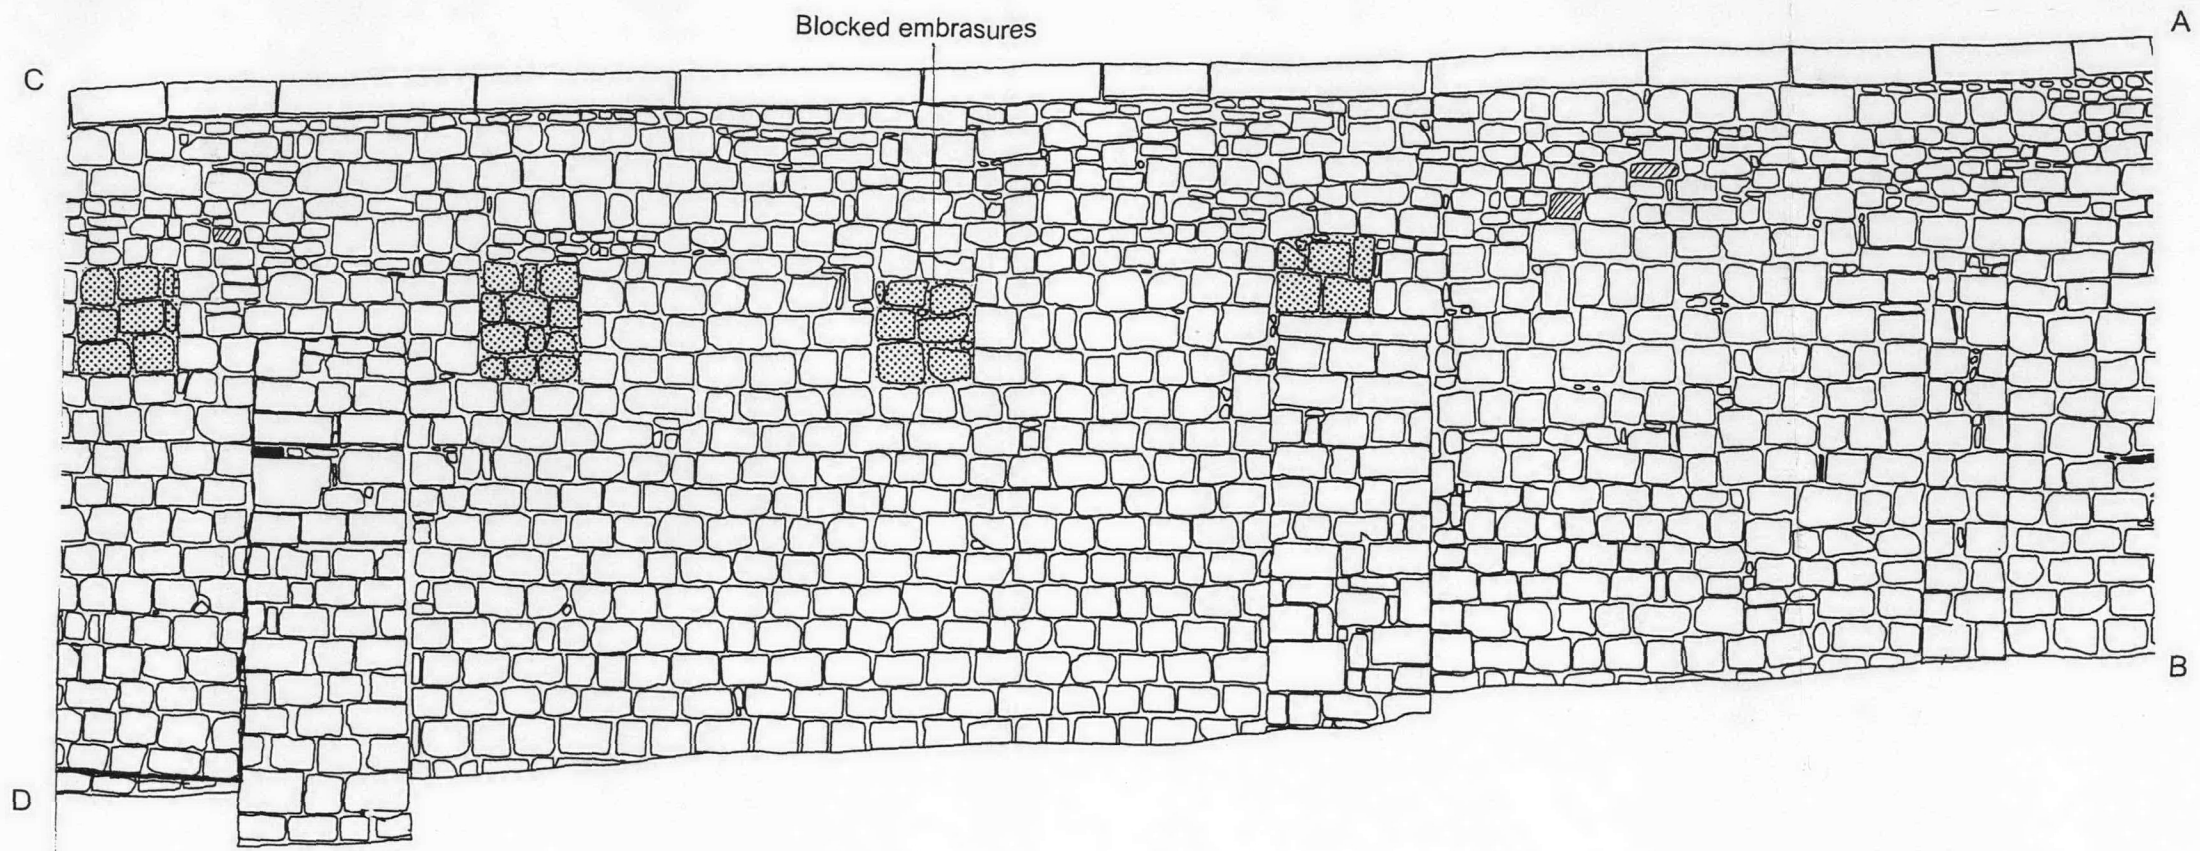
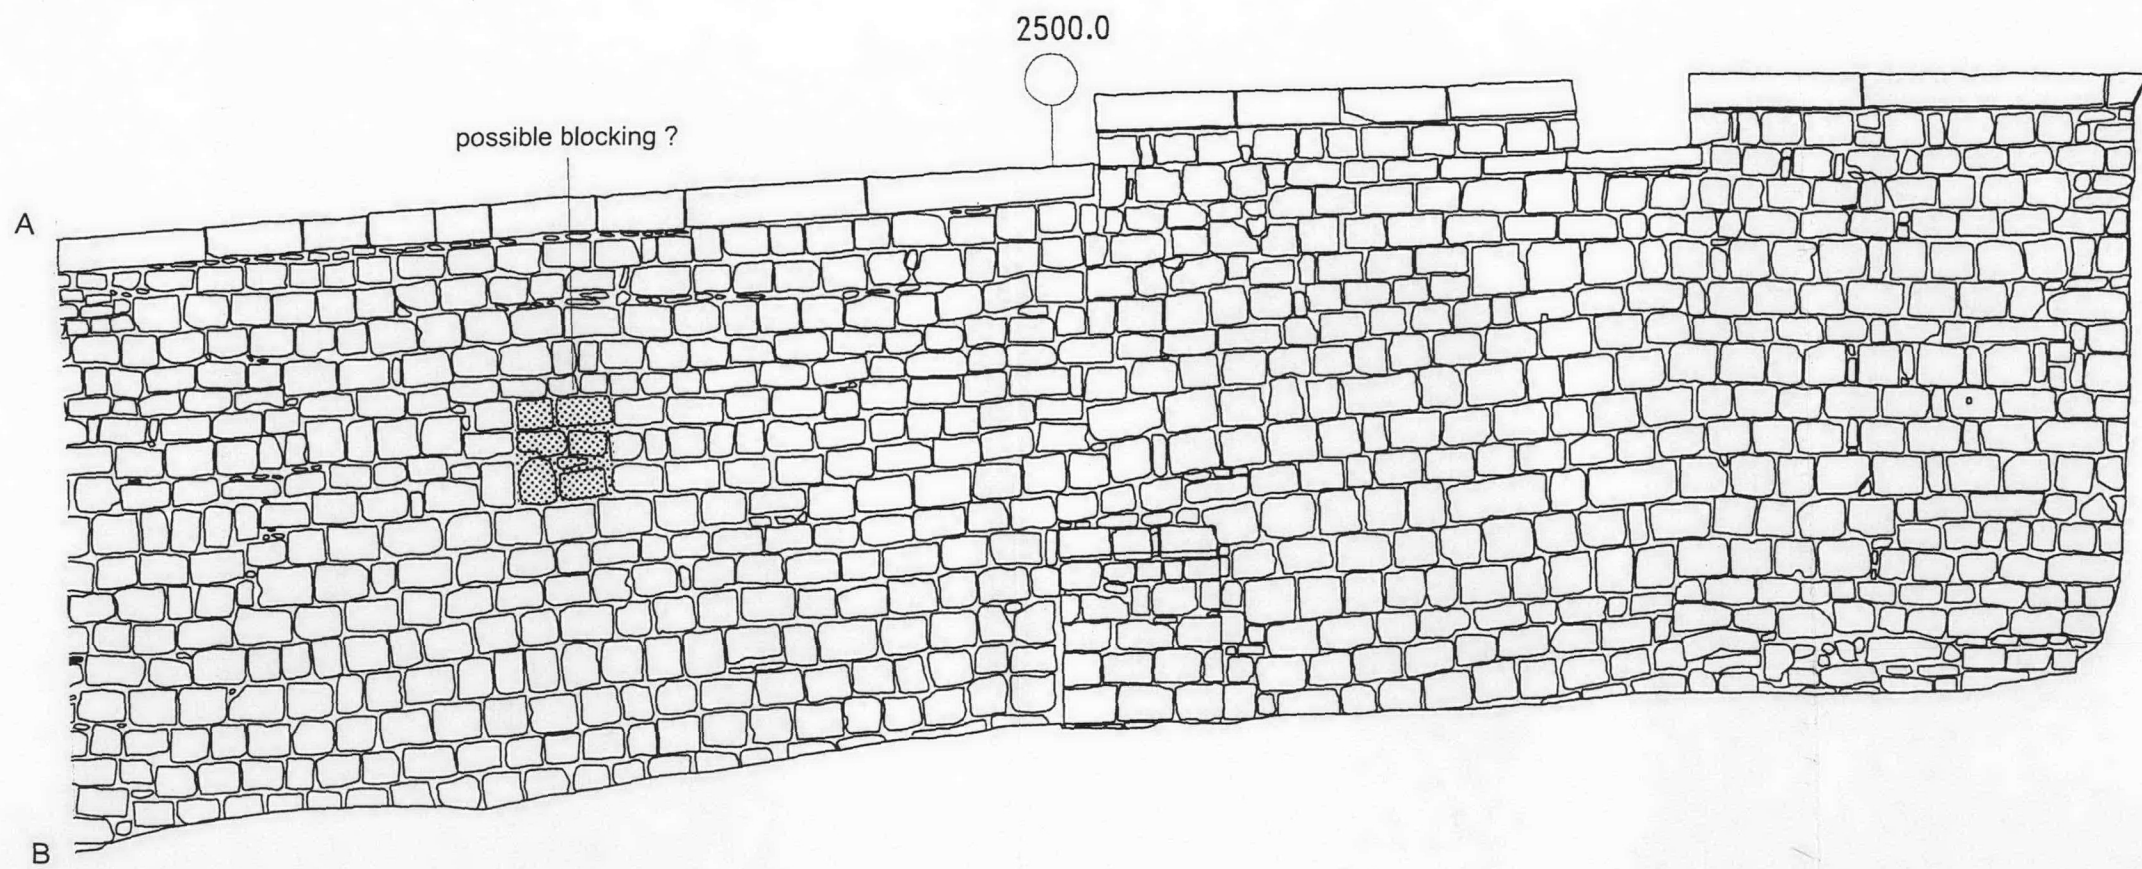
Figure 11

Figures 11 – 14 are of the outer elevation of the wall, figures 15 – 17 of the inner. Chainage measurements are shown on both elevations. The numbered locations on Figures 15 – 17 relate to the position of engineering tie-in works.
