Section1: Tower 1 to Bitchdaughter Tower (walls and minor towers)

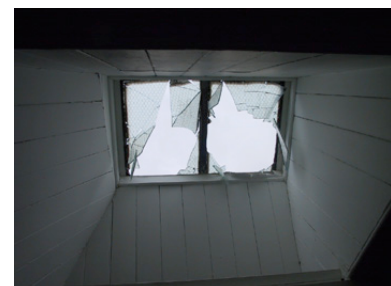
The engine house / payments hall suffers from repeated vandalism

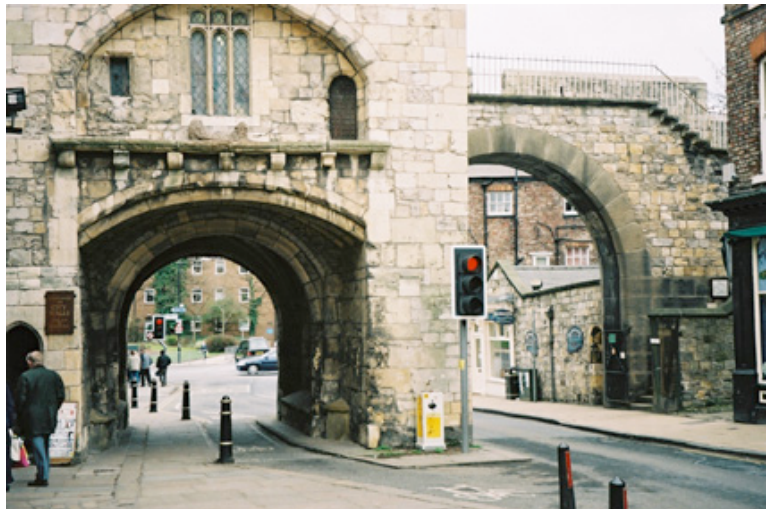
The internal stonework is subject to decay

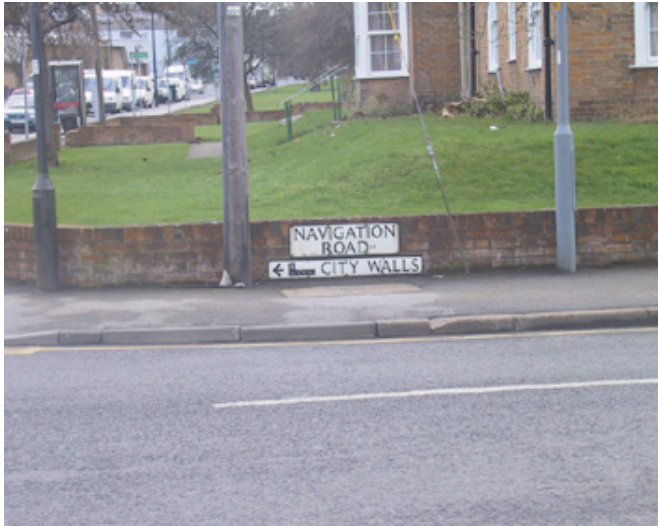
Orientation to the next section of City Walls can only be seen when walking south. Visitors walking northwards are likely to miss this sign.

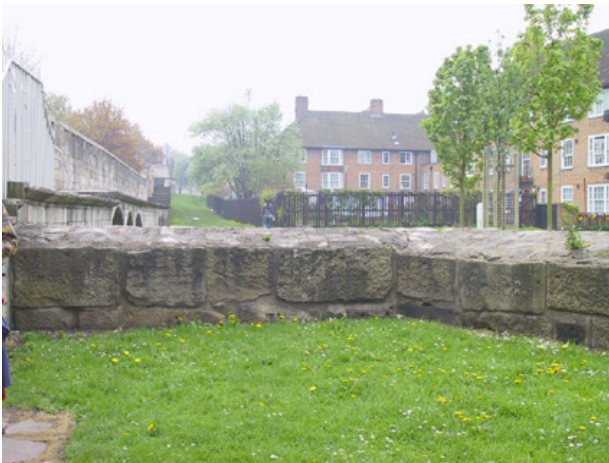
The low wall on the west side of the Red Tower, made from re-used stone blocks
