Heritage, Design & Access Report

14-16 Castlegate, York, YO1 2DN

Higgs Young Architects
June 2017

3.0 Existing Buildings Condition Survey

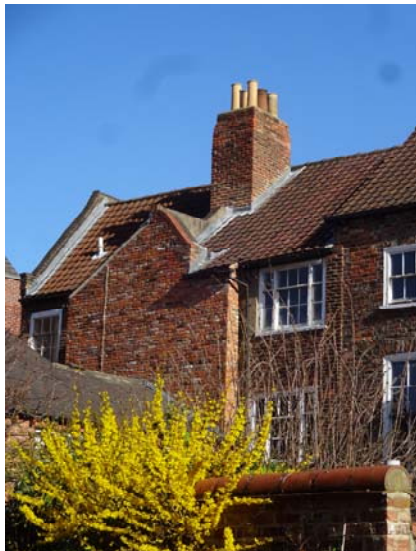
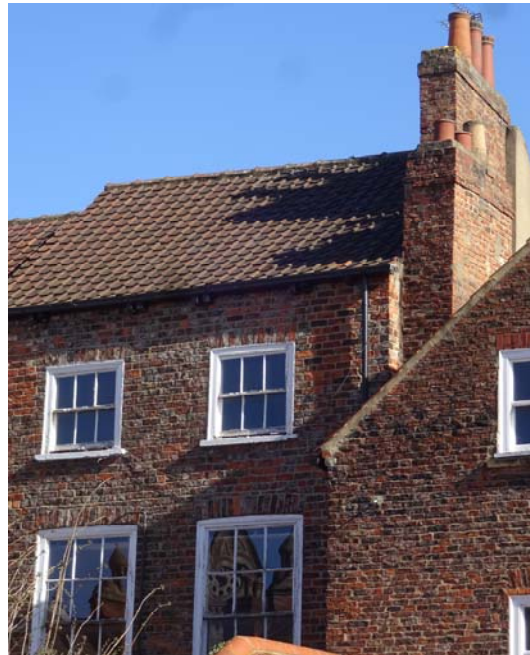
The rear elevation to the terrace is not prominent form the public realm but the rooftops can be seen from the garden to the Friends Meeting House off Friargate. The roofs have been recently repaired and the tiles and lead flashing appears to be sound

Rear View Roof top to Nos. 12 & 14 Rooftop to No. 12 Castlegate

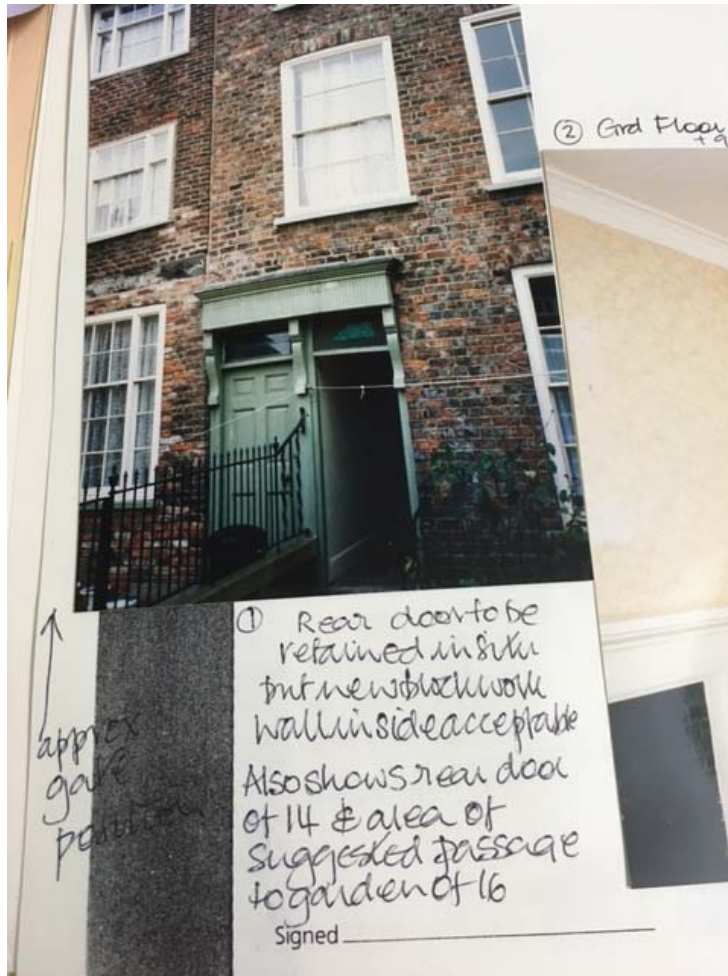
Photograph of rear doors to Nos.14 and 16 taken in 1979 (CoYC planning files)

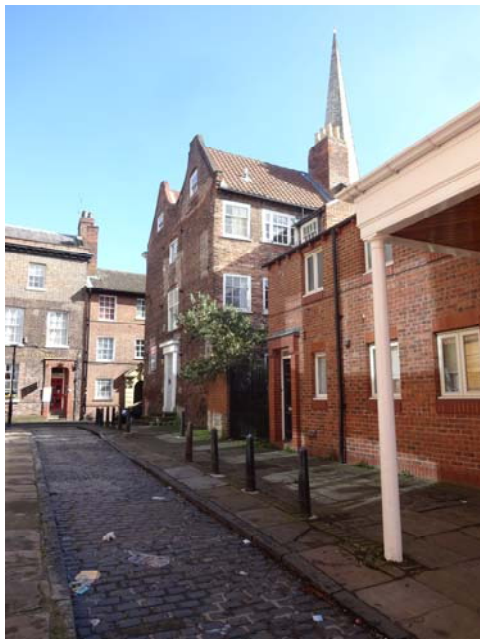
View of No. 12 seen from Friargate

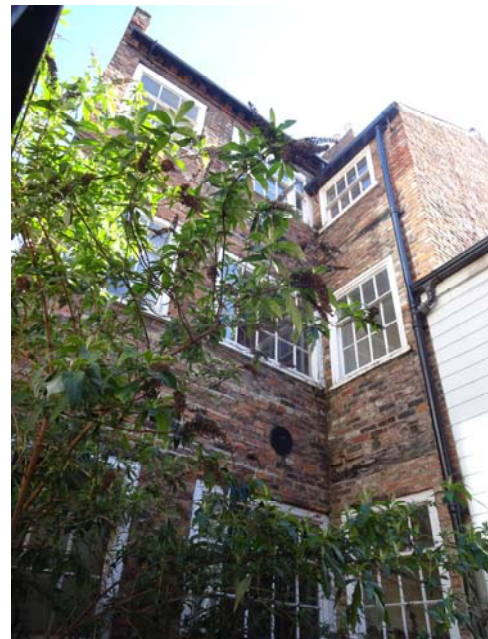
Windows to rear elevation of No. 12

- 4.9 All windows will be retained, overhauled and repaired where necessary.
- 4.10 Decorations externally to all windows and doors and surrounds. Paint scraping to be undertaken on existing frames and original colour determined. Colour to be agreed with Conservation Officer.

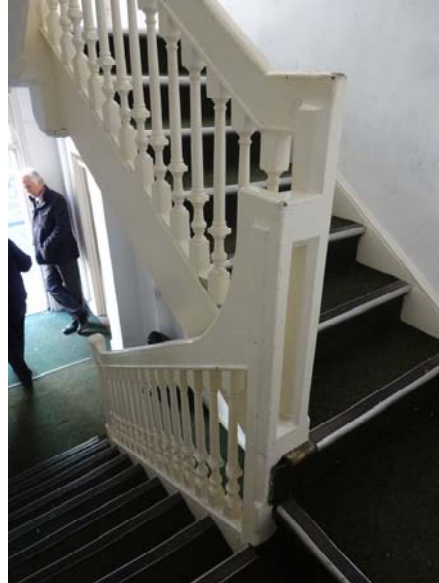
Balustrade, strings and handrail complete and painted. Stairs covered with carpet and nosings.

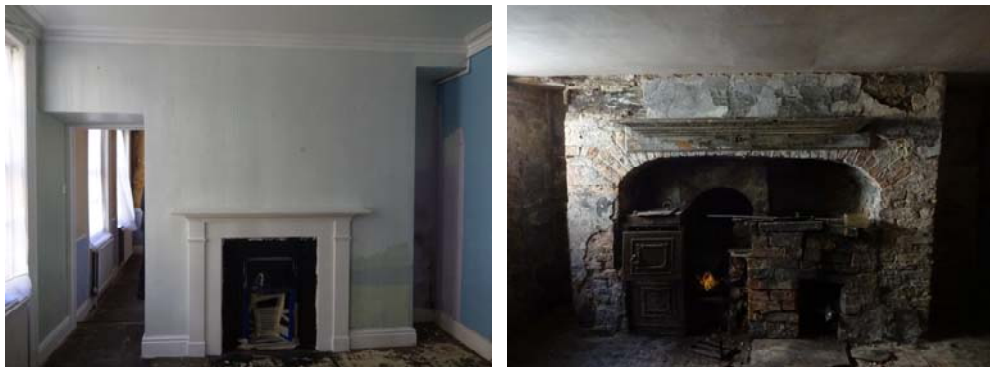
12 Castlegate Ground Floor Fireplace and Basement Range

The principle rooms have fire surrounds and hearths as indicated on drawing HYA 01 Existing Plans. In places hearths have been over boarded and site investigations will take place once soft strip demolition is approved.

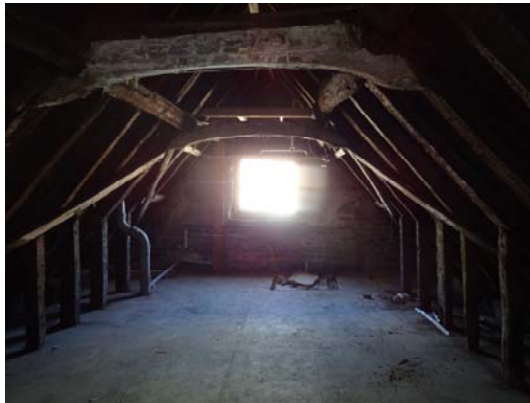
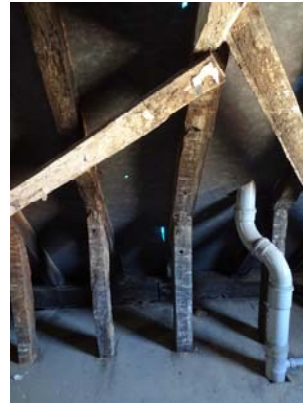
Attic to no. 12 Castlegate

Original timber roof structure – no changes proposed to attics other than restoration of existing and reorganization of services. Spaces to remain as storage use.
