Photographic Recording Report
Relating to Structural Timber and Render Repairs at
72 Goodramgate, York, YO1 7LF

ON BEHALF OF:
North Country Properties Ltd c/o Vine Property Management

Reference: WACBLD272

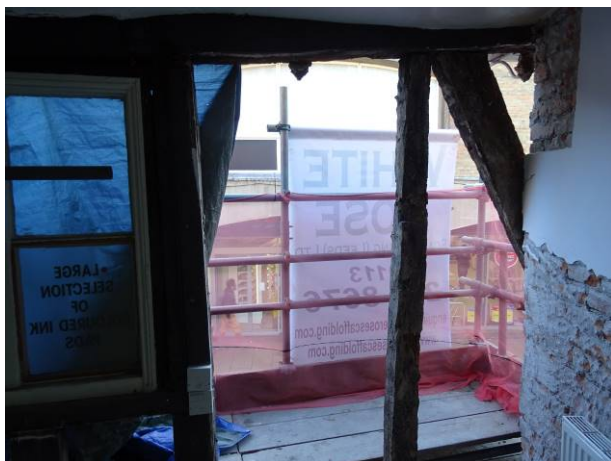
07 - Exposed timbers of front elevation – from internal

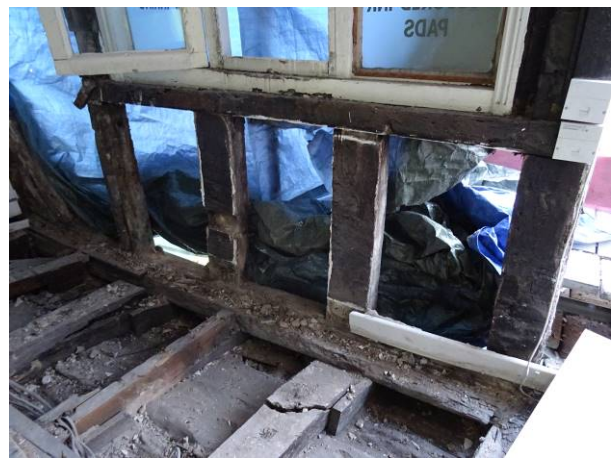
08 - Exposed timbers of front elevation – from internal

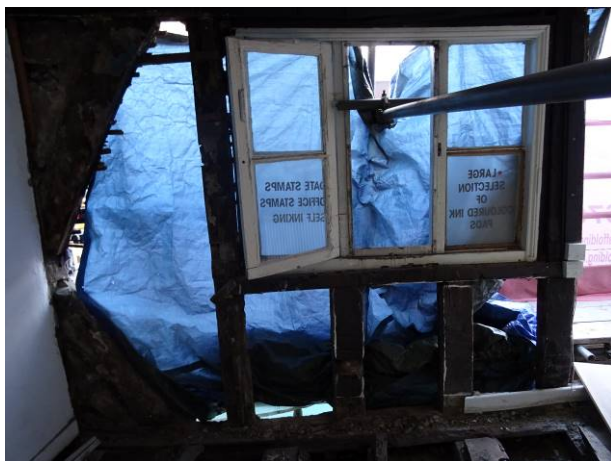
09 - Exposed timbers of front elevation – from internal

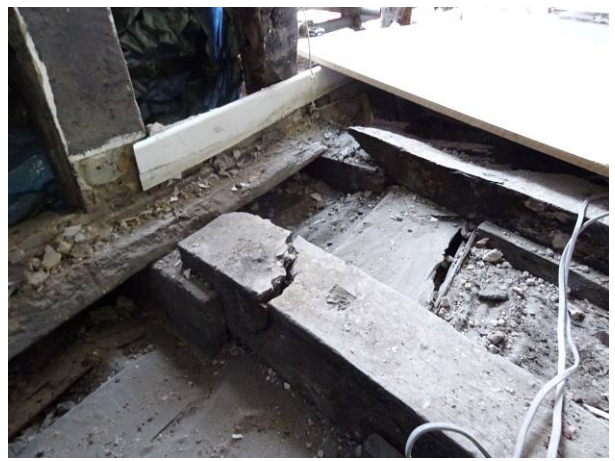
10 - Exposed timbers – taken from inside the property

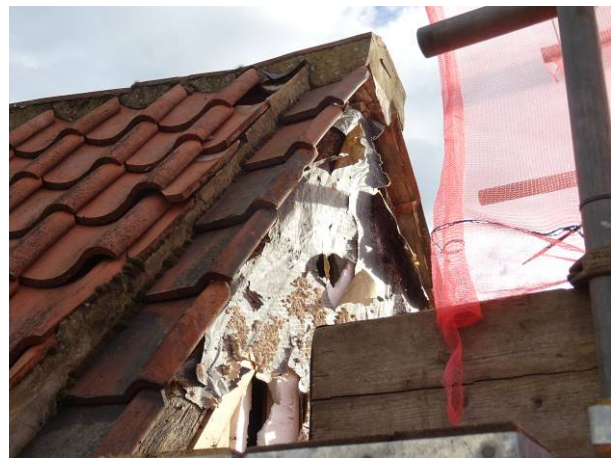
44 - LHS elevation - gable

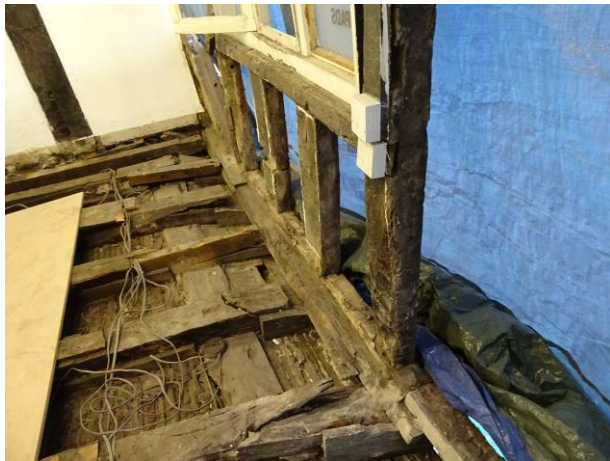
82 - Internals – snapped joist ends at jettied structure at first floor level

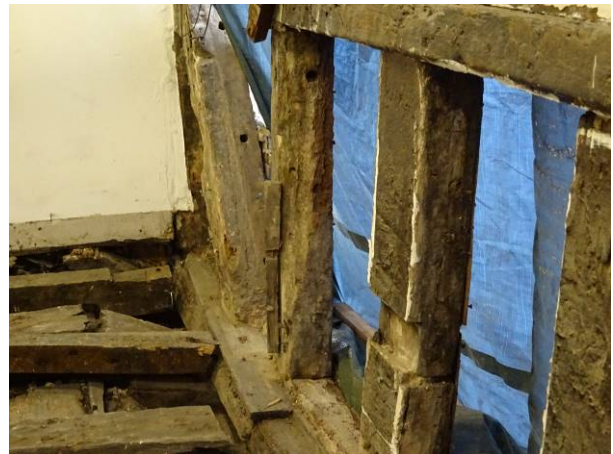
83 - Internals – snapped joist ends at jettied structure at first floor level and exposed timbers

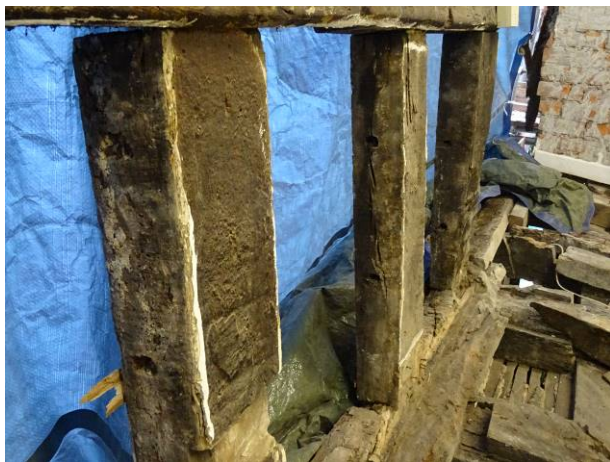
84 - Internals – exposed timbers of front elevation

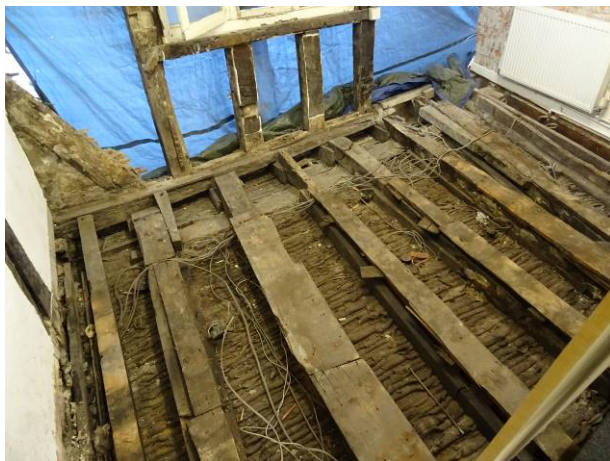
86 - Internals – snapped joist ends at jettied structure at first floor level and exposed joists and timbers

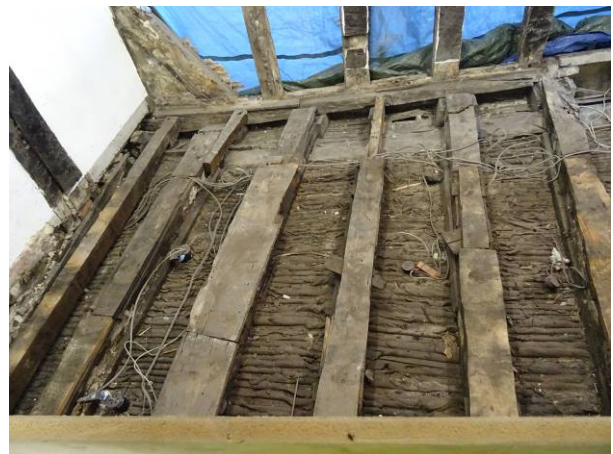
87 - Internals – snapped joist ends at jettied structure at first floor level and exposed joists and timbers

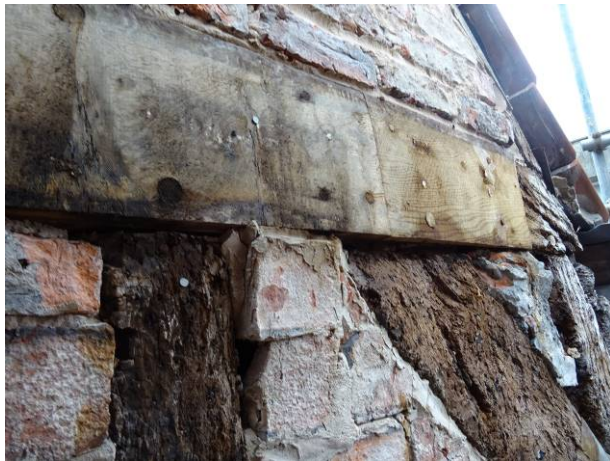
108 - LHS elevation – previous timber repairs

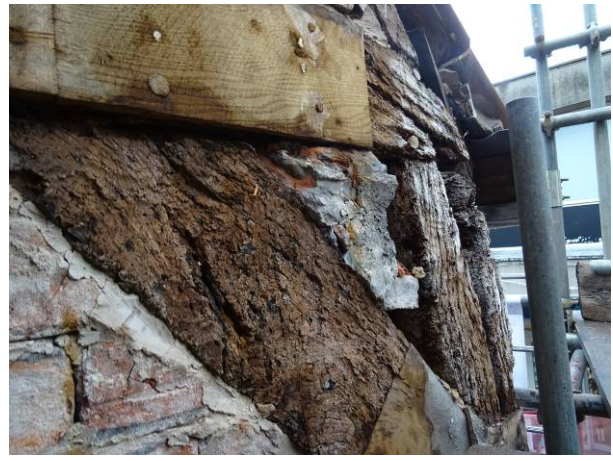
109 - LHS elevation – previous timber repairs

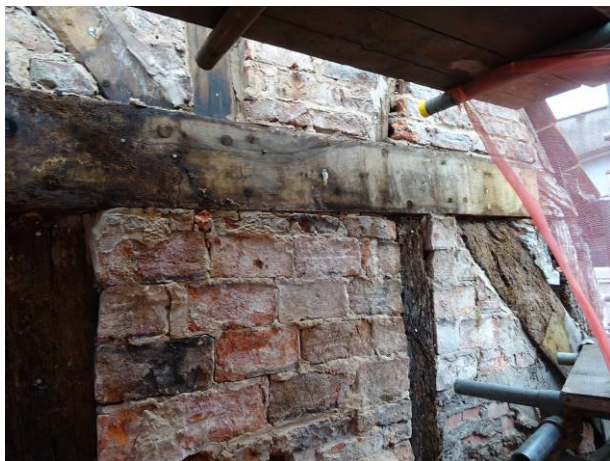
110 - LHS elevation – previous timber repairs

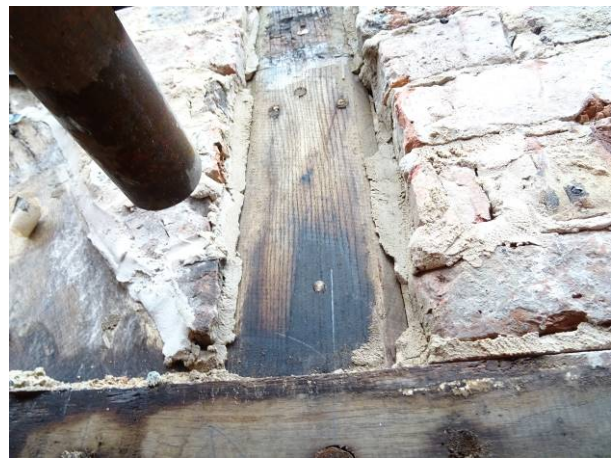
111 - LHS elevation – previous timber repairs

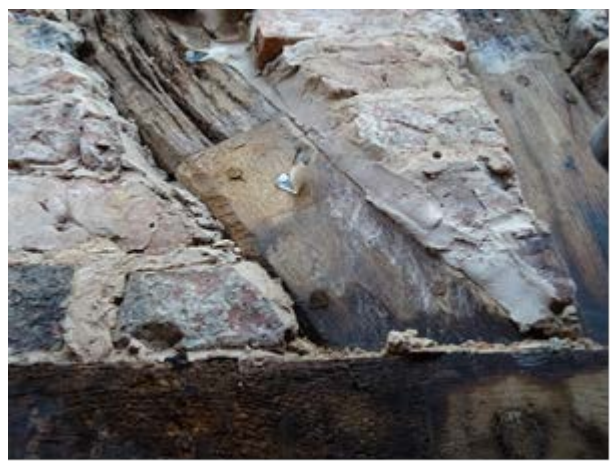
112 - LHS elevation – exposed timbers and previous repairs

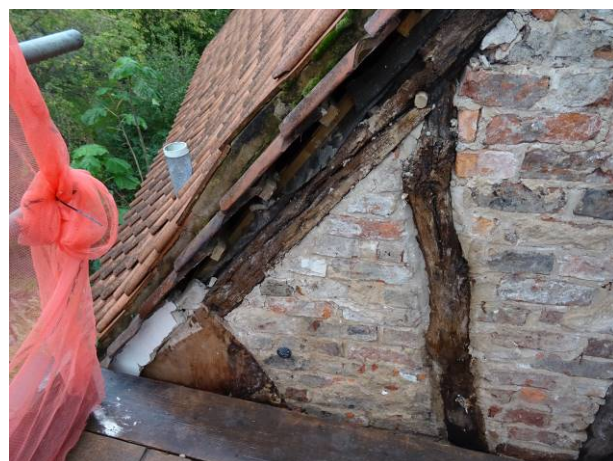
113 - LHS elevation - exposed timbers and previous repairs

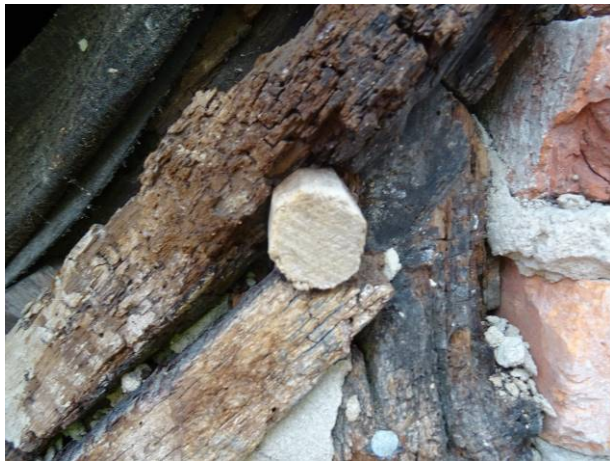
114 - LHS elevation - exposed timbers and previous repairs

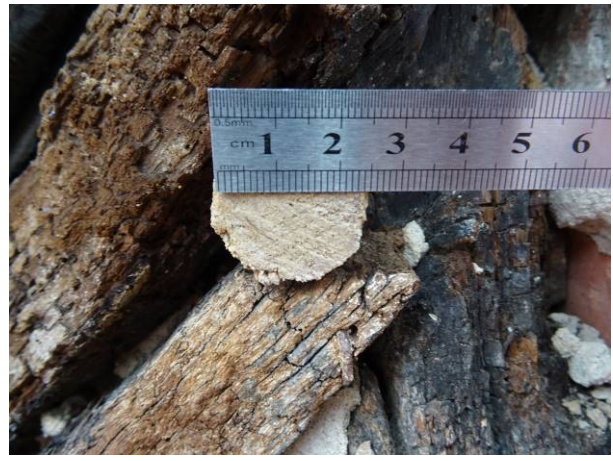
115 - LHS elevation - exposed timbers and previous repairs

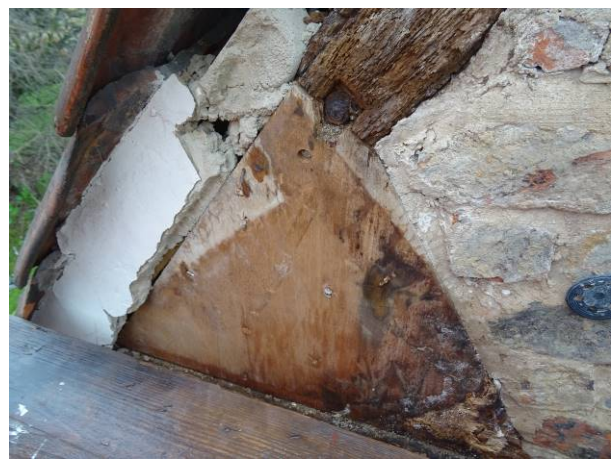
117 - LHS elevation - exposed timbers and previous repairs

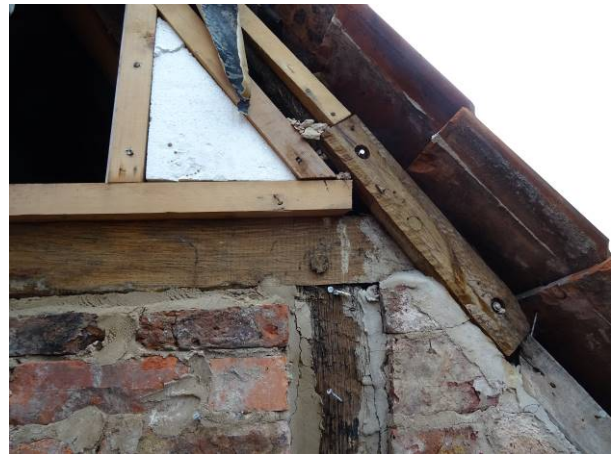
121 - LHS elevation – exposed timbers and previous repairs

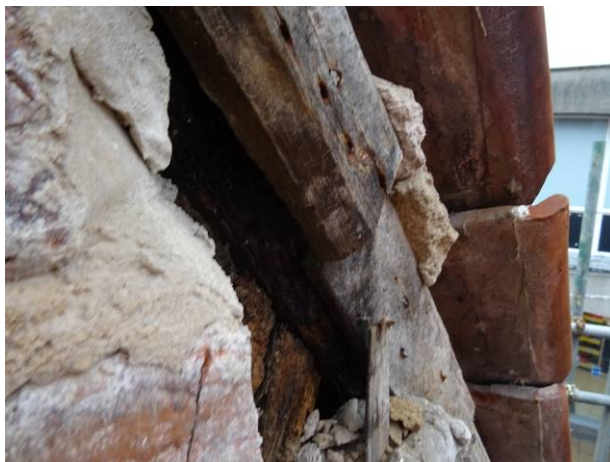
122 - LHS elevation – exposed timbers and previous repairs

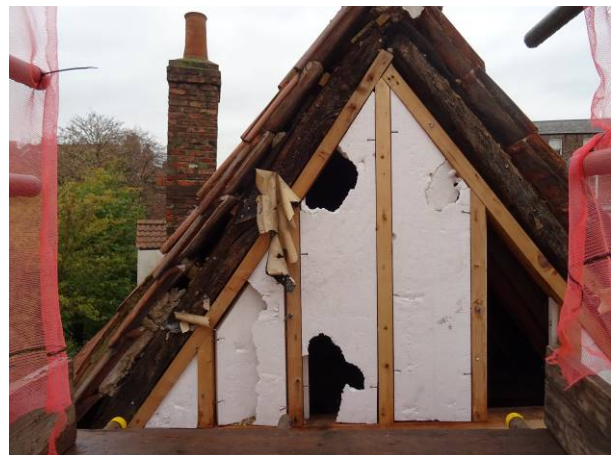
123 - LHS elevation – exposed timber and gable timbers

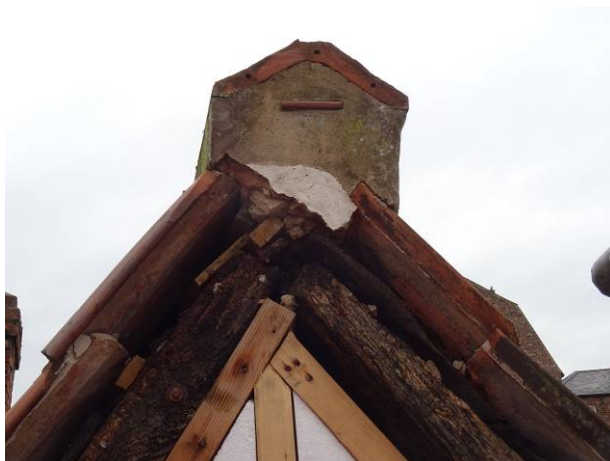
124 - LHS elevation – exposed timbers at roof apex

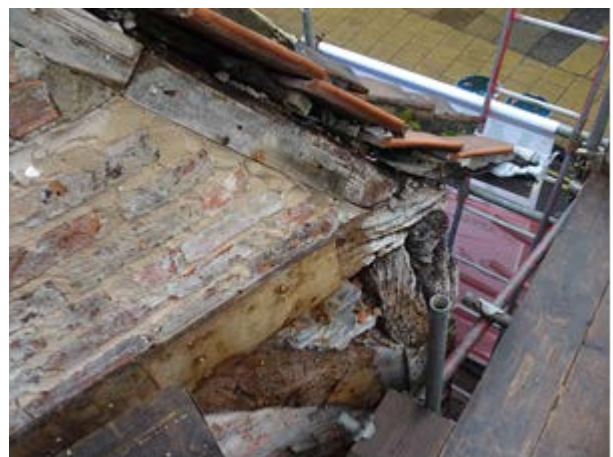
125 - LHS elevation – exposed timbers and previous repairs

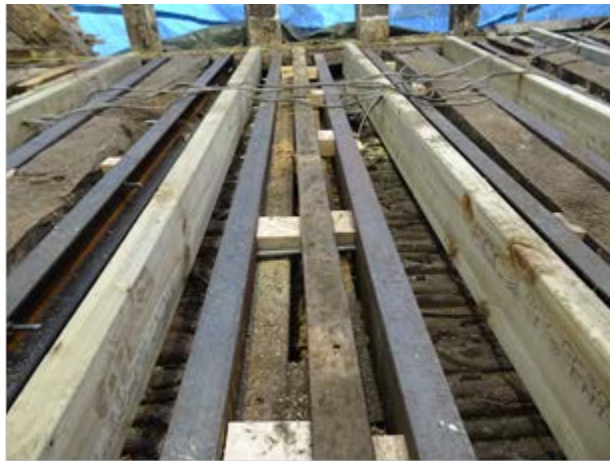
134 - Internals – First floor channel steel sections

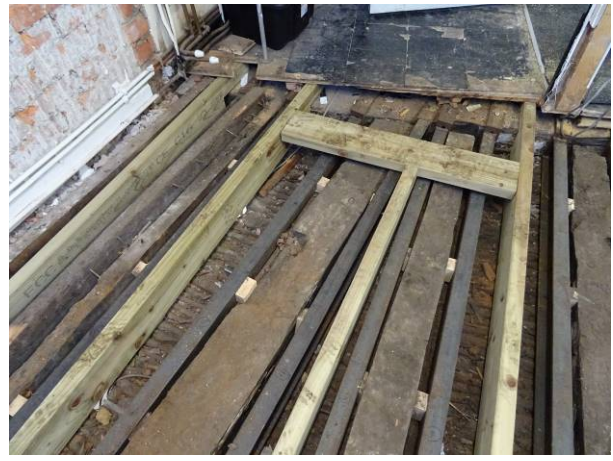
135 - Internals – First floor channel steel sections

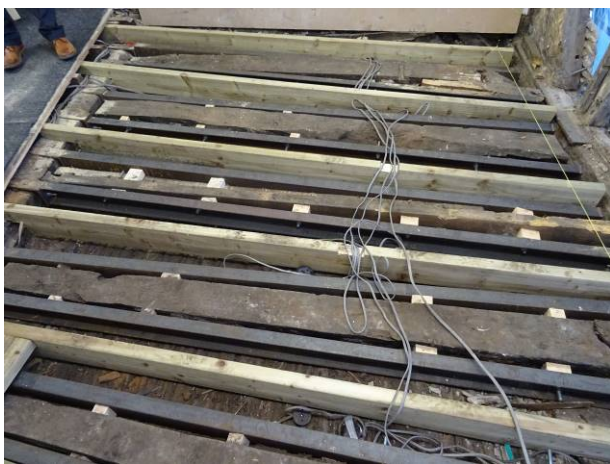
136 - Internals – First floor structural reinforcements / channel steel sections in pairs

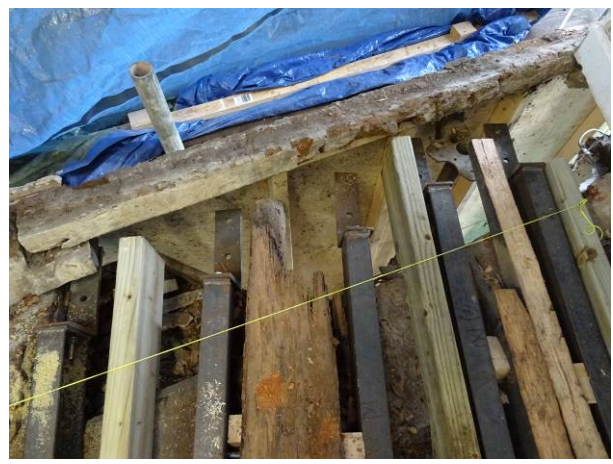
137 - Internals – First floor structural reinforcements with sole plates

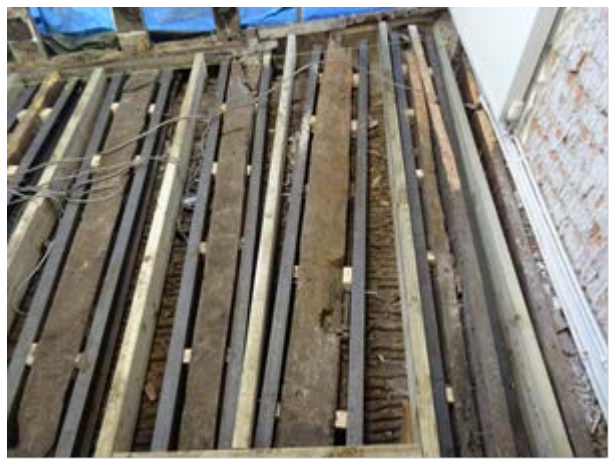
138 - Internals – First floor structural reinforcements / channel steel sections in pairs

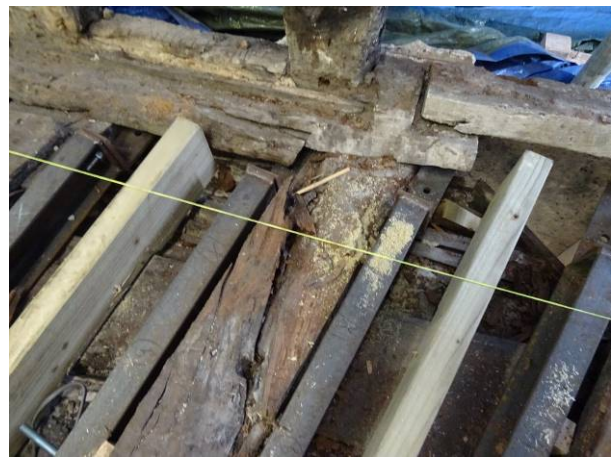
139 - Internals – First floor structural reinforcements with sole plates

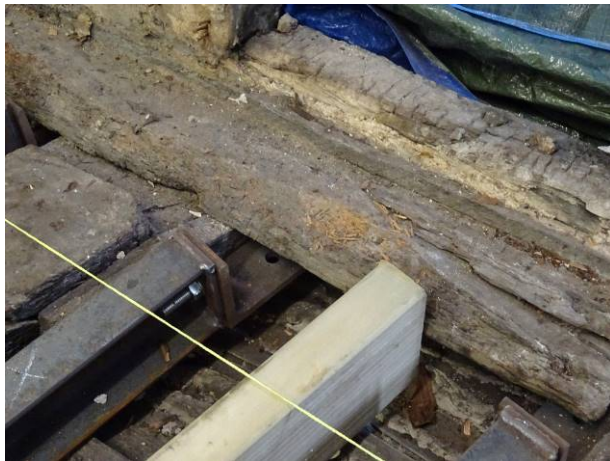
140 - Internals – First floor structural reinforcements with sole plates

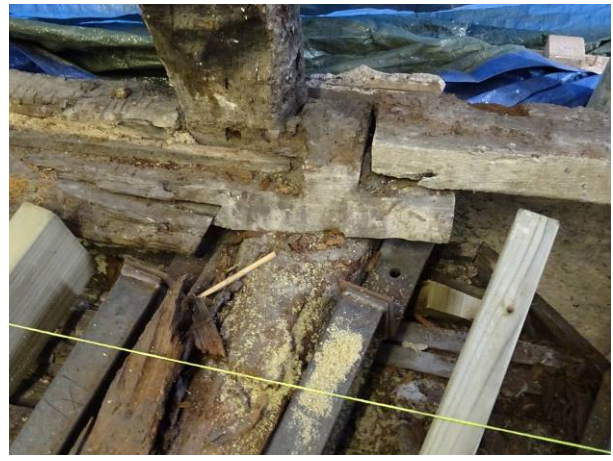
141 - Internals – First floor structural reinforcements with sole plates

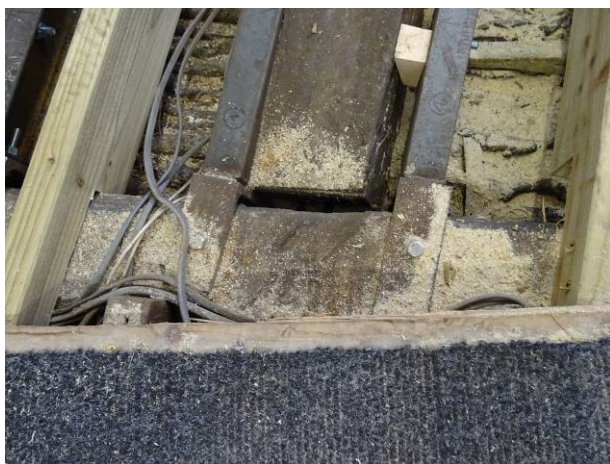
142 - Internals – First floor structural reinforcements / channel steel sections in pairs

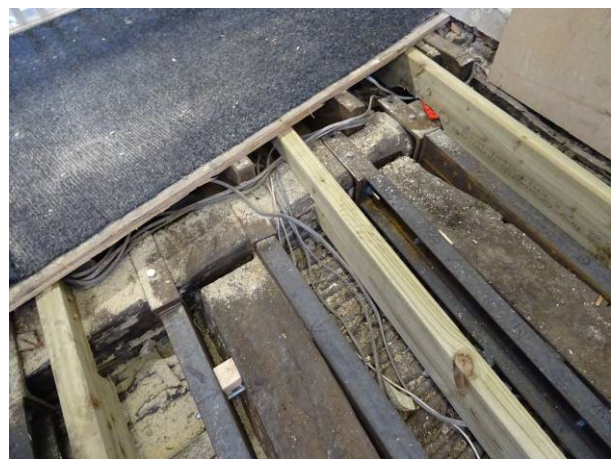
143 - Internals – First floor structural reinforcements / channel steel sections in pairs

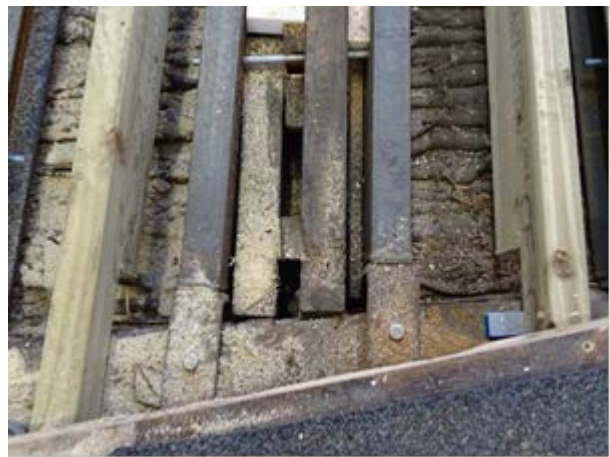
144 - Internals – First floor structural reinforcements / channel steel sections in pairs

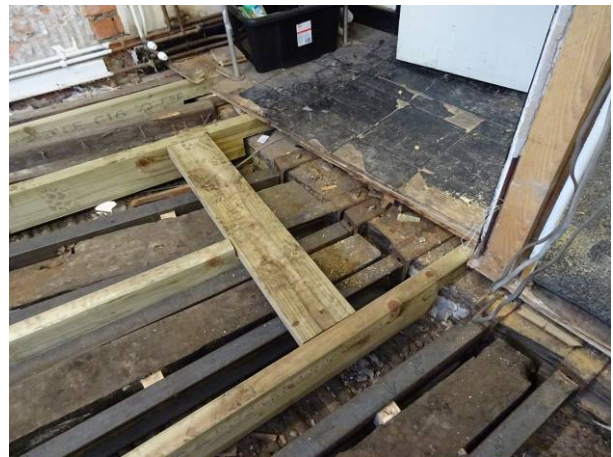
145 - Internals – First floor structural reinforcements / channel steel sections in pairs

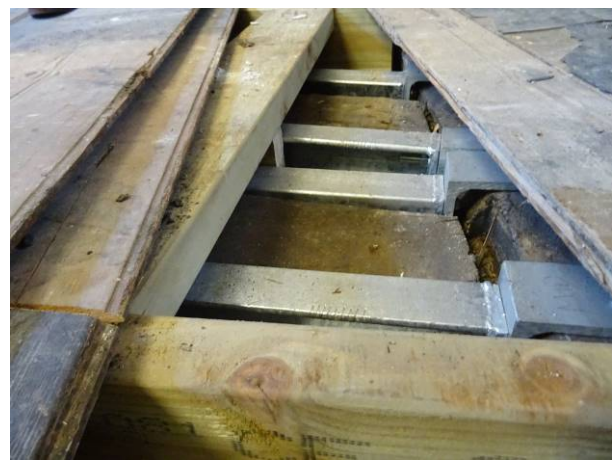
151 - Steel channels tied into the central beam

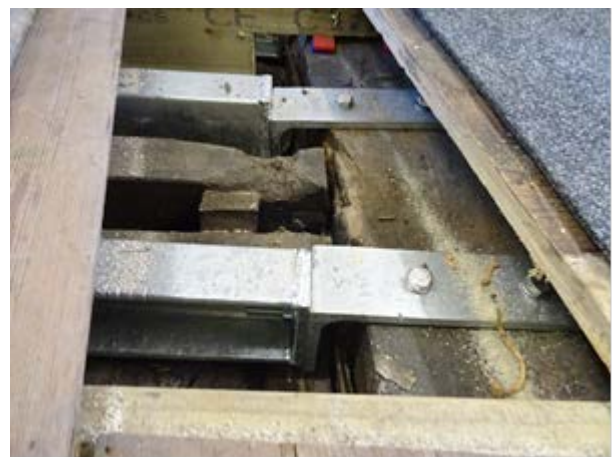
152 - Steel channels tied into the central beam (at the centre of the property).

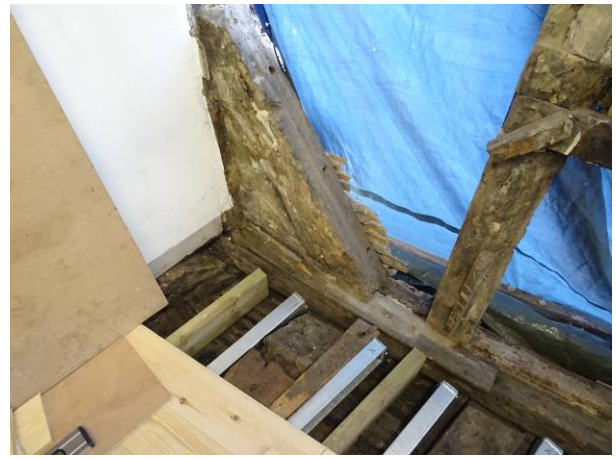
155 - Steel channels connected to the front elevation sole plate.

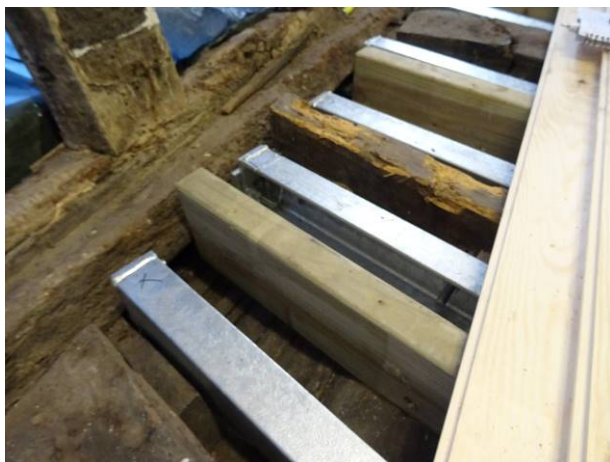
156 - Steel channels connected to the front elevation sole plate.

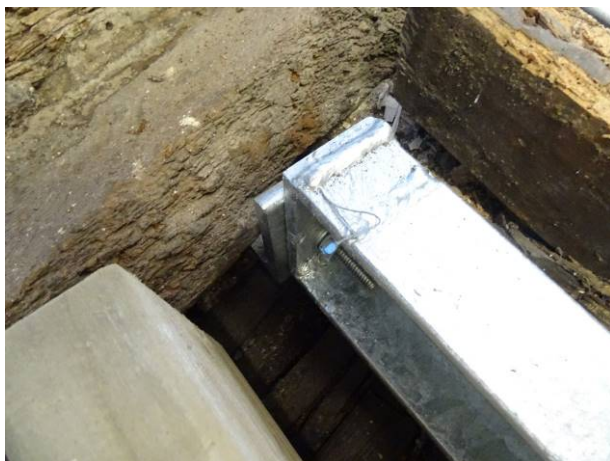
158 - Steel channel connected to the front elevation sole plate.

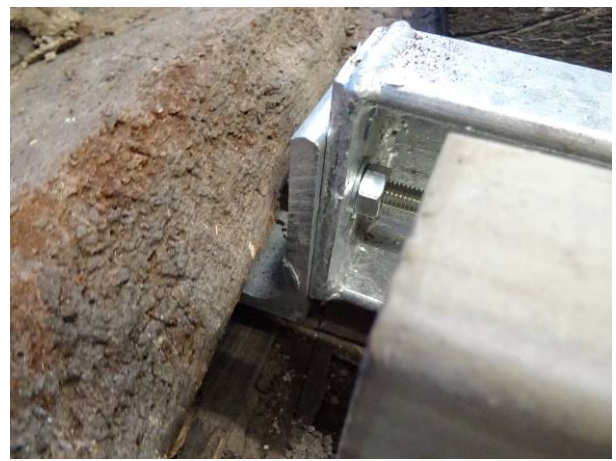
159 - Steel channel connected to the front elevation sole plate.

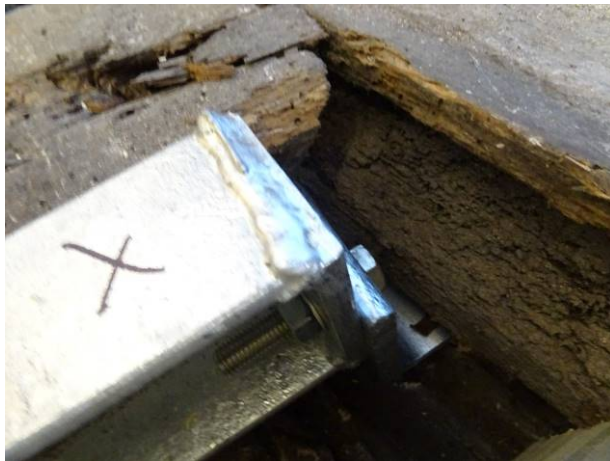
160 - Steel channel connected to the front elevation sole plate.

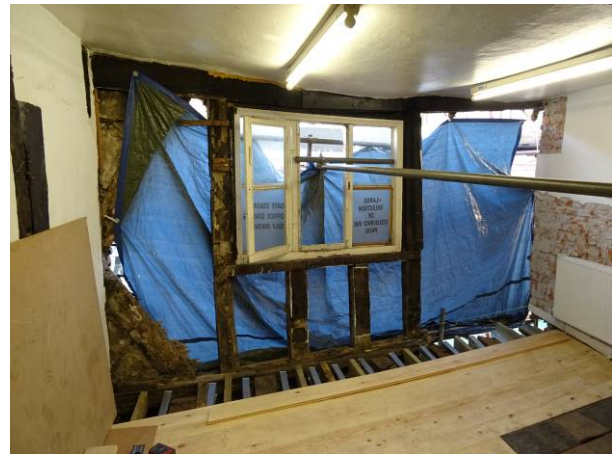
161 - Exposed timbers at the front elevation

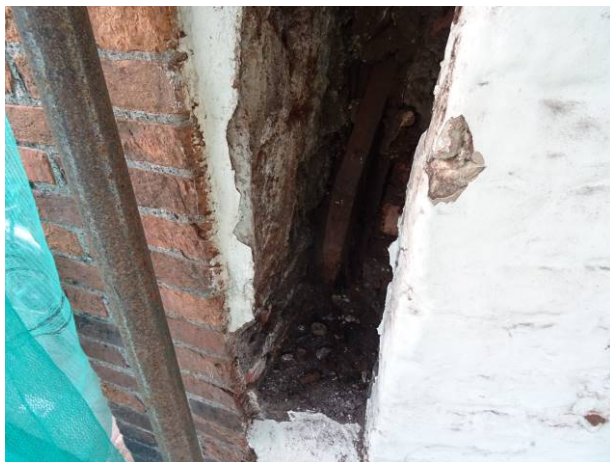
162 - Void remaining following the removal of the corner post at front LHS corner

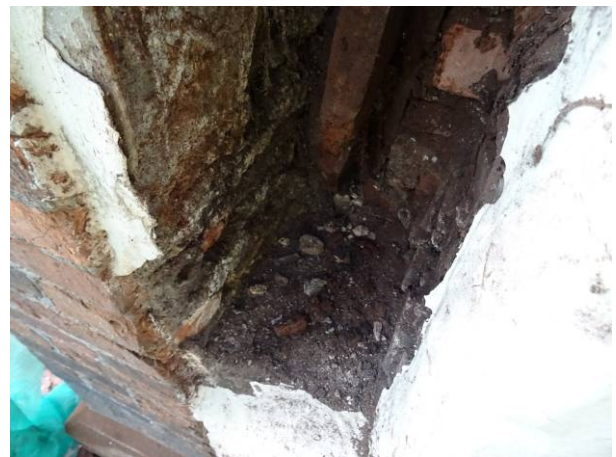
163 - Void remaining following the removal of the corner post at front LHS corner

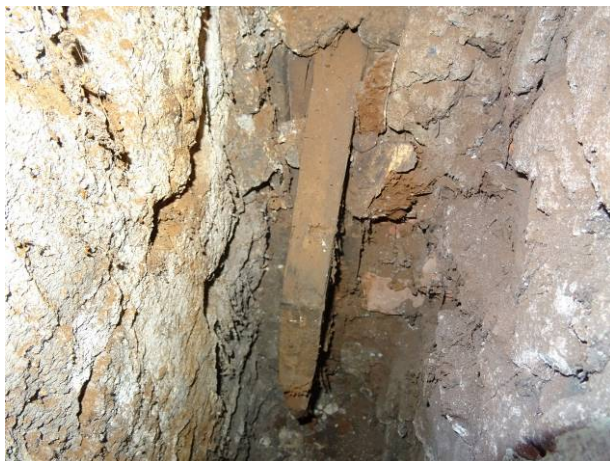
164 - Void remaining following the removal of the corner post at front LHS corner

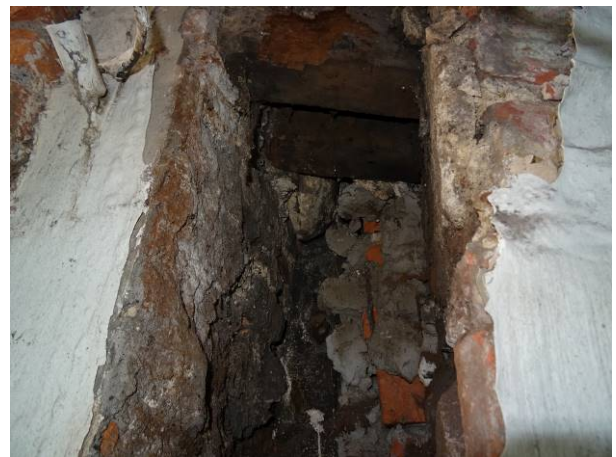
165 - Void remaining following the removal of the corner post at front LHS corner

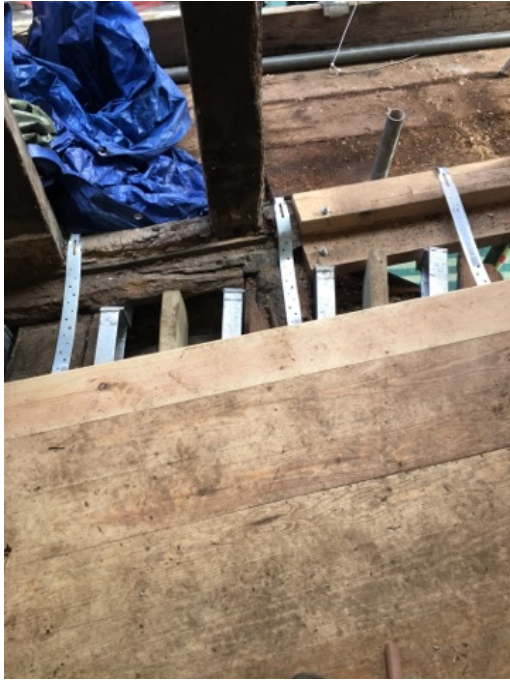
168 - New straps installed to the front of the property to tie into the structure

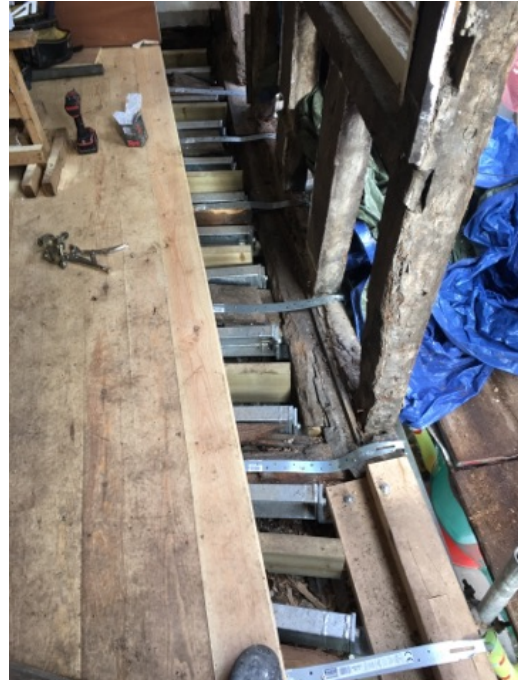
169 - New straps installed to the front of the property to tie into the structure

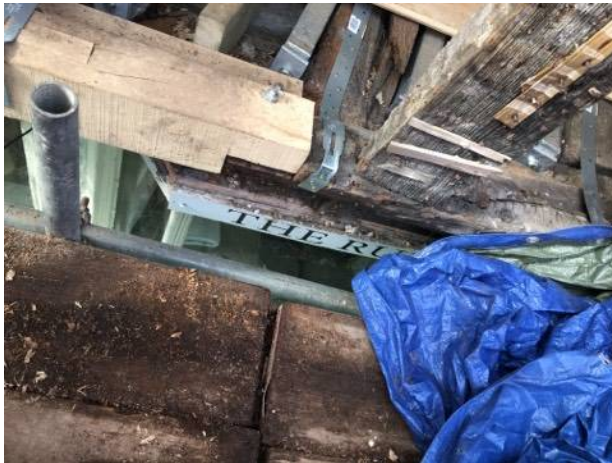
170 - New straps installed to the front of the property to tie into the structure

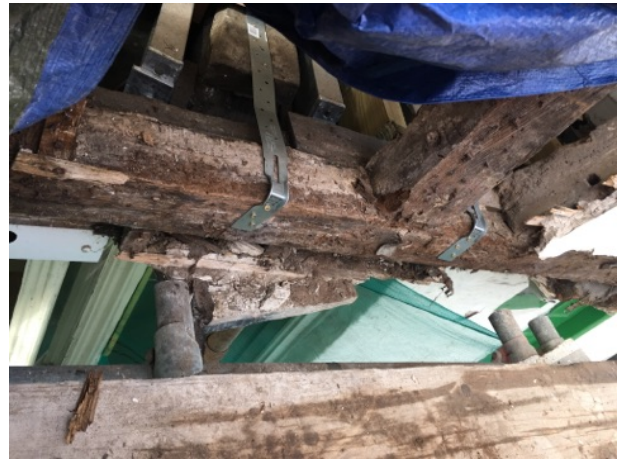
171 - New straps installed to the front of the property to tie into the structure

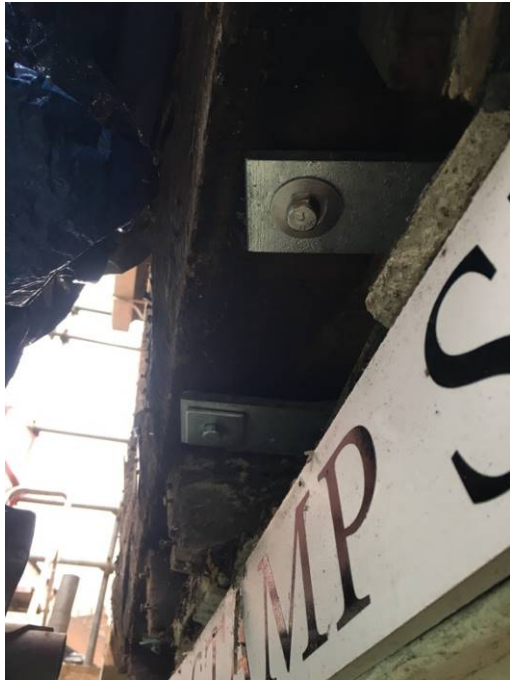
172 - Under side of jetty structure showing sole plates

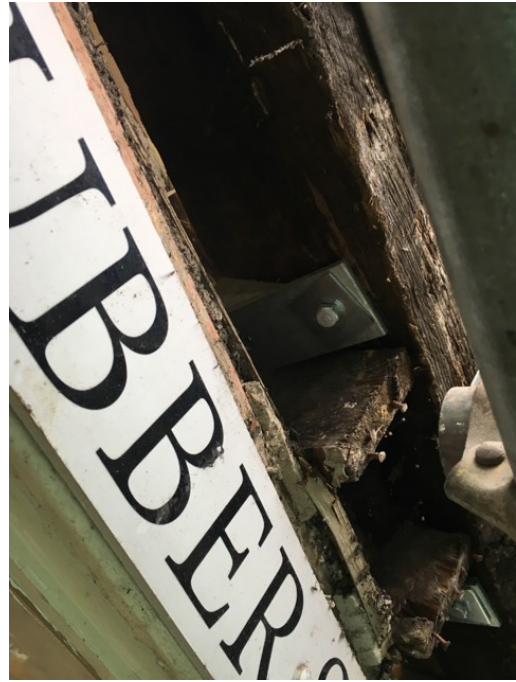
174 - New oak timbers to front LHS corner of the property

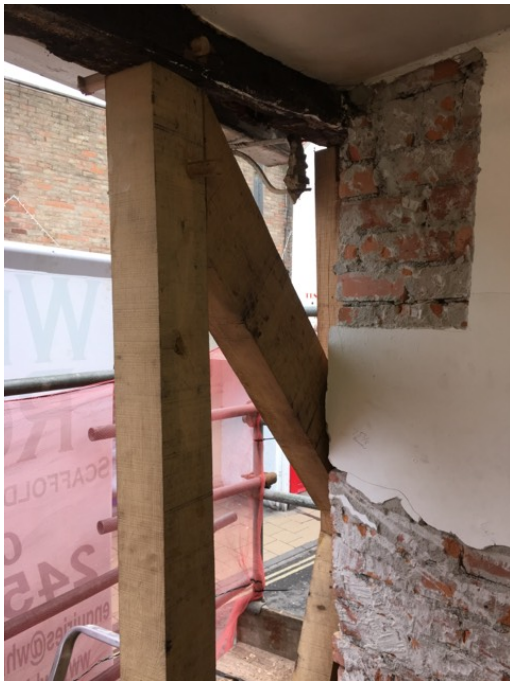
175 - New oak timbers to front LHS corner of the property

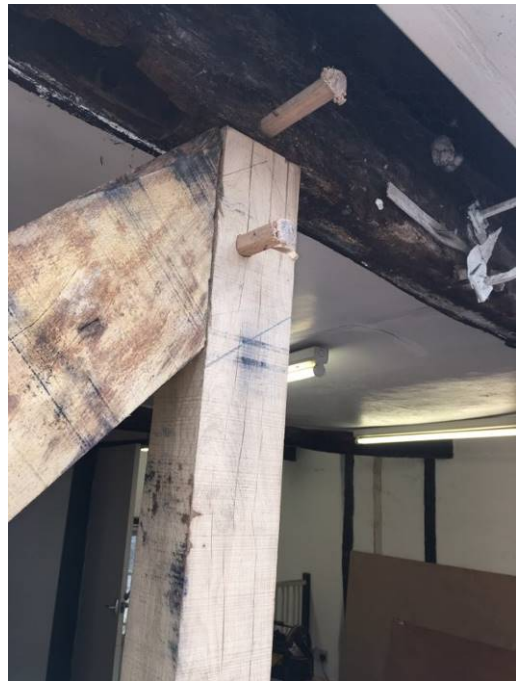
176 - New oak timbers to front LHS corner of the property

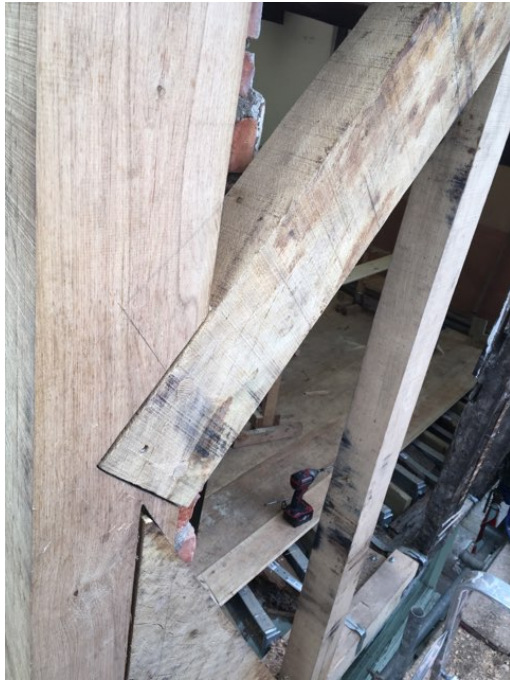
177 - New oak timbers to front LHS corner of the property

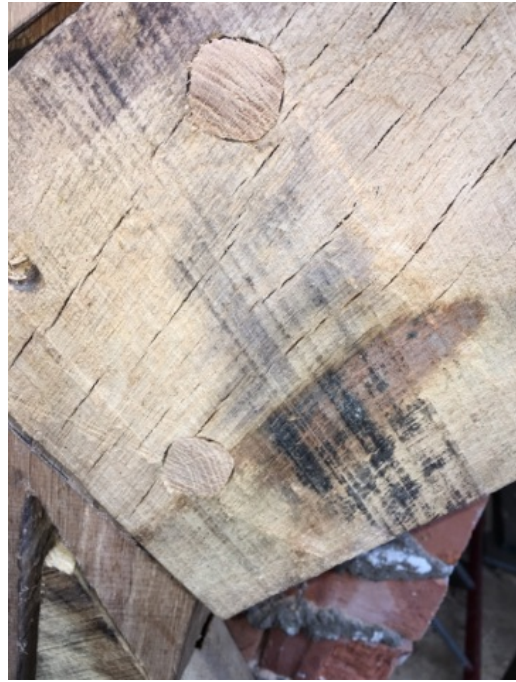
178 - New oak timbers to front LHS corner of the property

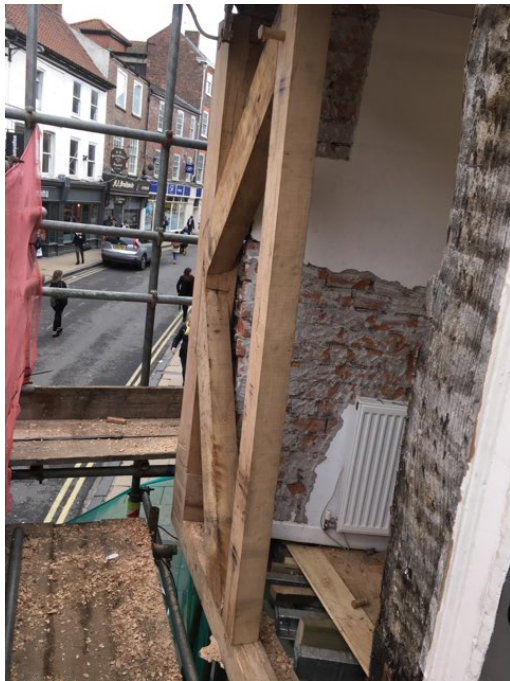
179 - Open construction to underside of jetty structure

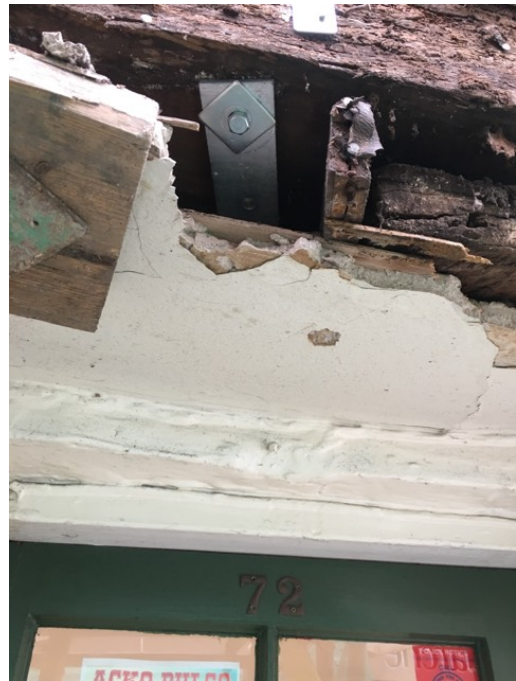
180 - Open construction to underside of jetty structure

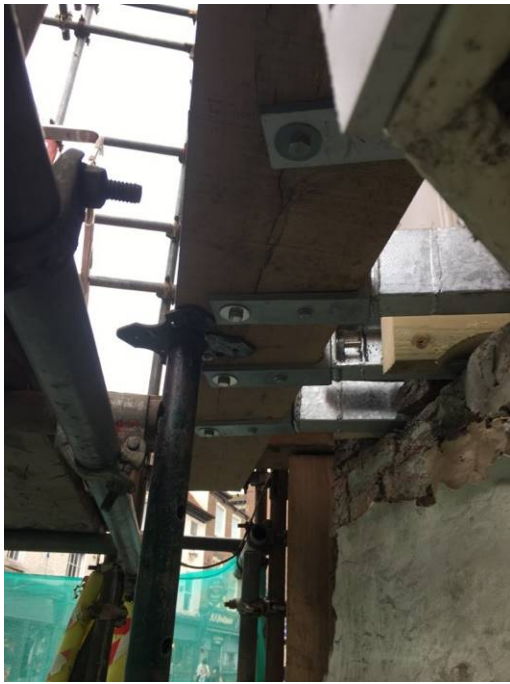
181 - Void remaining following the removal of the corner post at front LHS corner

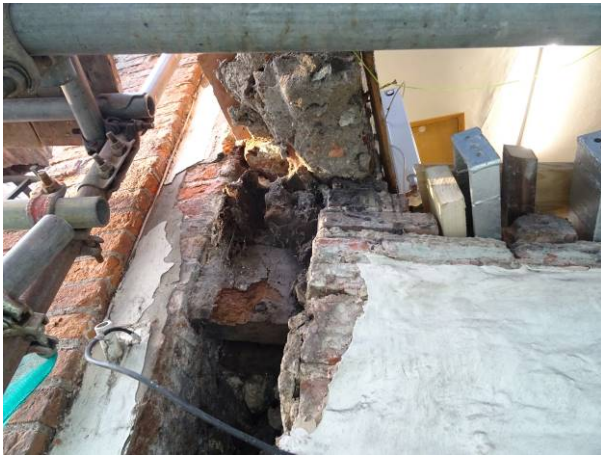
183 - Underside of the jetty structure

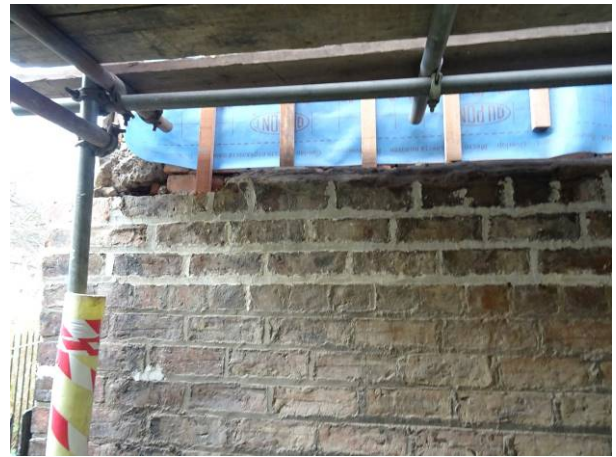
186 - Top 3 courses of brick work installed, new breather membrane and timber battens installed

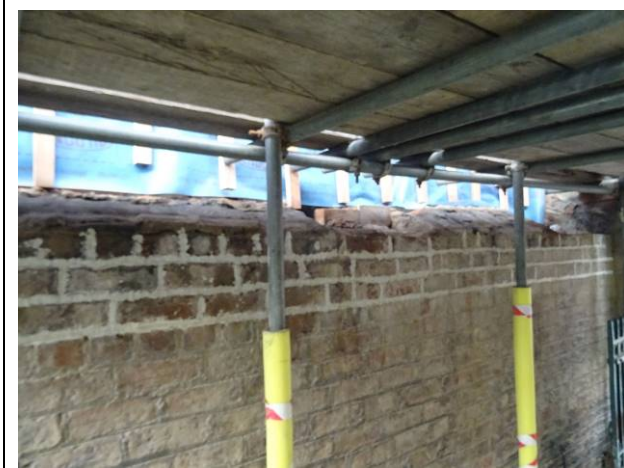
187 - New breather membrane and timber battens installed

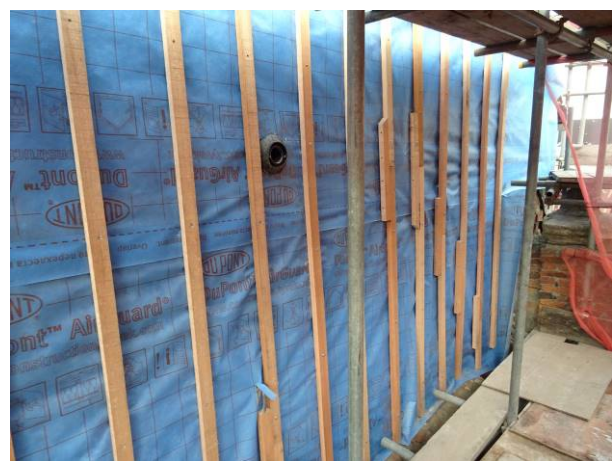
188 - New breather membrane and timber battens installed

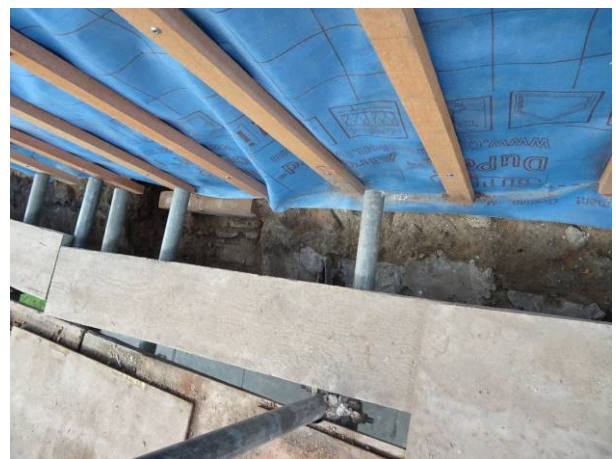
190 - New breather membrane and timber battens installed

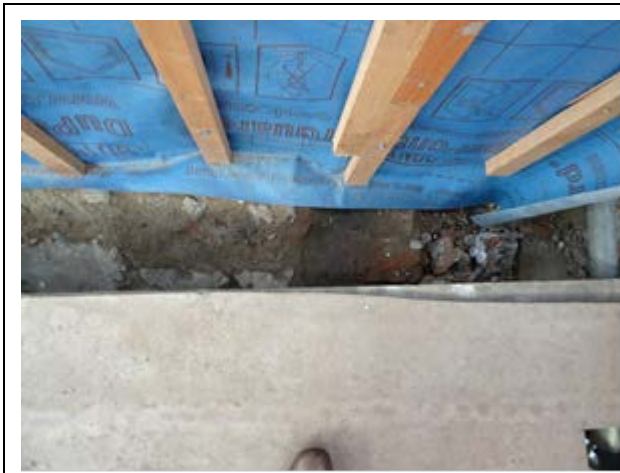
191 - New breather membrane and timber battens installed

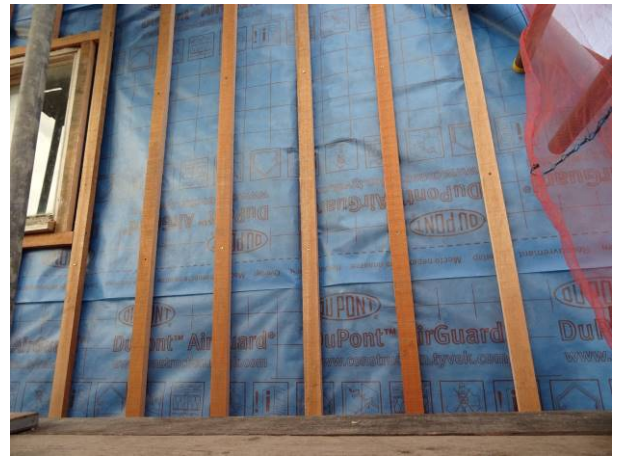
192 - New breather membrane and timber battens installed

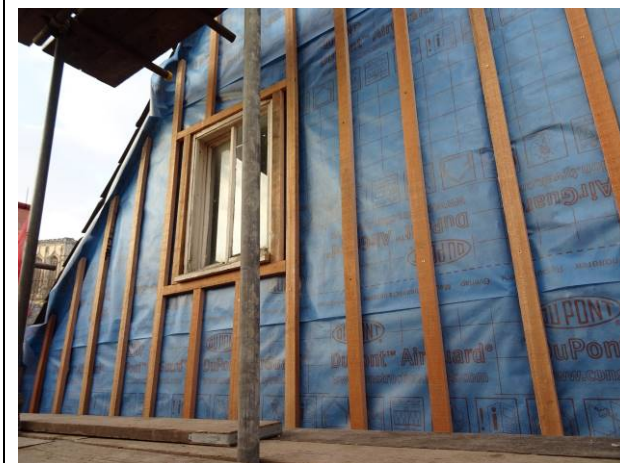
193 - New breather membrane and timber battens installed

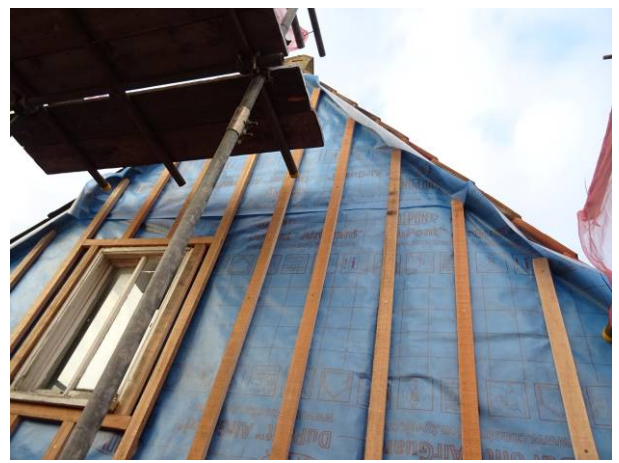
194 - New breather membrane and timber battens installed

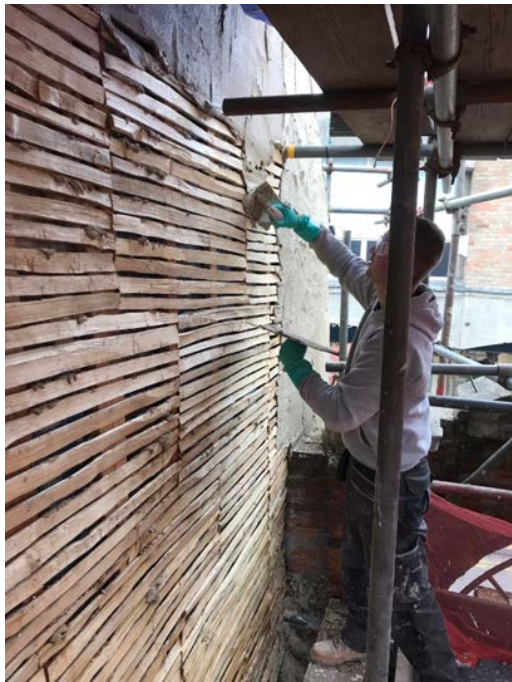
197 - Render being applied at the LHS elevation.

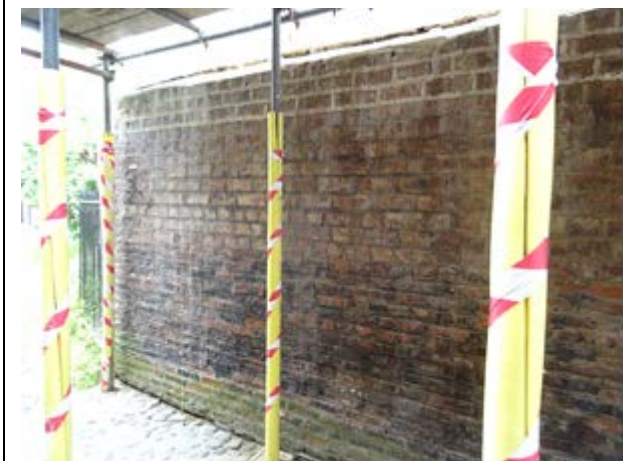
213 - Brickwork at LHS elevation

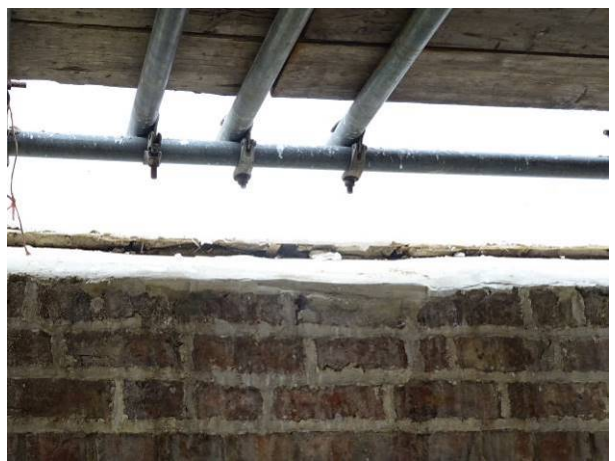
214 - Brickwork at LHS elevation
