**36 CONEY STREET**

**YORK**

**HISTORIC BUILDINGS  
ASSESSMENT**

**REPORT v1  
FEBRUARY 2023**

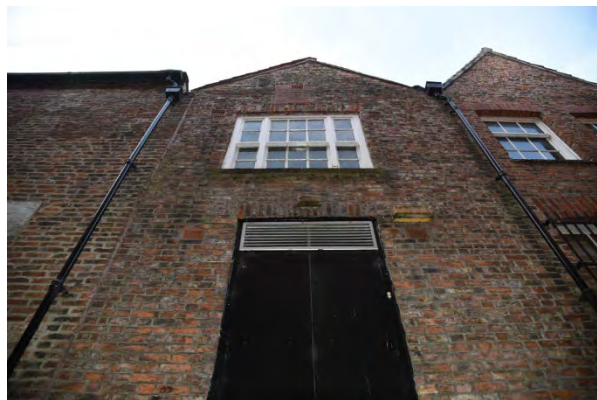
The exterior of the timber-framed building is now entirely encased in brick and no framing is visible. The encasing brick walls are of mid-18th to mid-19th-century date, with opening positions that are unlikely to relate directly to the position of those that were in the timber-framed building (Plate 6, Appendix B: YCY001-008).

**Plate 6** Exterior brick walls of the building (YCY008)

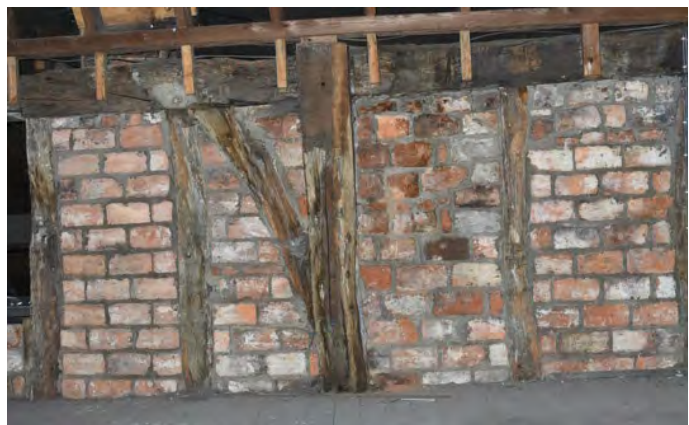
Studs remain along both the northwest and southeast walls fixed to the wall plates (Appendix B: YCY041-2, 044; Plate 16). Most are replacements and nailed in place, but there some secured with pegs which are likely to be original.

**Plate 16** View of NW wall (YCY041)

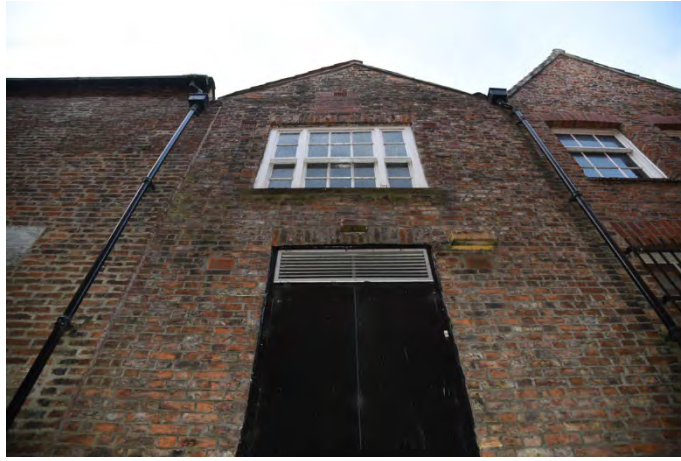
**YCY008** Upper part of northeast elevation with taking in door at first floor level

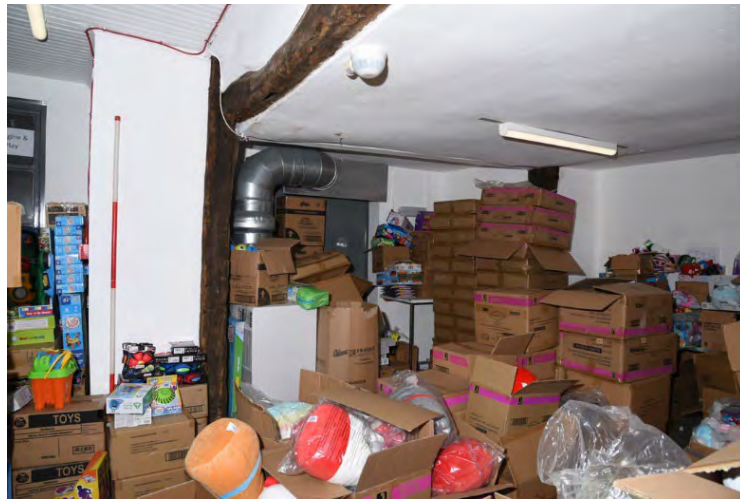
**YCY014** Interior first floor looking east showing post B and wall plate (2m scale)

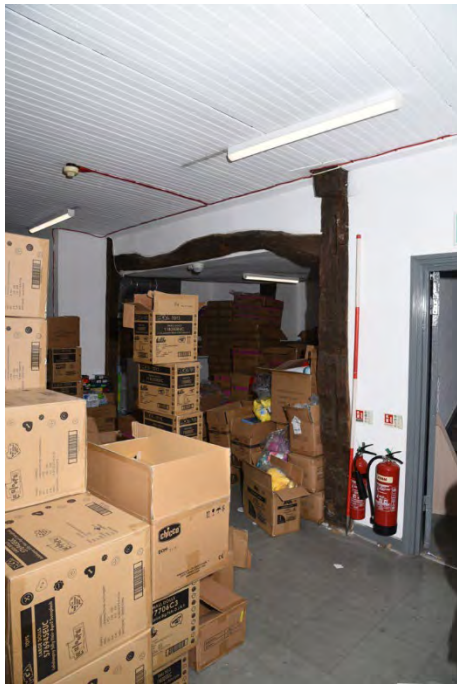
**YCY015** Interior first floor looking east showing posts A and B and wall plate (2m scale)

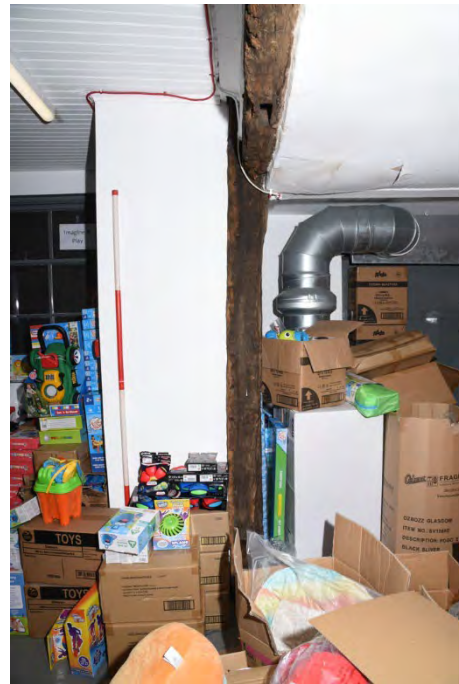
**YCY016** Interior first floor looking north east showing post B and wall plate (2m scale)

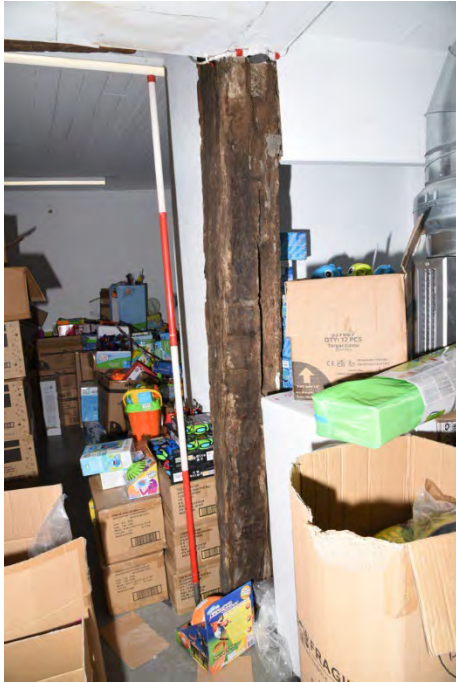
**YCY017** Interior first floor looking north showing post B (2m scale)

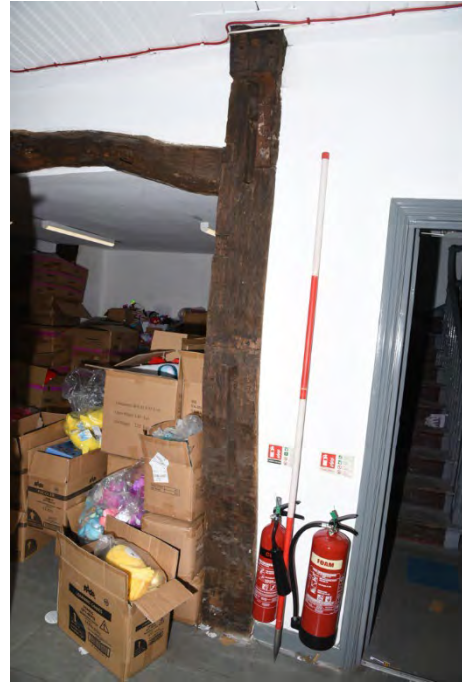
**YCY018** Interior first floor looking north east showing post A and wall plate (2m scale)

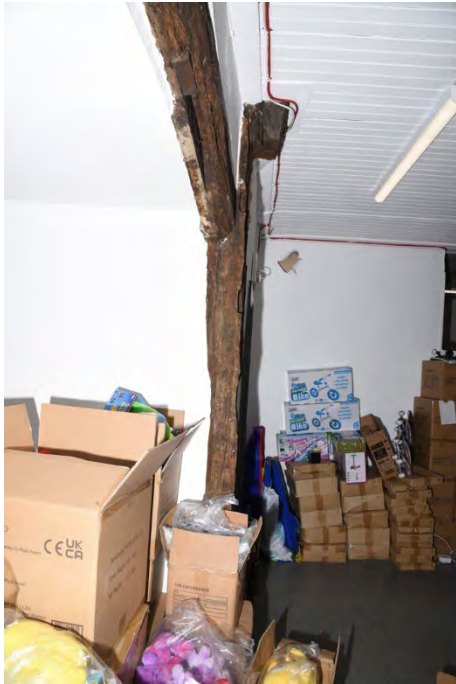
**YCY019** Interior first floor looking southwest showing post A and wall plate

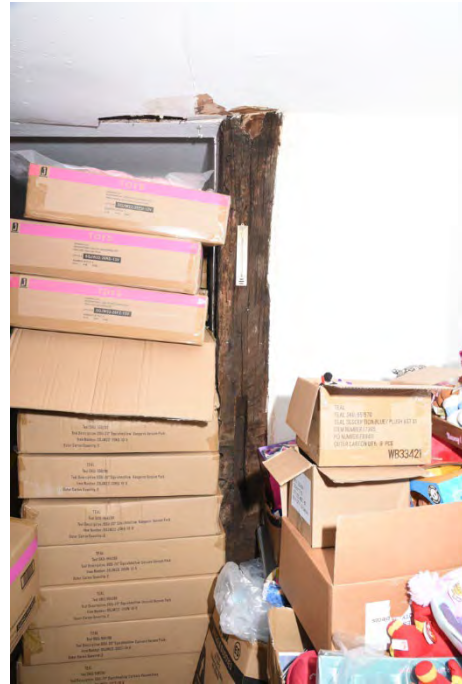
**YCY020** Interior first floor looking northeast showing post C and wall plate

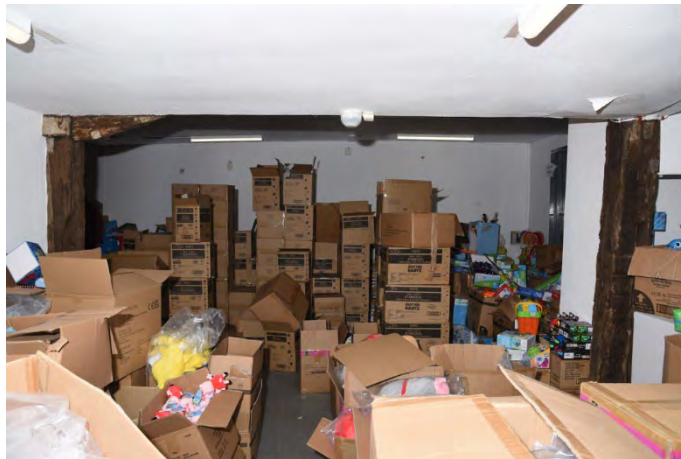
**YCY022** Interior first floor looking northwest showing post A (left), post B (right) and wall plate

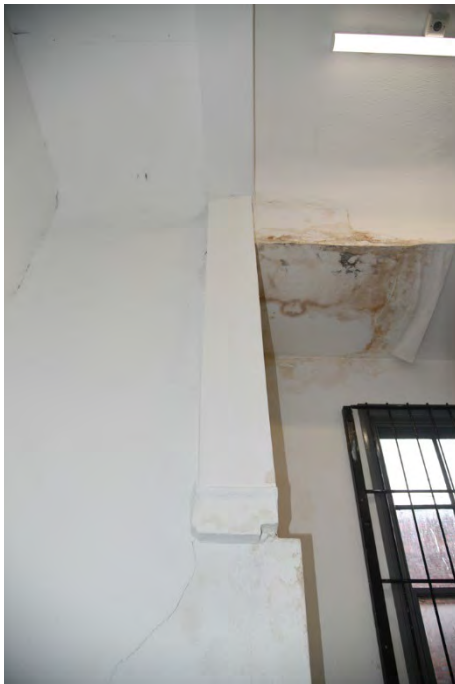
**YCY025** Interior first floor looking southeast showing corbel with post above

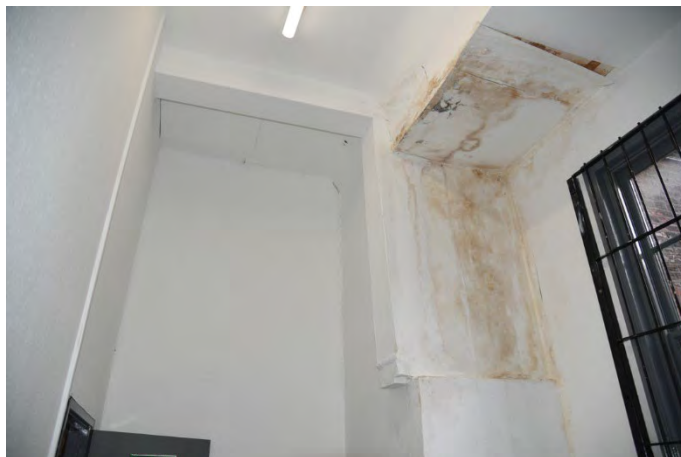
**YCY026** Interior first floor looking east showing corbel with post above

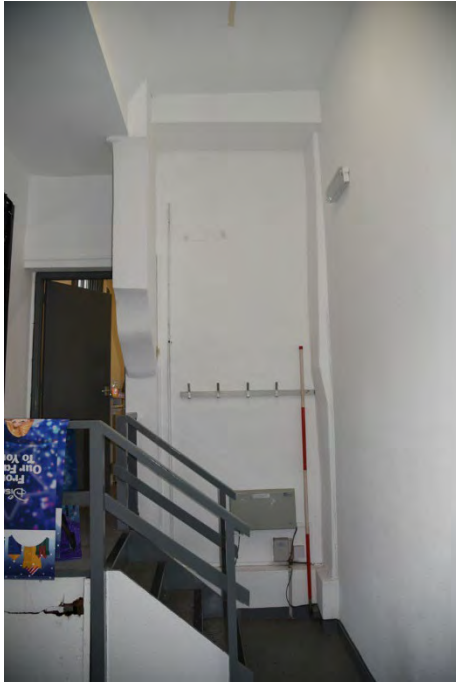
**YCY027** Interior first floor looking southwest showing moulded bracket with small section of post above (2m scale)

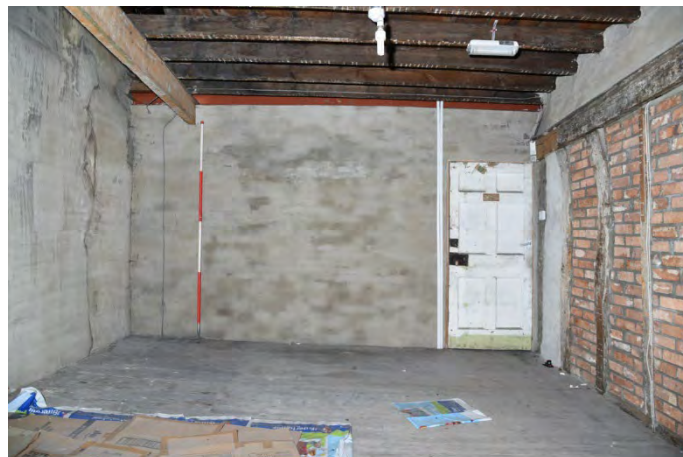
**YCY030** Interior second floor looking southwest showing wall plate and studs (right) (2m scale)

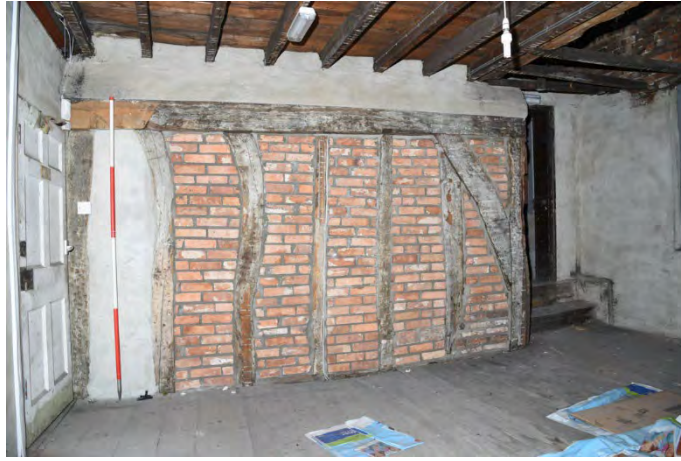
**YCY031** Interior second floor looking north showing wall plate, studs, arch brace and post D (right) (2m scale)
