THE ELECTRIC THEATRE FOSSGATE YORK

Historic Building Assessment

**Colin Briden
Historic Buildings Archaeologist**

November 2015

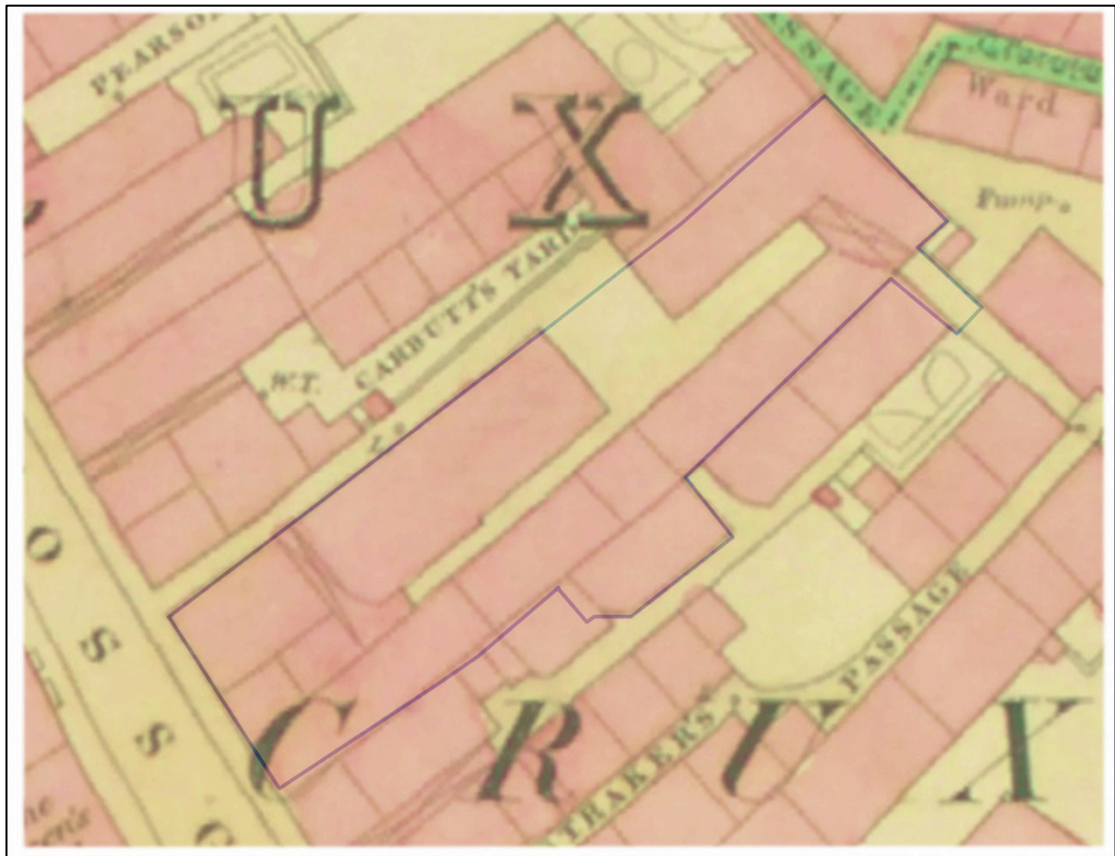
Fig 3: Outline of 1911 cinema superimposed on 1852 OS

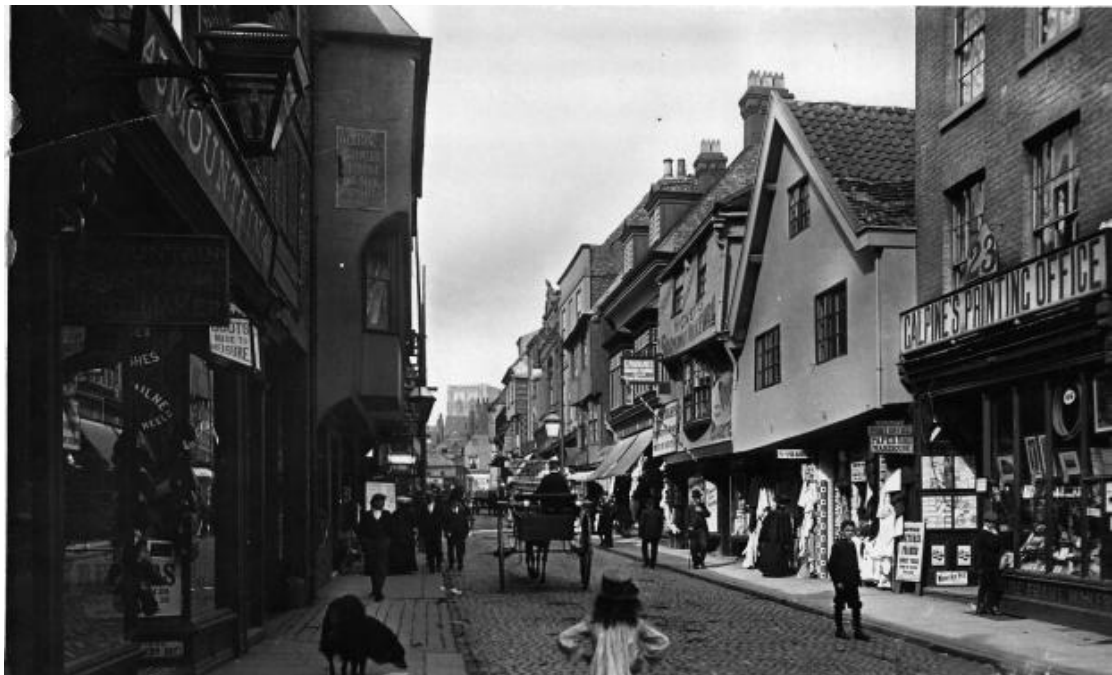
Fig 4: The street frontage before 1911

In the late C19 the burgage plot now wholly occupied by the cinema building was taken up by a loose grouping of individual buildings, doubtless of widely differing dates, separated by small open yards. The two frontage buildings onto Fossgate were both timber-framed, with jetties: they appear in historic photographs. Given their form of construction the likelihood that any part of these frontage structures survived the construction of the cinema is vanishingly small. Fig 2 shows the extent of firmly identified fabric of 1911 in the present building; Fig 3 shows the 1851 survey overlaid with the footprint of the cinema. At high level it is likely that *all* the fabric of the principal external walls dates from 1911 since only brickwork of that period could be seen in the roof space beneath the wall-plate.

The account of the site history and of the Phase I buildings, above, will already have made clear how the construction work was approached. The two jettied timber-framed buildings on the street frontage [Fig 4] were taken down and replaced by an elaborate frontage; it is possible that the south side wall of the southern frontage building was partly retained (that would account for the rendering) but the north side wall was completely replaced by a well-built new wall in 3" brickwork with hard red brick dressings. This new wall extended to the east to meet the west wall of an earlier structure aligned north-south. What must have been an internal wall of that structure provided the cinema with a further few meters of its own north wall. Further to the east again other earlier walls took the cinema north wall right back to what is now the east plot boundary wall. A very similar but less visible process on the south side gave the cinema a south external wall. It is likely that all the older walls were raised in new brickwork to give the cinema regular eaves heights.
