Clifford's Tower York

Archaeological investigation

REPORT No 836
SEPTEMBER 2023

FAS HERITAGE

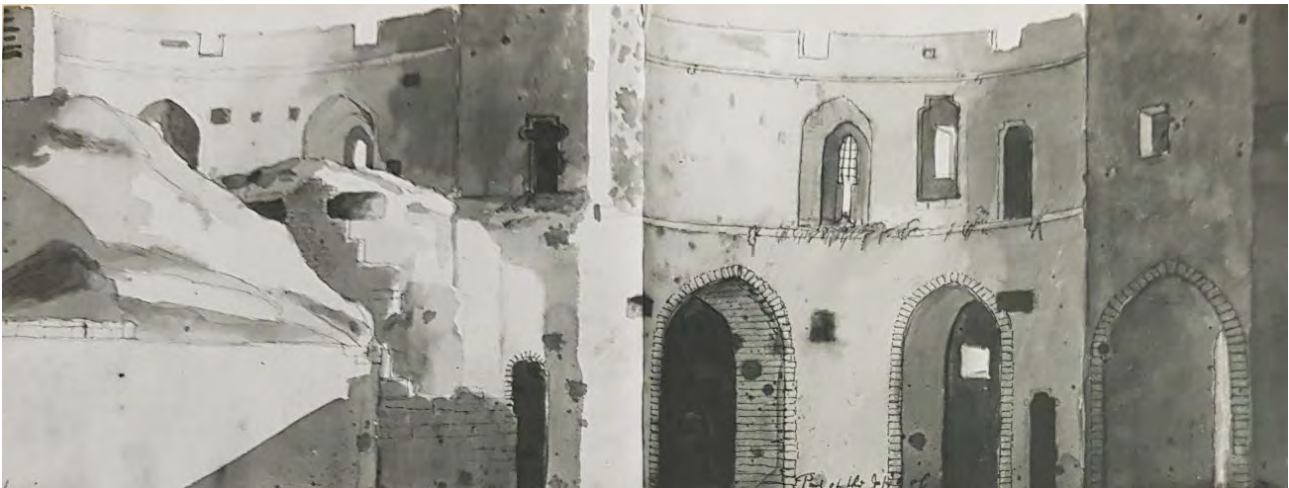
Plate 5 View of the interior of Clifford's Tower c.1690, by F Place (V & A Museum)

Sketches by Francis Place (1647-1728) also provide an indication of the condition of structural remains in the interior of the tower (Plate 5, reproduced in RCHME 1972, PI 7). As Ashbee has observed, rather than representing a single view looking north, this image is best interpreted as separate views of the west and east lobes, showing the remains of dilapidated buildings, particularly within the west lobe. The structure appears to be well-built ashlar masonry, and Ashbee observes sinkings in at the approximate level of the offset for the medieval first-floor level.

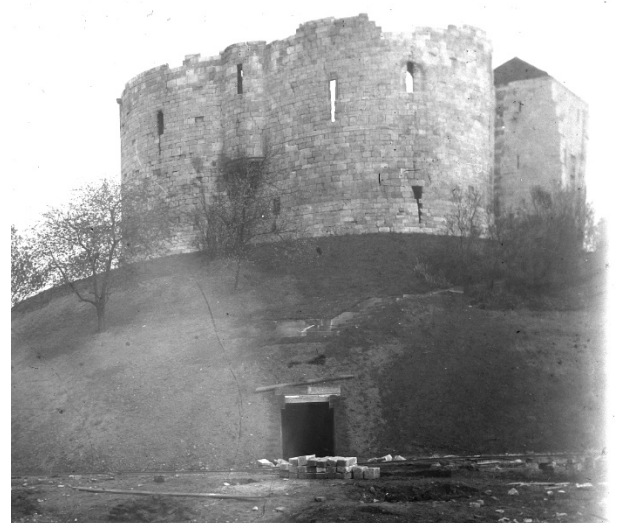
Plate 13 1930s image showing the entrance and stair constructed in the early 19th century (York Archives)

The entrance approach to the tower was moved to the southwest and the path up the motte curved round to the forebuilding. This entrance, from the plans of the period, appears to be all above ground, but photographs taken before and during the demolition work of the 1930s show that the entrance was in fact straight into the motte, with the path emerging to ground level further up the slope, curving round to the forebuilding (Plate 12 and

Plate 13). This arrangement meant that the entrance to the tower lay within the outer walls of the prison; the site was only accessible with permission from a magistrate.

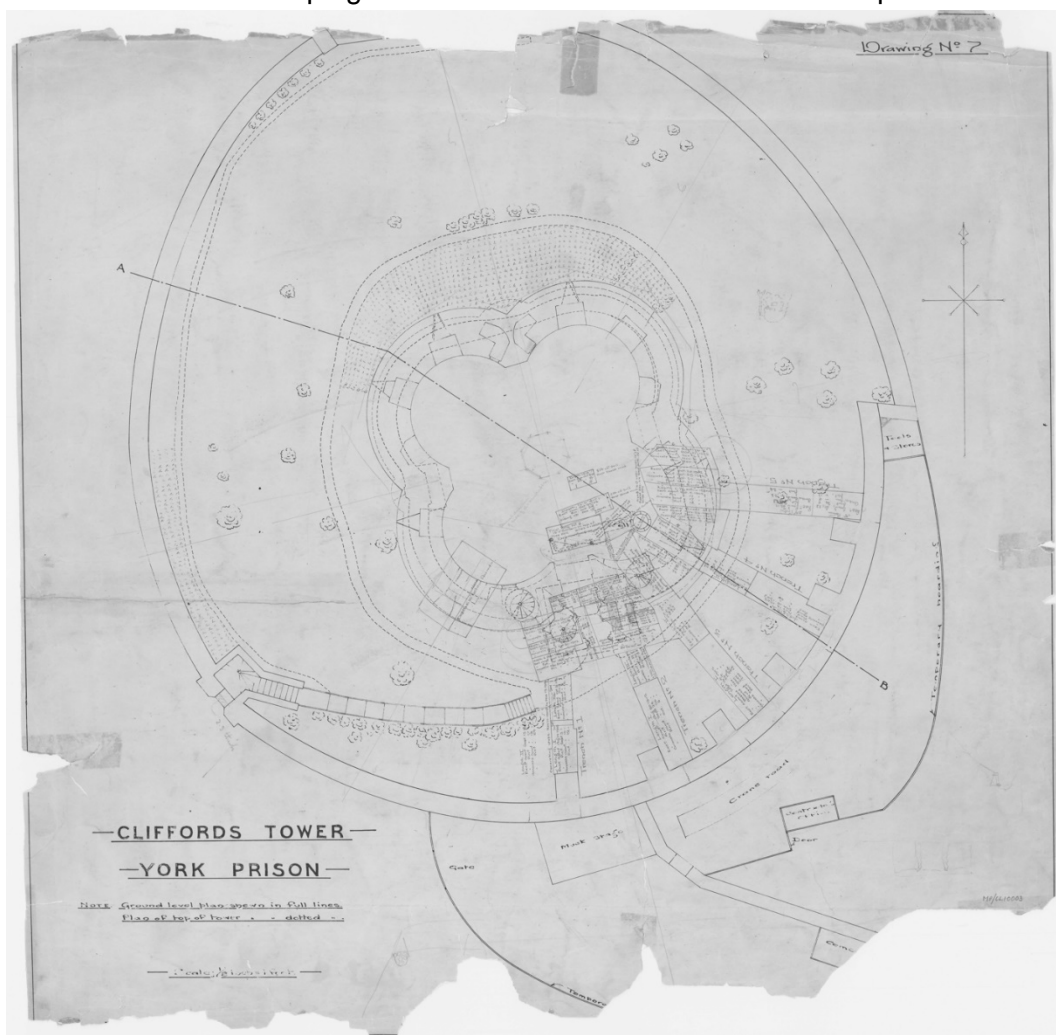
Plate 14 Plan of underpinning trenches (MP/CLI0003)

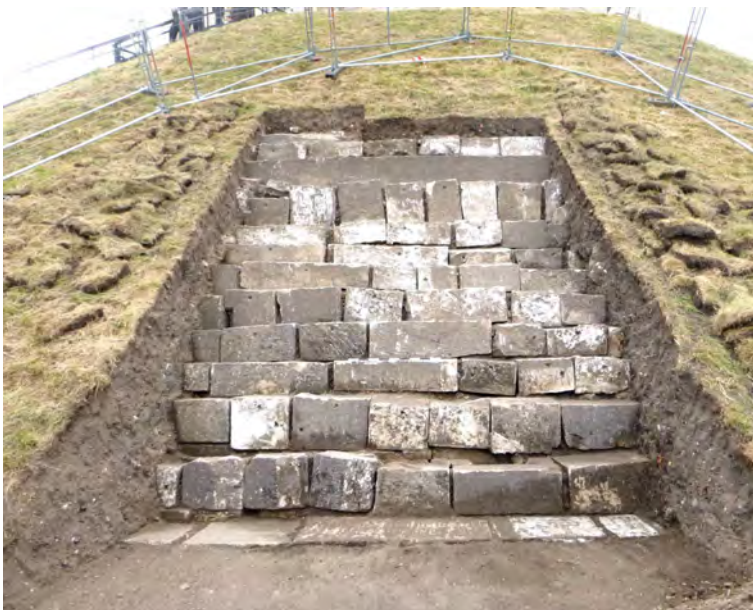
Plate 15 Gritstone blocks reinstating the slope of the motte

In order to understand and locate the retaining wall within the motte and make a partial assessment of its condition, a trench was excavated at the foot of the motte in May 2016 (TP9). Excavations revealed that huge masonry blocks had been placed against the retaining wall, infilled with smaller demolition debris. The stone (which had to be drilled to allow lifting with Lewis pins) was partly removed to reveal the in situ retaining wall (Plate 15 and Plate 16).

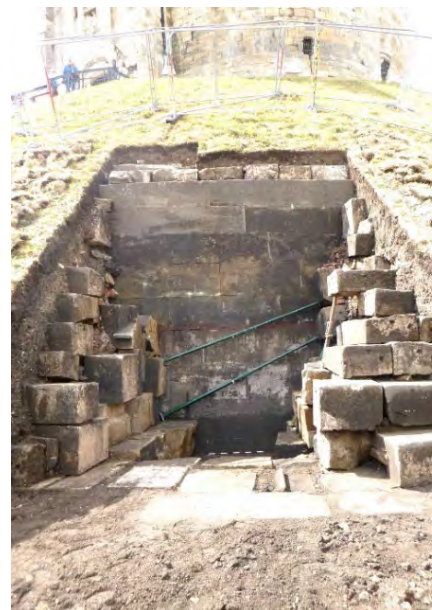
Plate 16 Surviving retaining wall behind the gritstone blocks

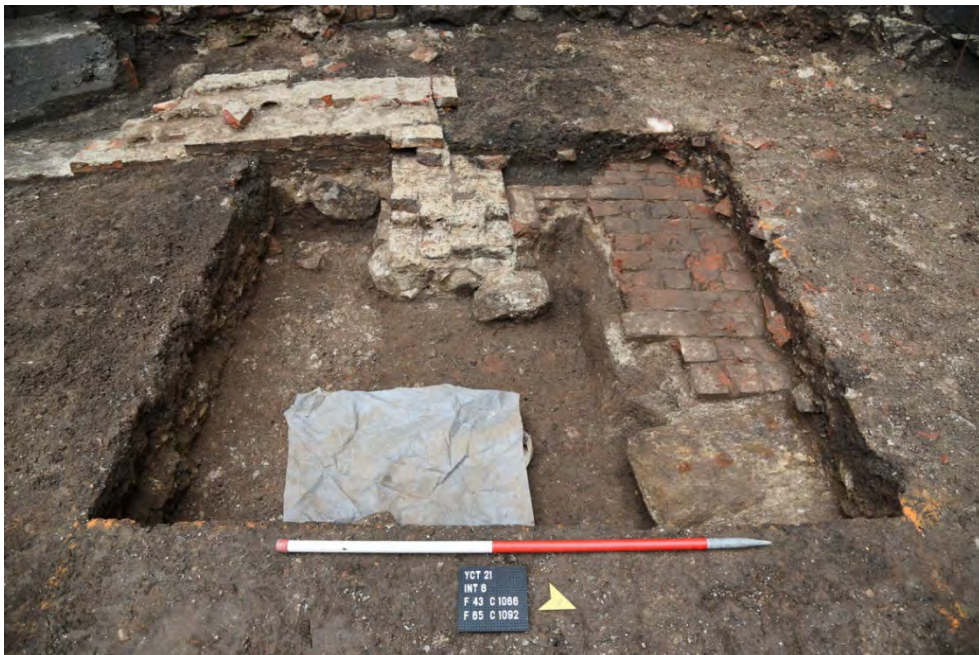
Plate 17 Excavation for inspection chamber, showing possible motte make-up C1095 with brick wall F43 and associated floor F65, looking SW. Scale 1.0m

The possible motte make-up C1095 lay directly beneath brick wall (F43) and associated brick floor (F65), the latter representing the remnants of structural remains that had previously been glimpsed in the 2014 test pits (TP2)(Plate 17).

Abutting the north side of the wall was a brick floor (F65), exposed for maximum area of 1.48m x 0.93m within the inspection chamber excavation, with the upper surface contacted at 23.18m AOD (see Plate 17 and Plate 18). The bricks, similar to those in the wall construction, were laid flat in rows perpendicular to the wall, and bedded on a layer of firm white mortar (C1092) directly over possible motte make-up (C1095). In the northern corner of the excavated area, two large blocks of limestone

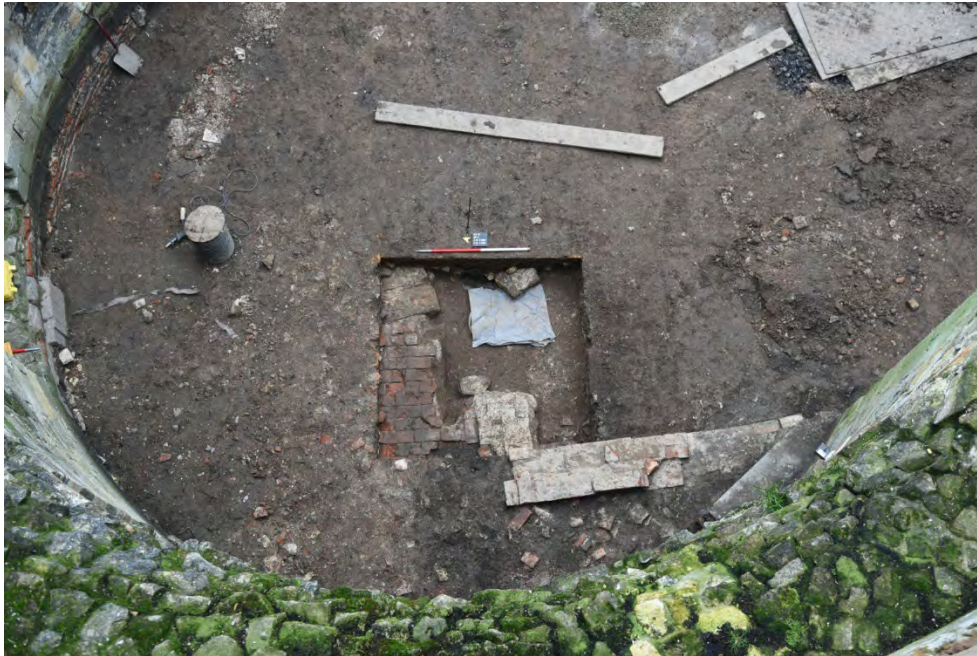
Plate 18 View of west lobe from the wall-walk, looking east. Scale 1.0m

Brick wall F43 was initially observed at Horizon 2 when a c.3m length of walling was recorded, oriented NW-SE and forming a continuation of the straight elevation between the south and west lobes. Subsequent excavations for the inspection chamber exposed a right-angle and lower foundations. The courses continued beneath later concrete underpinning between the south and west lobes (Plate 18).

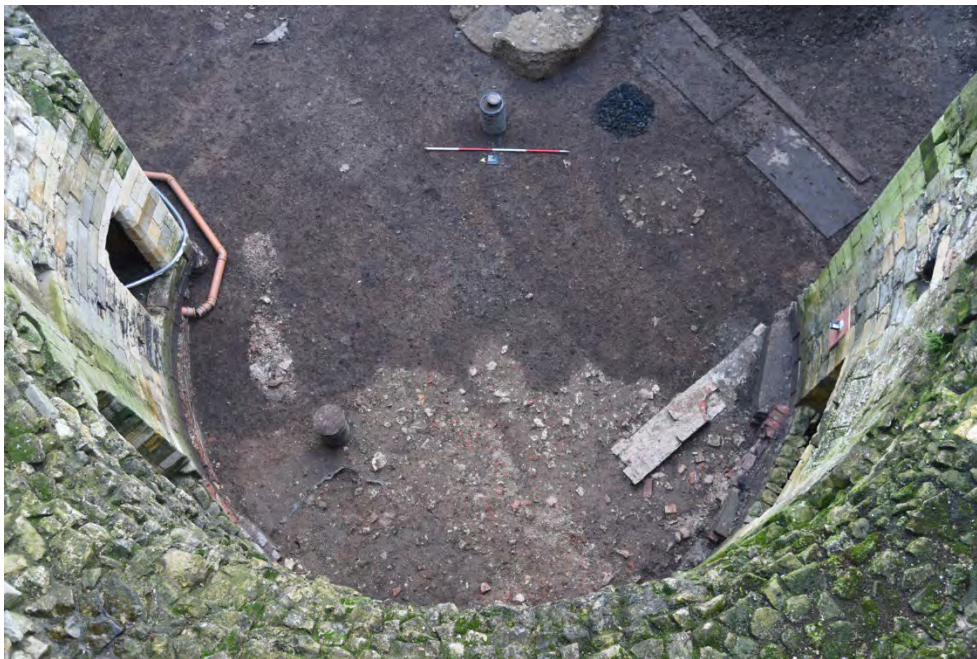
Plate 19 View of the western lobe showing the extent of rubble layer C1050, with part of wall F43 visible, looking E. Scale 2.0m

Floor F65 was overlain by a distinct layer of brick and stone rubble (C1050) seen at Horizon 2 to measure at least 3.0m NE-SW x 3.4m NW-SE (Plate 19; see Figure 9). Notably, the rubble deposit was confined the west lobe, and in plan appears contained to the northwest of the brick wall, possibly representing gradual collapse within the structure while the wall was still standing, and different post-disuse activity within and outside the former building. Ceramic recovered from C1050 included two sherds from a large Ryedale jug or jar (mid-16th to early 18th century) and a large decorated Tingle glazed Earthenware dish (late 17th and mid-18th century)(Appendix 9).

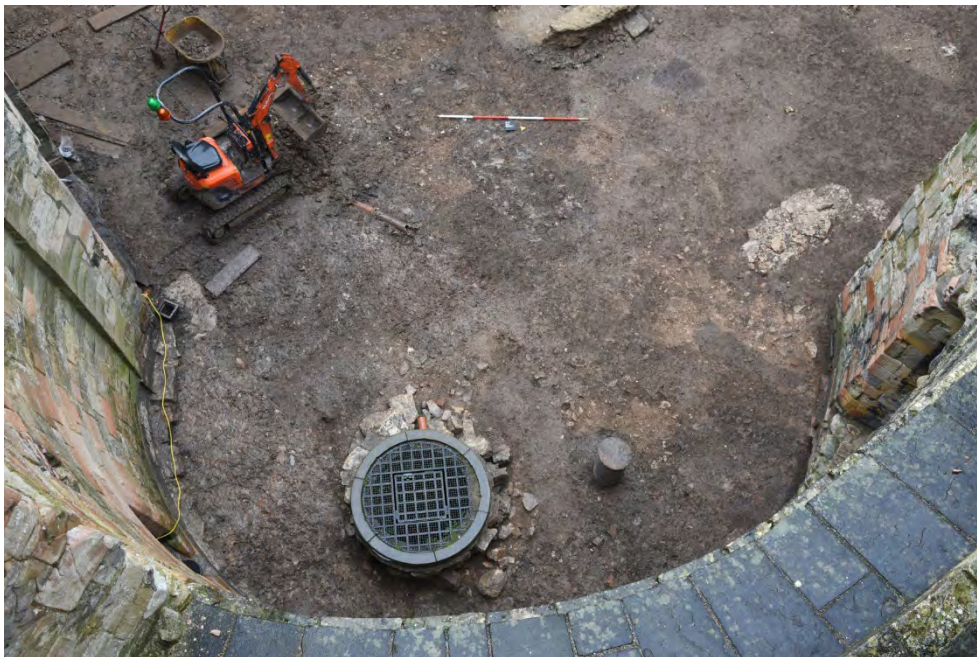
Plate 20 View of the east lobe looking west, showing rubble within the construction cut of the upper part of the well (Scale 2.0m)

Situated centrally within the east lobe is a well, the stone-lined shaft of which descends the full depth of the motte (F3)(Plate 20). The superstructure of the well is evidently of several phases, including a modern construction, but the shaft is likely to be medieval in origin, cut through the original motte

A construction cut was exposed during ground reduction around the part of the upper part of the well, and allocated F42 (see Plate 20). The backfill of this cut (C1065) consisted of a dark yellowish-brown silty sand containing voided mass of limestone blocks. Finds included fragments of architectural stone, clay pipe, ceramic and CBM. The six fragments of clay pipe, including one bowl fragment, are dated to the 17th to 18th centuries, while the glass bottle indicates a date in the 19th to 20th century (Appendix 10). The ceramic assemblage included two sherds, one of 16th to 17th, and one of 18th-century date (Appendix 9).

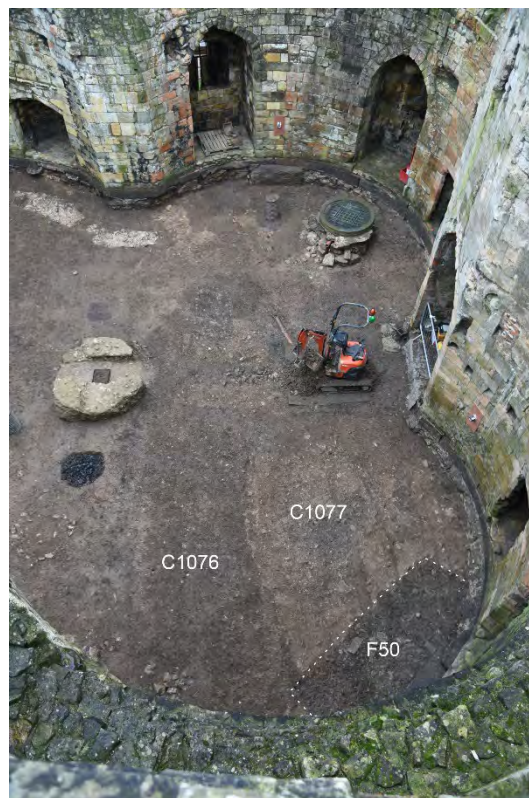
Plate 21 View of the south lobe looking east, with C1076 and C1077 and later F50

The levelling represented by C1039 did not extend to the south lobe, where two discrete deposits of made ground were identified and allocated C1076 and C1077 (Plate 21). C1076 consisted of a dark yellowish-brown silty clay with occasional inclusions of angular limestone fragments and rounded pebbles. C1077 consisted of a distinctive deposit of mortar and rubble, containing angular limestone fragments and CBM (brick) in a matrix of pale brown sand and mortar. This latter deposit produced two fragments of late medieval brick or wall tile, which may have arrived as hearth tiles within the tower. These layers appear to represent levelling or ground consolidation, potentially stratigraphically equivalent to C1039. Some of the finds recovered from C1064 may have originally derived from these deposits.

In the south lobe, F50 was allocated to a rectilinear cut measuring 3.10m x 1.30m against the internal elevation beneath the southern embrasure (see Plate 21). The very dark grey silty clay backfill (C1079) was observed against a concrete underpinning; the backfill also contained fragments of brick, fragments of limestone and mortar.

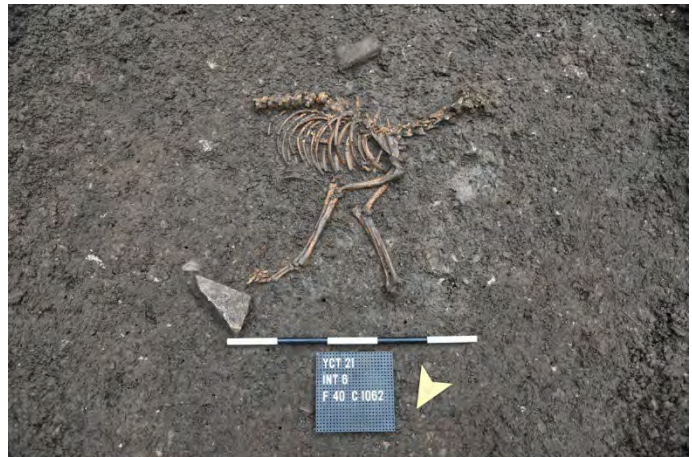
Plate 23 Dog burial F40 C1062, looking southeast (Scale 0.50m)

The dog burials lay within the north lobe, close to the centre of the tower. One example, F40, was excavated, and was found to contain the partial remains of a young dog (C1062), c.18 months old, which would have stood 51-53cm high at the shoulder (Appendix 11). The remains were laid out west-east and within a poorly-defined, sub-rectangular cut (Plate 23). Further dog burials were identified close-by; F56 C1082 was defined only by articulated lower leg bones, while F63 C1090

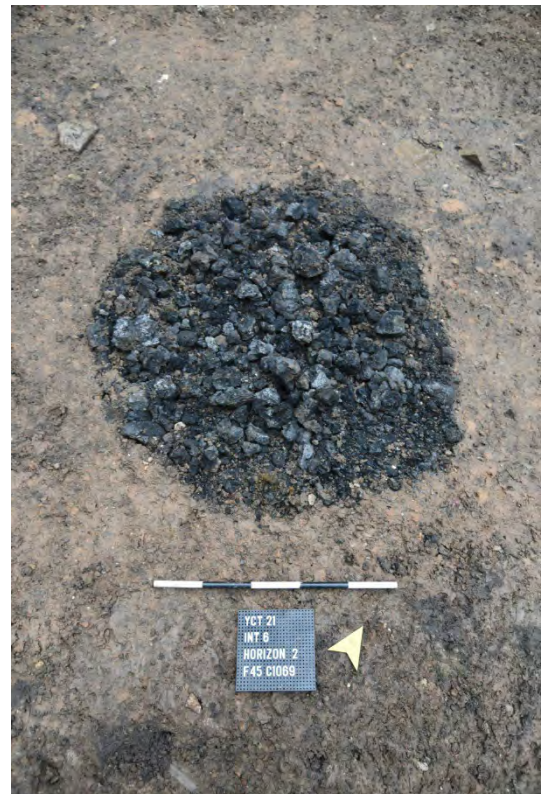
Plate 22 F45 C1089, looking northwest (Scale 0.5m)

Close to F44, but very different in character, F45 was initially identified as a spread of black ashy/clinker material (Plate 22). Subsequent ground reduction revealed this to be a clearly-defined, subcircular feature, 1.0m in diameter and containing a consistent fill of fuel ash or clinker. The feature continued beyond the depth of excavation and no obvious function could be identified.

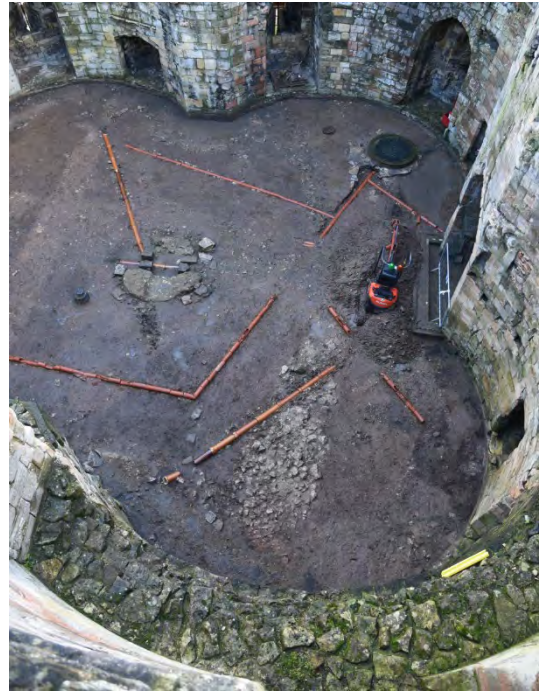
Plate 24 View of the south lobe looking east, showing rubble-filled F26 in plan

In the south lobe, F26 was identified as a large rubble-filled feature, oriented NE-SW and measuring 5.90m x 1.30m. The backfill was defined by the presence of large angular blocks of limestone and mortar in a long sub-oval cut (C1037)(Plate 24). Just inside the tower, F57 was allocated to mortar-bonded stone feature, rectilinear in visible plan, measuring 0.95m west-east, with right angled corners to the northwest and northeast (C1083).

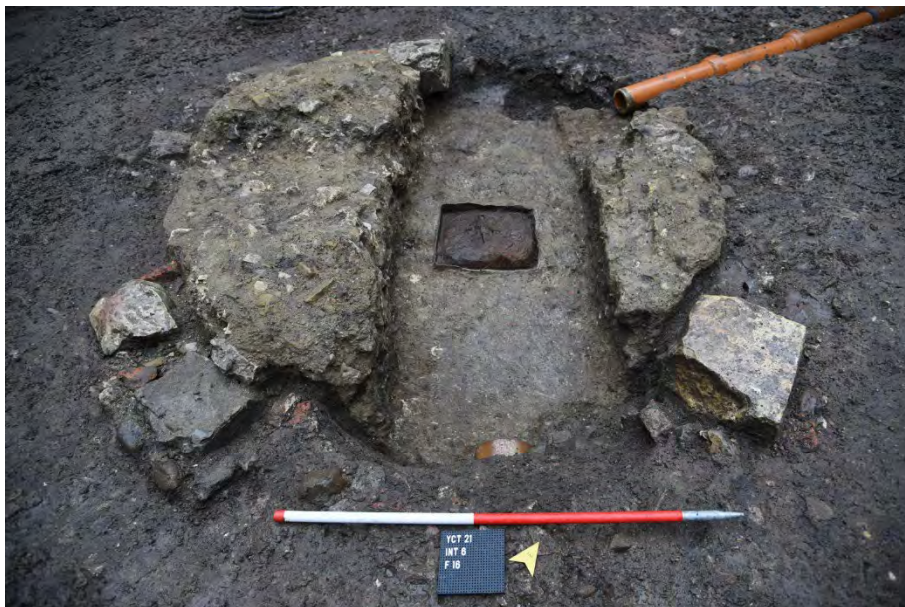
Plate 25 Central flagpole base F16, looking northeast (Scale 1.0m)

Situated centrally within Intervention 6, a subcircular structure was defined and allocated F16 (Plate 25). This lay directly beneath a modern octagonal feature in the paved interior of the tower, which clearly referenced a previous observation of this feature (Figure 10).

F16 consisted of an irregular, rubble filled construction cut (C1019), c.2.90m in diameter, within which a compact setting of angular limestone rubble and CBM fragments set in a weak lime mortar had been constructed (C1019). The surrounding backfill included fragments of 19th or early 20th-century glass bottle (Appendix 10). This compact setting measured 2.20m in diameter, with faceted edges suggesting that the feature had been shuttered during construction. The mortar setting held in place the base of a substantial wooden post, rectangular in section and measuring 0.44m x 0.40m, lined in lead (C1056). Historic maps allowed this to be identified as the base of a flagpole that existed on the site in the late 19th century (see Discussion).

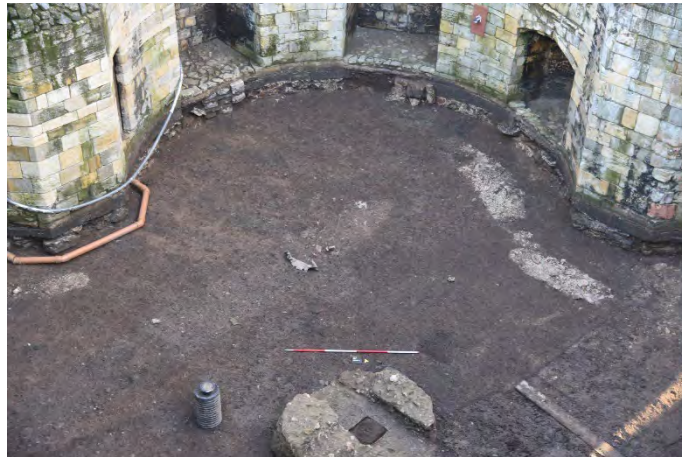
Plate 26 North lobe, looking north, with F47 (right) and F55 (left)(Scale 2.0m)

Potentially contemporary with the central flagpole, a series of linear feature and gravel surfaces were identified, running parallel to the interior of the tower. The earliest of these were allocated F55 and F47, both were identified as linear features, running parallel to, and offset from, the interior of the tower by between 0.70m and 0.80m. In the north lobe, F47 measured c.5.00m long and c.0.60m wide, and was backfilled with a pale brown silty sand with inclusions of brick, stone and mortar (C1071)(Plate 26). Among the rubble fill, a fragment of Roman limestone *mortarium* was identified (Appendix 12, Find No. 46), and a fragment of 17th-century slop-moulded brick (Appendix 8). F55 measured 2.50m long and 0.60m wide, and contained angular stone blocks and pebbles, brick and CBM in a loosely compacted sand and mortar matrix (C1080). These features have been interpreted as possible drainage features, associated with paths that skirted the edges of the tower interior.

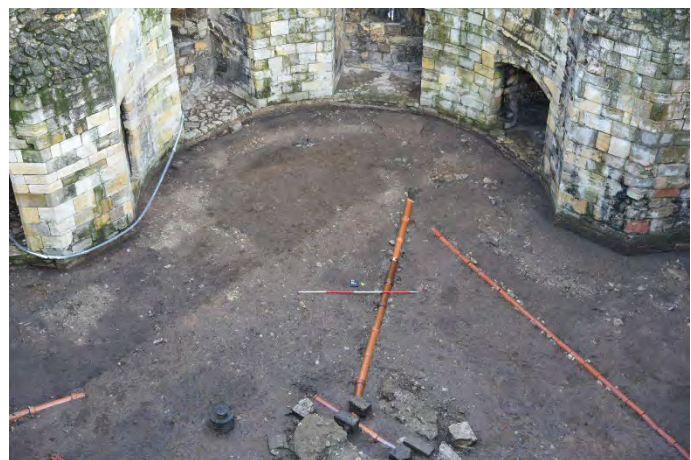
Plate 27 North lobe with vestiges of external paths around the perimeter (Scale 2.0m)

Vestiges of surfacing were identified in the north and west lobes, overlying F47 and F55, and allocated F8 and F11 (Plate 27). These features skirted the interior elevations of the tower, measuring 1.40m wide. F11, identified in the west lobe, consisted of two phases of surfacing, with fine rounded pebbles in a reddish-brown matrix (C1010) overlying a compacted, pale brown sandy silt with gravel and mortar inclusions (C1057)(Plate 28). The earlier deposit (C1057) was very similar to the make-up of F8 (C1005), which was allocated to surfacing around the interior of the west, north and south lobes. In places, a varied kerb was noted, made from rounded and angular cobbles. The surface had been heavily truncated by later activity.

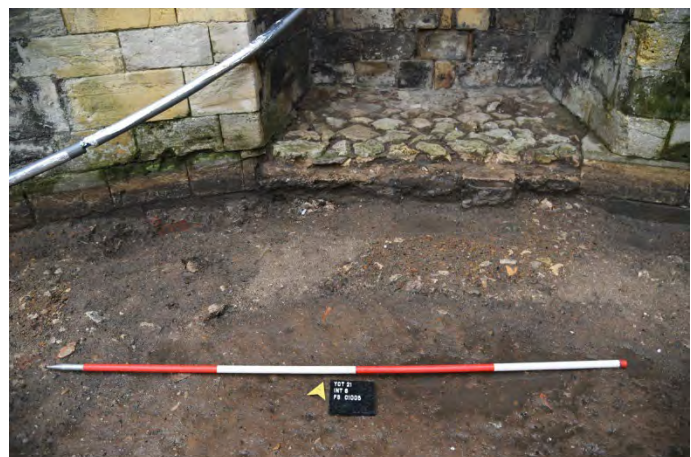
Plate 28 Sequence of gravel surfaces in the north lobe (Scale 2.0m)

The earlier deposit (C1057) was very similar to the make-up of F8 (C1005), which was allocated to surfacing around the interior of the west, north and south lobes. In places, a varied kerb was noted, made from rounded and angular cobbles. The surface had been heavily truncated by later activity.

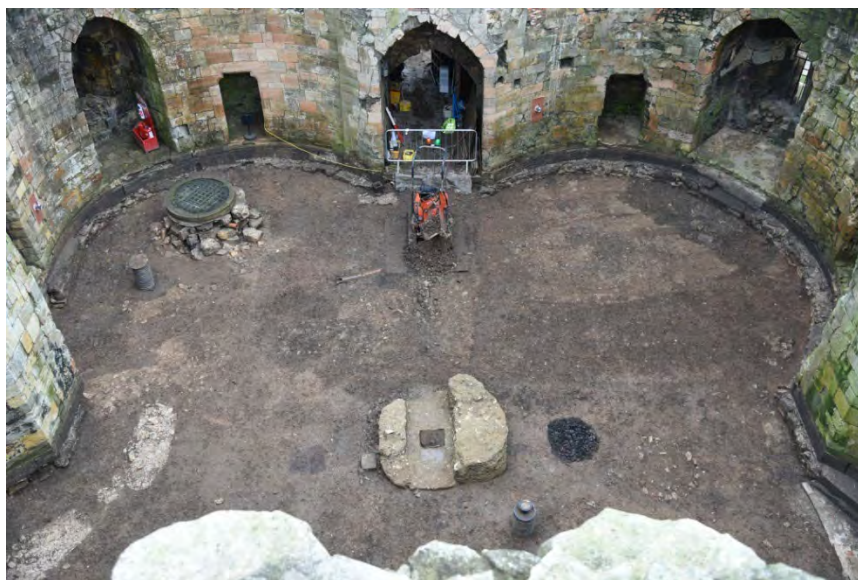
Plate 29 East and south lobes, looking south

This activity was focussed in particular in the east lobe, where a feature was observed in plan extending around the internal edge of the lobe from the forebuilding to the northern embrasure, extending c.1.5m into the interior (Figure 11; Plate 29). This feature, allocated F49, was observed in plan but was not fully excavated. The backfill (C1049) was variable, indicating backfilling at various times, but generally comprised a reddish-brown clay with occasional rounded and angular pebbles. Where truncated by the ground-reduction, this was seen to have been backfilled against concrete reinforcement beneath the tower walls.

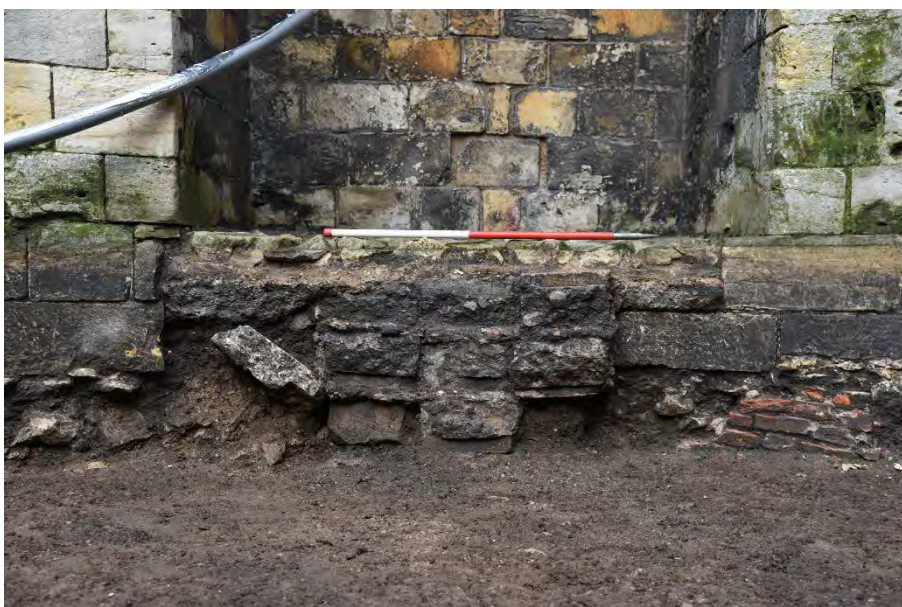
Plate 30 Concrete blocks in the north lobe west embrasure, corresponding with F62 (Scale 1.0m)

A further rectangular cut was identified against the west embrasure (F62 C1073). This feature measured 0.90m wide and extended 0.45m from the internal elevation; excavation of the mixed clay silt backfill (C0173) showed that this feature corresponded with a series of concrete blocks underpinning the embrasure (Plate 30, see Intervention 9 results).

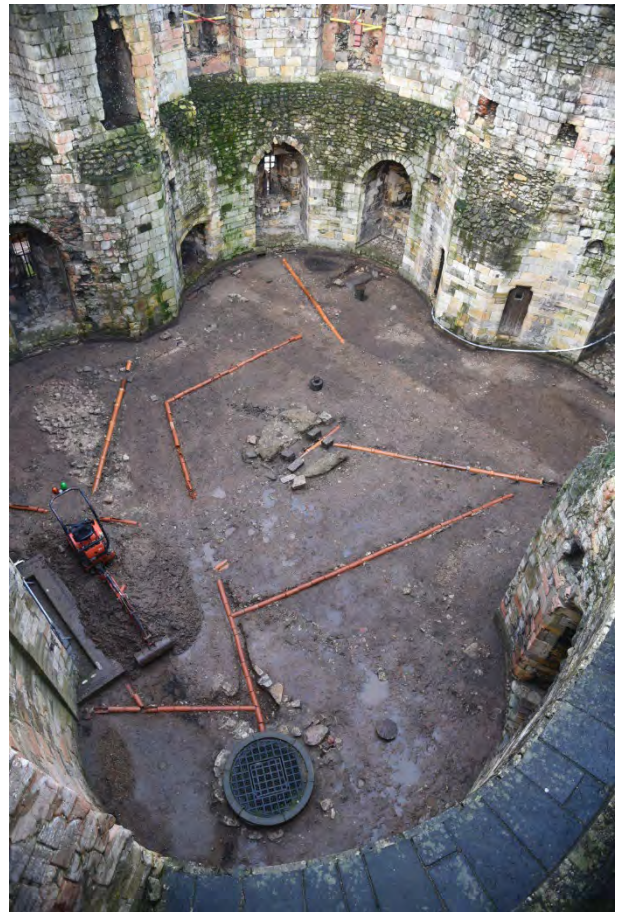
Plate 31 Drainage systems crossing Intervention 6

A system of salt-glazed pipes was identified across the interior of the tower, recorded as a number of discrete, but connected, features (F4, F5, F15, F36, F68). The system drained from north to south, towards the entrance to the tower (Plate 31; see Figure 11).

A central drain bisected the tower interior (F15), cutting through the centre of the flagpole base. The drain consisted of a salt-glazed pipe with external diameter of 0.13m (0.17m at the collar), within a trench measuring 0.35-0.40m wide. The drainage trench had been backfilled with a loose, dark brown silty clay which included rubble, bricks and mortar. Two similar lengths of drain fed into F15

from the north lobe and west lobe (F5 and F4 respectively); where the pipes met, the pipework had been supported by stone blocks. Further lengths of salt glazed pipe led from the east lobe (F36) and across the south lobe (F68) towards the central pipe and the main exit. A ceramic gully pot (F58) situated close to the east internal side of the entrance passage may also have formed part of this system.

A series of field drains was also identified (F6, F12, F13), constructed from unglazed, circular clay pipe lengths, 0.10m in external diameter and 0.30m long. F6 extended from the west lobe towards the south for c.5.0m, before turning through 110° and continuing for c.9.2m, meeting soakaway F37 and issuing into the well (F3). Soakaway F37 was allocated to an amorphous cut at the western side of the well, backfilled with loose rubble; this may have been created to receive the drainage system represented by F6. Further, similar drains drew water from the north lobe (F12) and south entrance areas (F13) and fed into F6.

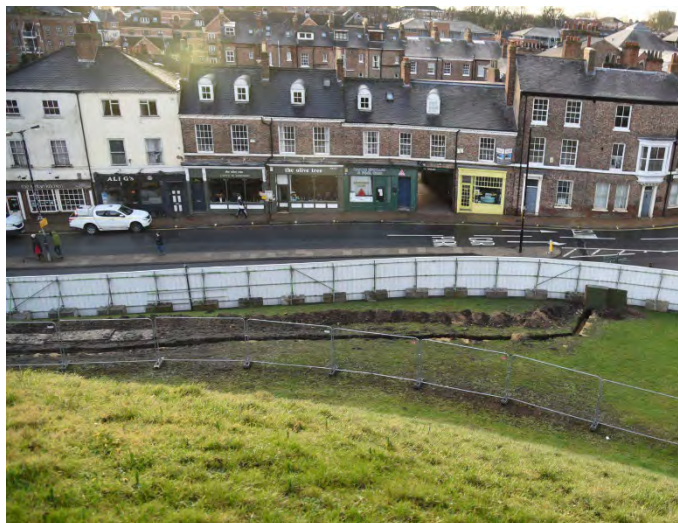
Plate 32 General view of electricity trench, looking west from the motte

A trench for a new electricity cable was excavated, descending the motte on the west side of the steps, before skirting the base of the motte on its western side, and crossing the road to connect with a power supply on the western side of Tower Street (Plate 32)(Figure 13).

The trench measured 0.3-0.5m wide and up to 0.6m deep and was excavated in three stages. The descent of the trench down the motte was hand-excavated by contractors under archaeological supervision. The trench around the base of the motte was excavated using a mechanical excavator fitted with a toothless bucket under archaeological supervision. The final stretch, across Tower Street, involved excavation over two nights due to the need for road closures (one half closed per night). This was carried out under archaeological supervision.

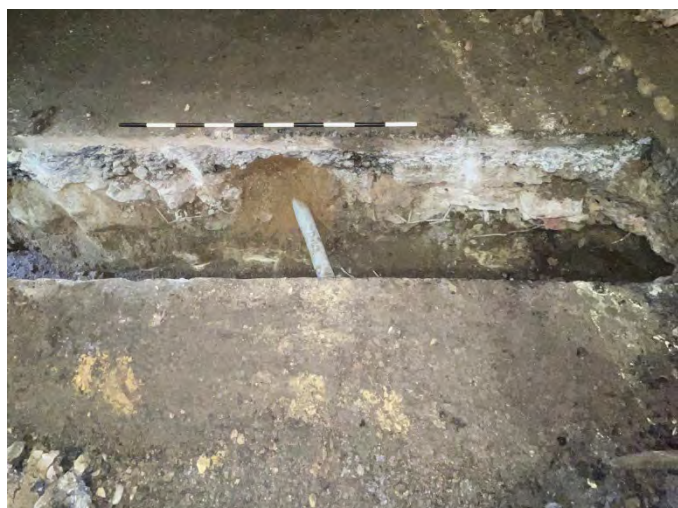
Plate 33 Wall make-up F86 in section, looking NW. Scale 1.0m

Within the road-crossing trench, on the east side of the road, a layer of reinforced concrete was observed in section, over large stone fragments and blocks. The stonework was allocated F86 C1133 and interpreted as the consolidated remains of a substantial wall; this corresponds with the known location of the external boundary wall of the Victorian prison.

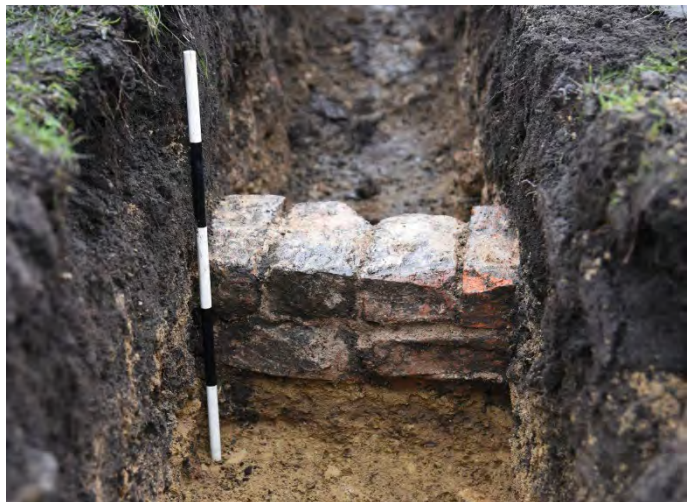
Plate 34 Wall F18, looking NW. Scale 0.5m

A series of features were identified overlying or cutting this made ground. At the northern end of the trench, a length of brick wall foundation was defined and allocated F18 C1021. This feature spanned the trench on a NE-SW alignment and surviving to two courses high (Plate 34). The bricks (which remained in situ) measured 250mm x 110mm x 50mm.

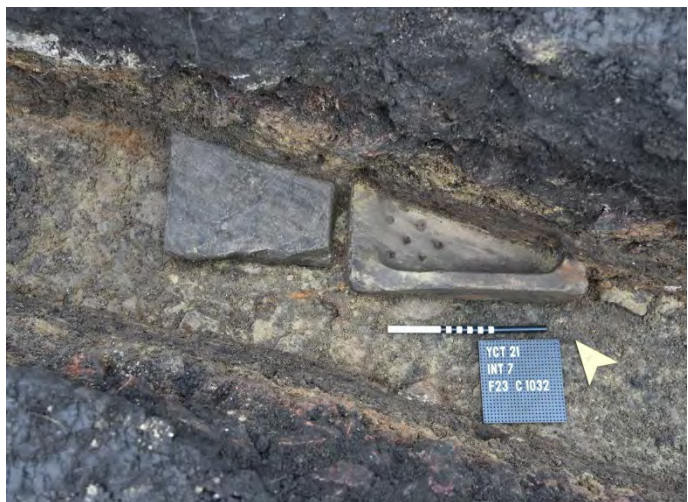
Plate 35 F23 C1032, looking northeast. Scale 0.3m

F23 (C1032) consisted of a NW-SE alignment of two blocks at the eastern limit of the intervention, one of which had a concave profile with drainage holes to one side (Plate 35). The latter may have related to surface water drainage but did not appear to be in situ.

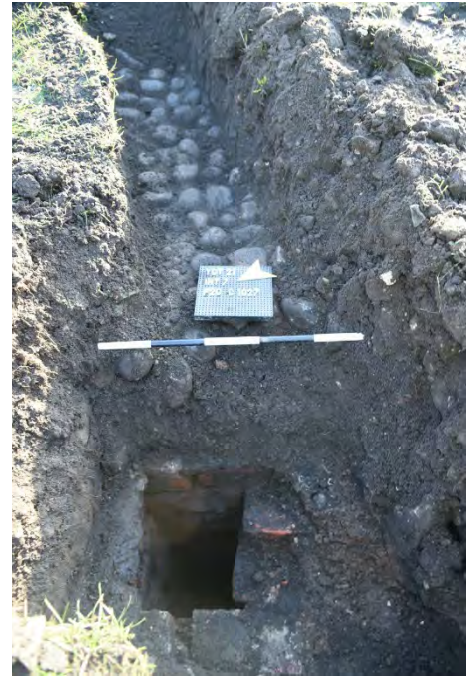
Plate 36 Cobbled surface F19 and soakaway F20, looking SE. Scale 0.5m

Still further south, part of a cobbled surface was identified and allocated F19 C1026, and observed for over 2.5m (Plate 36). The cobbled surface abutted the make-up of manhole F20 C1027, which consisted of a brick-built drainage shaft or soakaway with square top. The shaft was constructed from unbonded bricks – some of which had been reused – lining a square shaft with internal dimensions of 0.40m x 0.40m and extending to at least 1.20m deep; at this depth rubble infill was observed, indicating the feature had been partly backfilled. The stone collar with iron grid was displaced from this feature during machining but had clearly been associated (Plate 37). Nearby a later steel water or gas pipe was observed crossing the trench, and allocated F24 C1033.

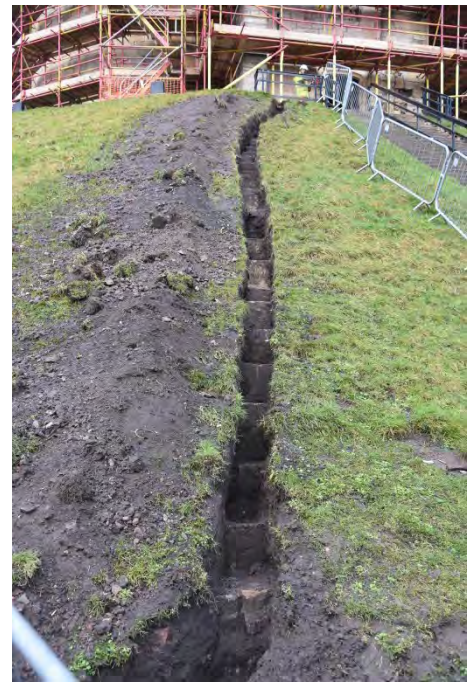
Plate 38 Electricity trench (Int 7) showing blockwork forming the motte profile (F25 C1036)

The length of electricity trench that ascended the motte revealed only deposits relating to the 20th-century reconstruction of the motte profile (Plate 38). These comprised the stepped profile of large blocks of gritstone (F25 C1036), positioned against retaining wall F27. The blockwork in this area extended beyond the known height of the retaining wall and had been covered with topsoil and turf

(C1040) to recreate the motte profile (Plate 38). A residual fragment of clay pipe was recovered from this deposit (Appendix 10), along with sherds of a Pearlware bowl of probable mid-19th-century date and English stoneware of 19th to early 20th-century date.

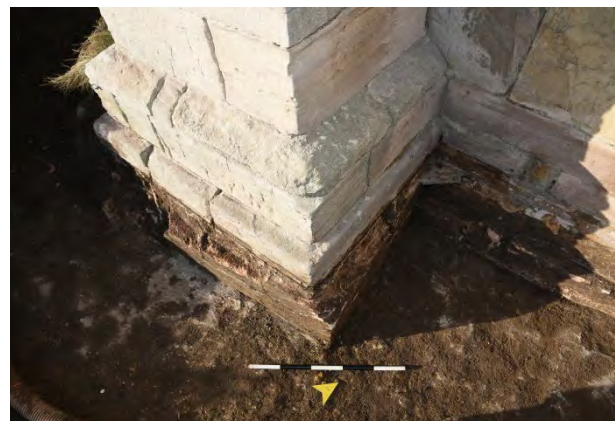
Plate 39 SW buttress of the forebuilding, showing lower courses and concrete underpinning

Removal of c.0.3m of turf, topsoil and made ground exposed two further courses of the northeast corner of the forebuilding and supporting buttress. Notably, the lower courses of the buttress appear slightly skew to the respective southeast and northeast elevations above. The projecting courses appear to have been roughly cut away, possibly so that paving could be laid flush to the main elevations (Plate 39). The stepped foundation

course of the main southeast elevation of the forebuilding had been similarly cut back at the level of former paving.

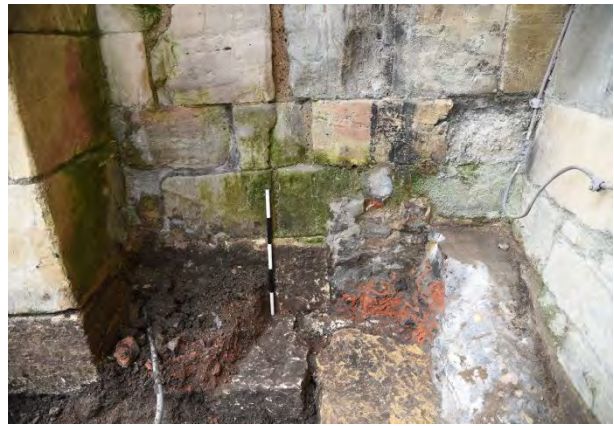
Plate 40 NE elevation of the forebuilding, looking SW. Scale 0.5m

Stepped stone foundations were noted where foundation trenches exposed lower courses. At the foot of the northeast elevation of the forebuilding, evidence for rebuilding or repair work in brick was noted, with a scar above (Plate 40).

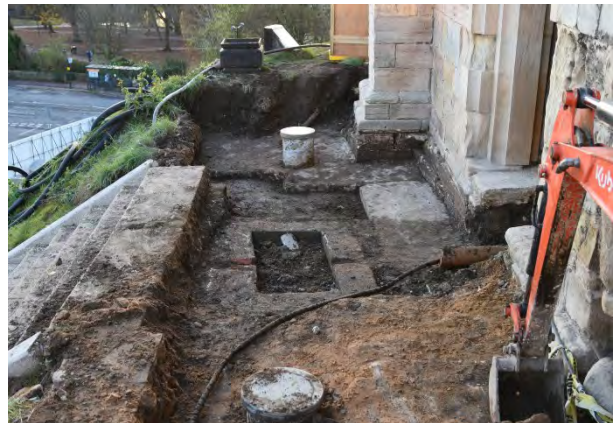
Plate 41 Area of ground reduction immediately outside the forebuilding, looking SE

Lowering of ground level across the front elevation revealed areas of concrete underpinning, particularly around the southern corner of the forebuilding (Plate 41). This consisted of a large area, 7.0m x 2.4m of poured concrete which continued beyond the western limit of intervention.

At the top of the motte stairs, the upper part of a rectangular manhole was exposed, measuring 1.55m x 1.0m (F87 C1024)(see Plate 41), serving drainage from the tower interior, that continued beneath the current stair. A stone cap was removed during groundworks, and the concrete upper part of the structure recorded.

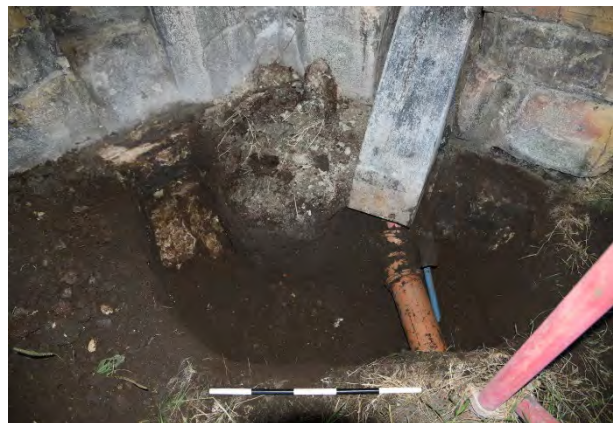
Plate 42 Drainage through the NW side of the tower

A limited area of investigation on the northeast side of the tower, within the angle between the north and west lobes, revealed 20th-century drainage passing through the walls of the tower. This included modern plastic drainage and water pipes, protected by lead chute; adjacent, a second chute had been cut through the fabric (Plate 42). Again, stepped stone foundations of the tower were observed.

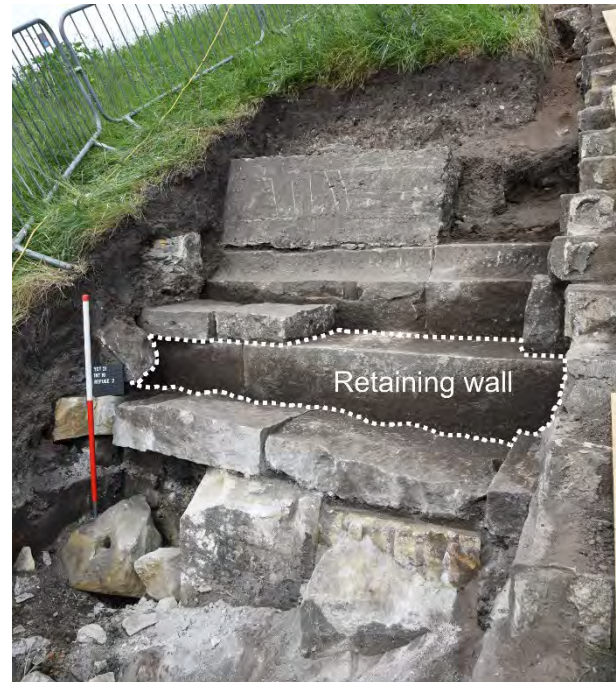
Plate 43 Retaining wall (F71 C1104), behind and beneath block make-up (F69 C1102)

Groundworks in this area provided a glimpse of the retaining wall that had been constructed in the 19th century to support the curtailed motte. The exposed area represented the upper course of the wall, allocated F71 C1104 (Int 7 F27 C1038), and seen to comprise well-dressed and closely fitting sandstone blocks, each measuring at least 0.90m x 0.50m.

Abutting F71 for the full height of the retaining wall and beyond was a stepped make-up of stone blocks (F69 C1102)(Plate 43). Above the highest course, the soil make-up of the reconstructed motte appears to have been supported by a collar of concrete, cast in situ over a chamfered upper course of blocks (see Plate 43). The stone blocks incorporated a number of fragments of reused architectural stone (Plate 44), including a possible window head with chamfered return, and a chamfered sandstone fragment with two sockets (one lead filled); the stonework is likely to derive from the prison buildings that were demolished prior to the motte reconstruction.

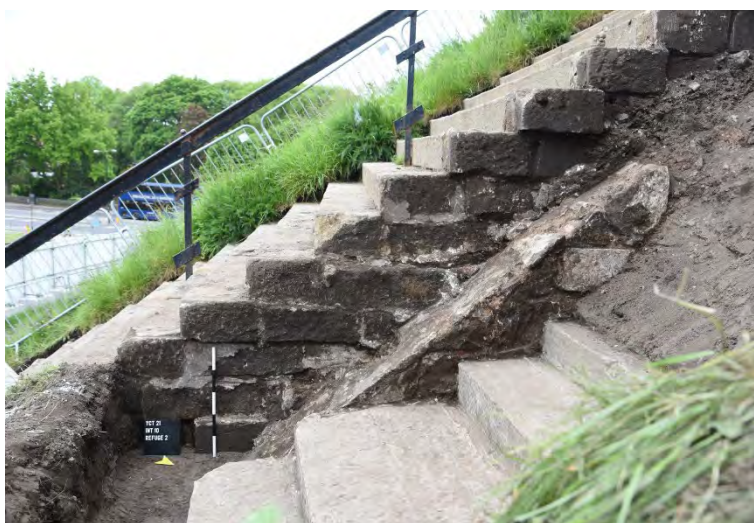
Plate 45 View of Rest bay 2, looking southeast (Scale 0.5m)

The earliest feature in this area was the stepped make-up of an area of concrete underpinning, allocated F70 C1103 (Plate 45). The exposed area consisted of four steps of concrete, with imprinted evidence for timber shuttering. The concrete was overlain with C1040, a dark brown clayey silt, laid down to reconstruct the upper part of the motte profile after the insertion of the concrete underpinning. This was then sealed by 0.30m of turf and topsoil (C1101).

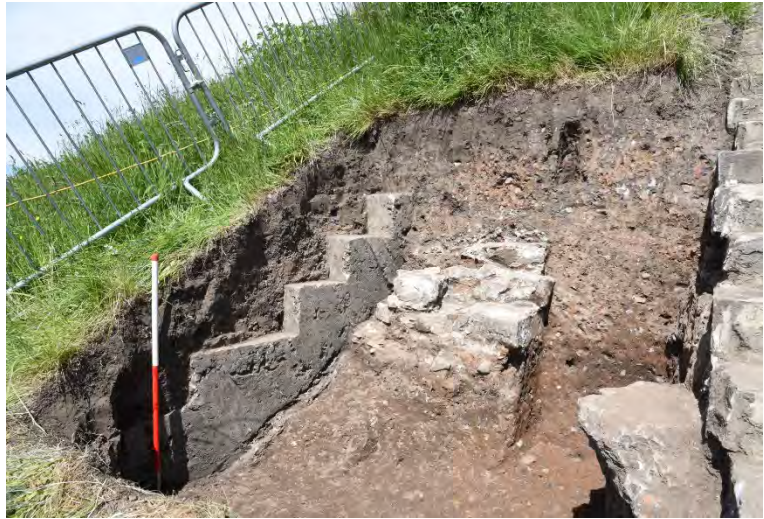
Plate 46 View of rest bay 3, showing wall F74 C1109 and concrete underpinning

Constructed over this deposit was a limestone wall, allocated F74 C1109. The wall would have been oriented NW-SE, parallel with the alignment of the current stair, but had been heavily truncated (Plate 46). To the northeast, the vestiges of the original elevation of the wall were seen to comprise three courses of squared limestone blocks, bonded with lime mortar; one stone had a dressed face. A rubble core to the rear (southwest) had been truncated when shuttered concrete was inserted

as part of the underpinning of the tower. The stepped profile of the underpinning (allocated F70 C1103) was visible in the northeast-facing section of the rest bay (see Plate 46).

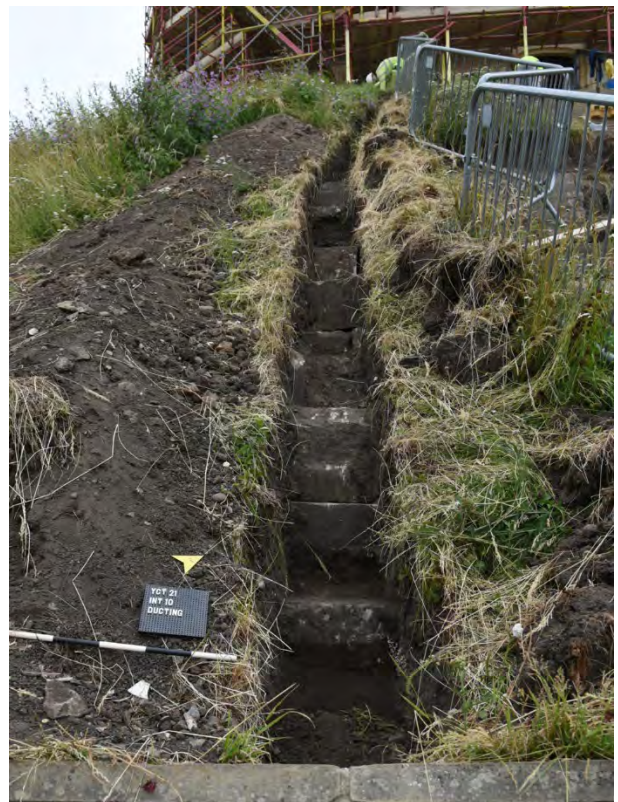
Plate 47 Ducting trench showing stepped makeup

A ducting trench was excavated a short distance from the southwest side of the motte stair, curving inwards towards the top of the slope. This exposed the stepped block make-up of the reconstructed motte (F69 C1102)(Plate 47).

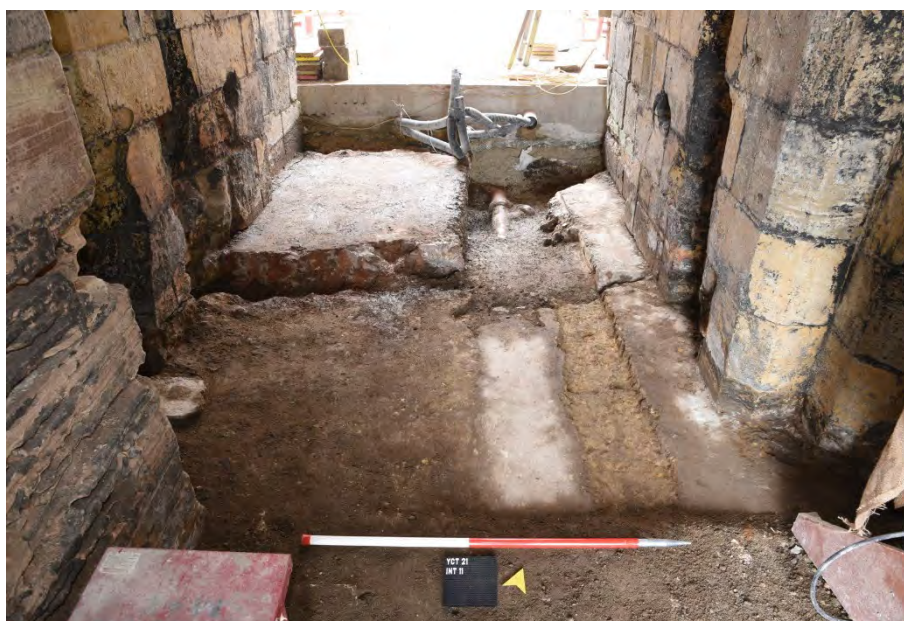
Plate 48 View of intervention 11, looking north (Scale 1.0m)

The earliest deposit within the forebuilding was a mixed, yellowish-brown made ground observed within the service trench cut in the central part of the area (C1135)(Plate 48). This layer had been cut, and sealed by, evidence for drainage and concrete underpinning.

An extensive concrete slab was encountered and allocated C1108. This lay predominantly across the northern half of the forebuilding (see Plate 48). The concrete raft had been cut through by the insertion of a salt-glazed pipe; two pipes fed into this at the northern end of the forebuilding, and the drain issued out of the entrance (F85 C1132).

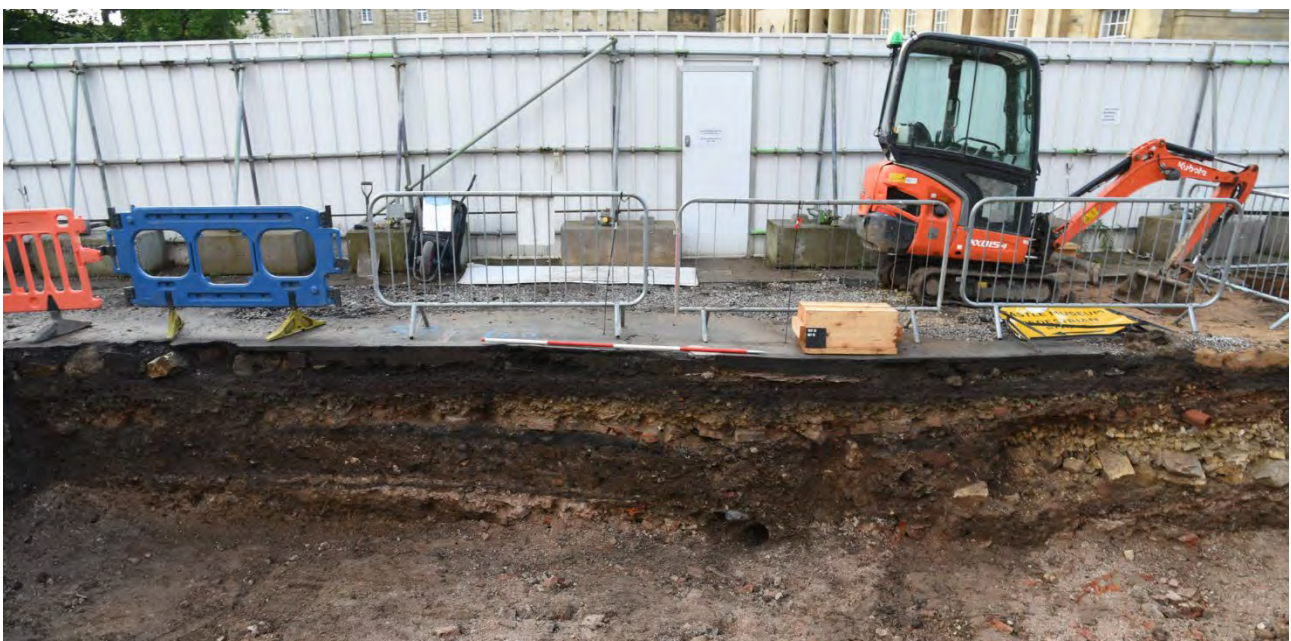
Plate 49 View of Intervention 12, north-facing section (Scale 2.0m)

Intervention 12 encountered a sequence of deposits relating primarily to the construction and subsequent demolition of the prison in the 19th to early 20th century (Plate 49; Figure 16, Figure 17 and Figure 18).
