Clifford's Tower York

Archaeological investigation

REPORT No 836
SEPTEMBER 2023

FAS HERITAGE

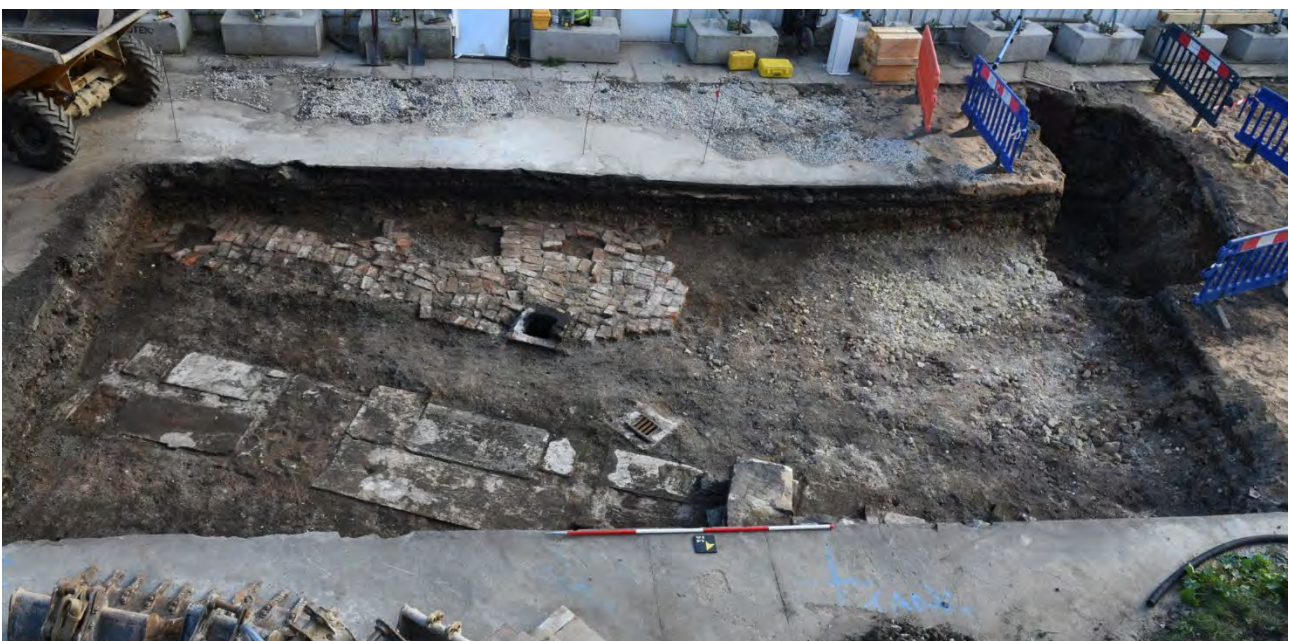
Plate 50 View of Intervention 12, looking southeast (Scale 2.0m)

Along the northern edge of the trench, a substantial wall foundation (F77, F80) was contacted, oriented west-east and continuing for over 10m, extending beyond the north and eastern limits of excavation (Plate 50). This feature overlaid the cast iron pipes represented by F82 and F83. A vertical sided cut (F80) had been excavated before the foundation (F77) was laid down. The wall foundation was constructed from large blocks of gritstone, exceeding 2.0m x 0.5m x 0.5m. Smaller blocks were also used and gaps between filled with a lime mortar containing crushed brick (F77 C1113). Many of the blocks had been reused, including in particular several large blocks of gritstone that appear to have represented components around various types of opening. Two of the stones had double chamfered loop heads and sockets for iron grille work. There appears to have been some variation in the widths of the two loops. One would have been c.0.20m wide and secured by a single by a single iron bar; traces of the loop embrasure remained (Plate 51). The other loop would have been c.0.24m wide with traces of what might have been a wider embrasure (Plate 52). The loop was also provided with iron bars with two single outer bars within the loop and a row of three bars, no

Post-dating service trenches F82 and F83, and at the ground level from which F78 and F79 had been excavated, a crude brick surface had been laid down. The bricks, allocated C1116, were semi-ordered, laid down around the edges of the collar drain F79; although roughly tessellated they were unbonded and levelled in places with crushed stone, and so do not appear to represent a formal surface. The bricks survived across an area measuring c.5.0m x 2.0m, continuing beyond the southern limit of excavation (see Plate 50).

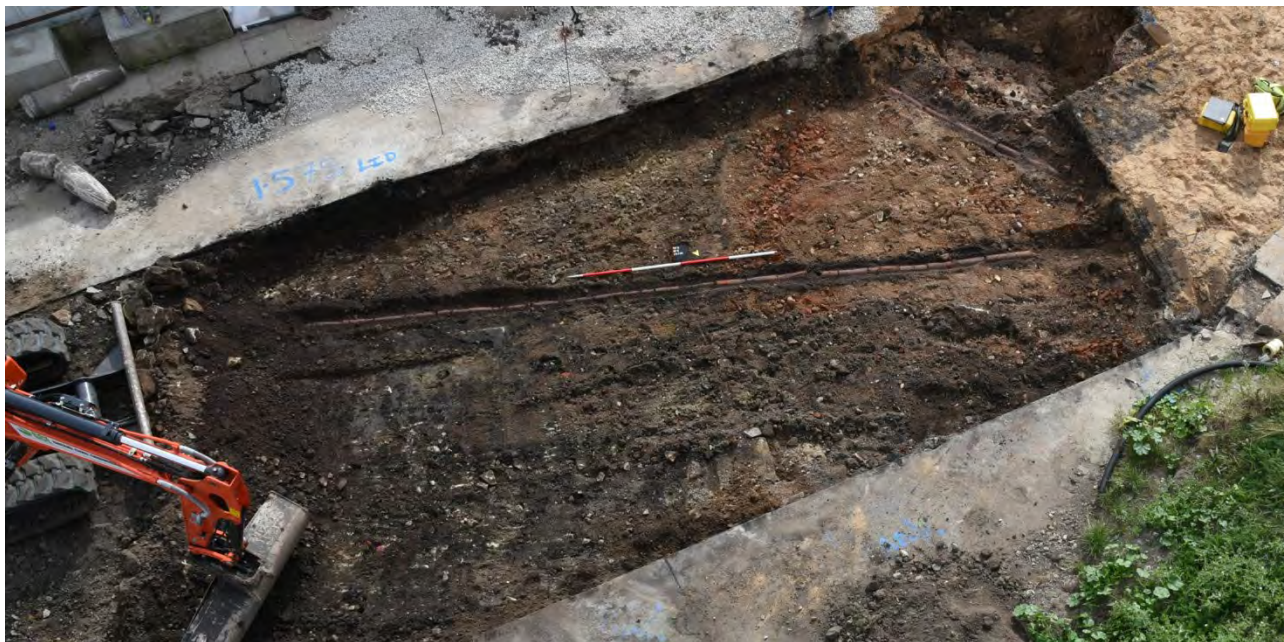
Plate 54 View of Intervention 12, looking southeast (Scale 2.0m)

Further drainage had been cut through from this higher, levelled horizon (Plate 54). At the western end of the attenuation trench, a ceramic drain was identified, oriented NW-SE and continuing beyond the western and southern edges of excavation (F75). The drain was constructed from circular, flat-bottomed ceramic pipe, 0.31m long and 0.11m in diameter (F75 C1111). A similar drain, allocated F77 C1113, was observed running for c.5m on a west-east alignment.

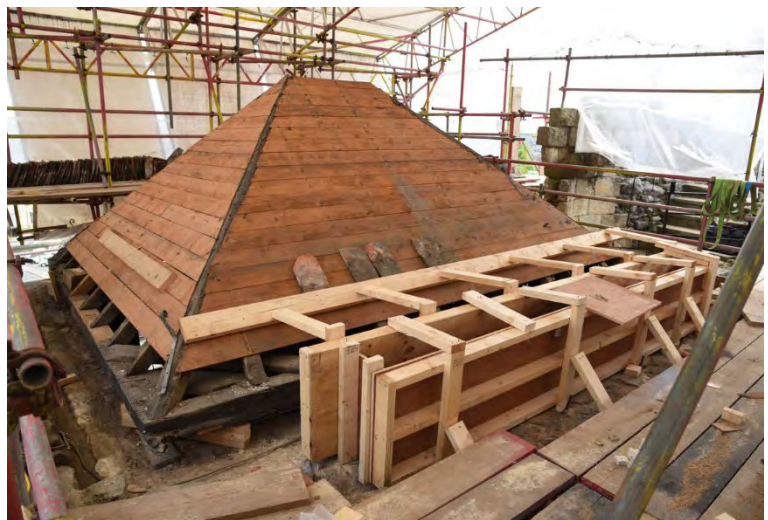
Plate 55 The roof structure on the forebuilding in the process of being re-covered

It had been hoped that the roof structure on the forebuilding might have contained some early timbers reused from medieval or post-medieval predecessors. However, stripping of the roof covering and access from within upper part of the interior confirmed that the roof structure was of machine-sawn timber from the late 19th century or early 20th century (Plate 55). The hipped roof consists of wall plates with rafters seated on them raising to a central ridge piece. As part of the current work the roof was raised and repaired (Plate 56).

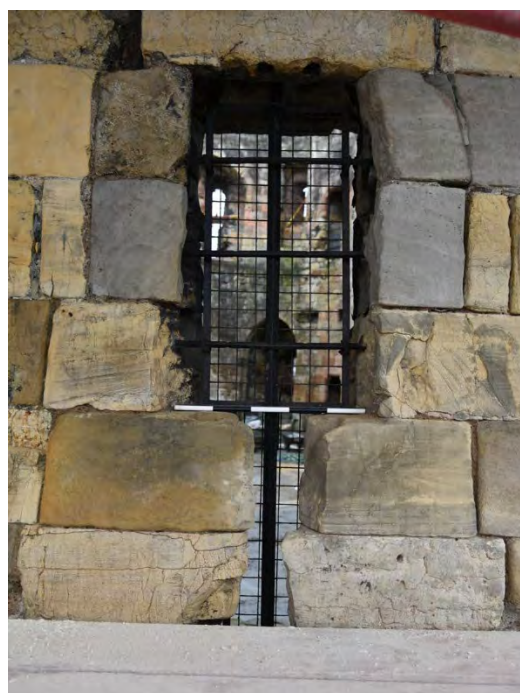
Plate 57 Ground-floor opening on the south lobe (Scale 0.5m)

At ground-floor level there are two openings consisting of tall, but narrow, slit openings. The upper part of the slits having been opened out to form a wider opening (Plate 57). Although some effort has been made to make this alteration neatly, with some chamfering on the corners of the cut back masonry, the internal evidence shows that the embrasures have also been cut to accommodate the alterations. It therefore seems likely that these two openings were originally designed as tall arrow slits, subsequently modified to provide openings that increased the admission of light. These larger openings appear to have been secured with an iron grille, the fixing sockets remaining (Plate 58 and Plate 59).

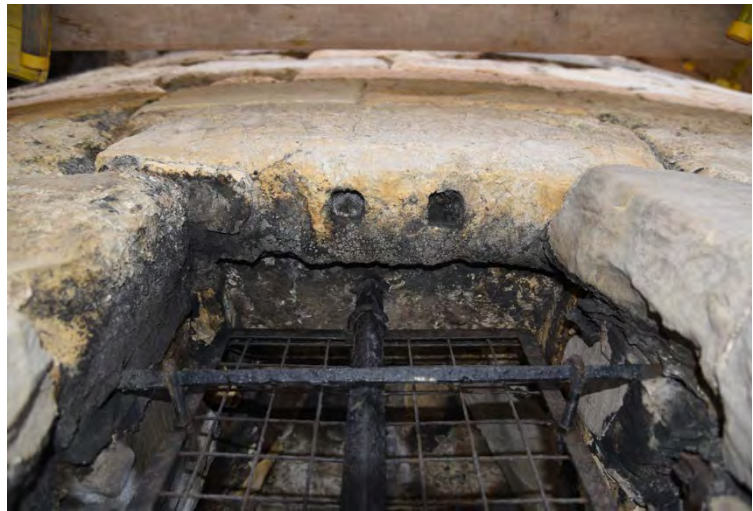
Plate 59 Ground-floor opening on the south lobe showing fixings for ironwork in the top of the enlarged opening

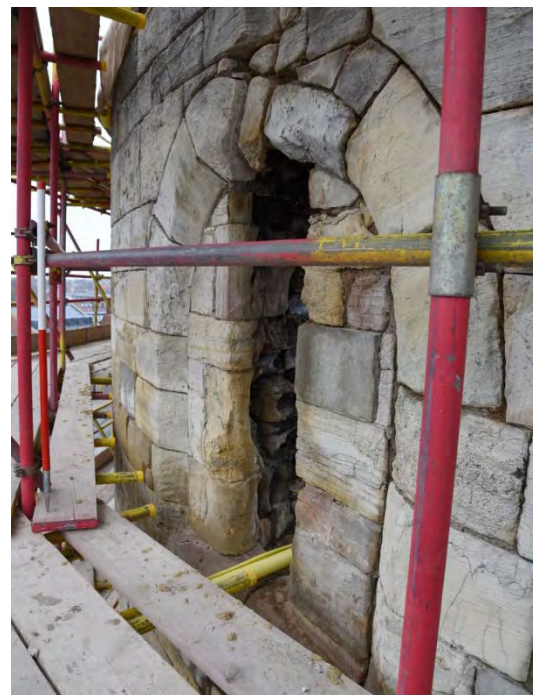
Plate 60 Upper part of partially blocked window, first floor, south lobe (Scale 0.5m)

externally, with another example on the east lobe, these are by far the largest surviving window openings on the tower (Plate 60). However, this opening, like its counterpart on the east lobe, has been partly filled-in with a mix of reused masonry including sandstone, burnt stones, grey limestone in addition to the more typical pale yellow Magnesian limestone of which most of the tower is constructed. The narrow opening thus formed is a more modest c.1.47m tall and less than c.0.3m wide, with some effort to carve a small chamfer around the edge of the opening (where this survives). The reason for creating a narrower opening is not difficult to identify; from the top of the tower, passing through the centre of the first-floor opening and then down towards one of the ground floor openings is a crack. Effort has been made to stitch and fill across the crack, but movement of at least c.0.14m is evident above the first-floor window opening.

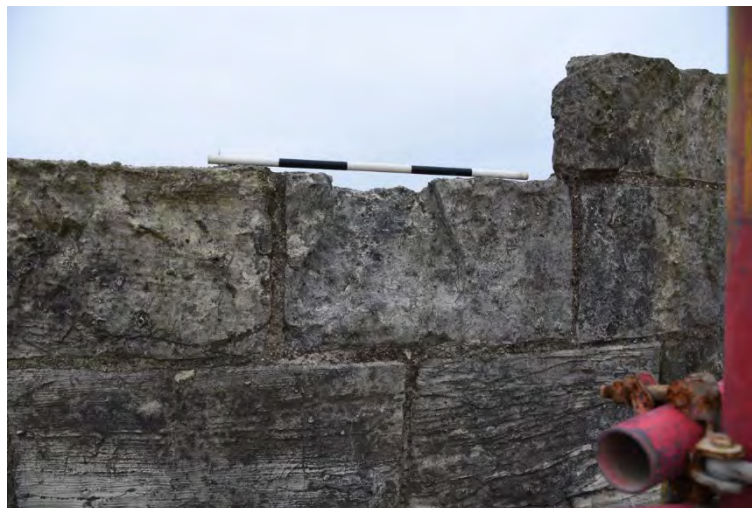
Plate 61 Fishtail arrow slit base, south lobe (Scale 0.5m)

The top course of stones in the elevation retains a single arrow slit base of fishtail form (Plate 61). Other bases of this form survive in the top course of the tower and recovered from excavation. The upper courses of stone have been reset and re-bedded during the early 20th-century repair campaigns and the fishtail

arrow slit base might not have been accurately repositioned. Nevertheless, it cannot be massively out of original location and can be taken as a benchmark for the lowest point of the arrow slit which it served. It would certainly suggest that the parapet wall must have been higher than it is today, perhaps stepping up to form merlons, containing the arrow slits, up to c.2m higher than the current wall height.

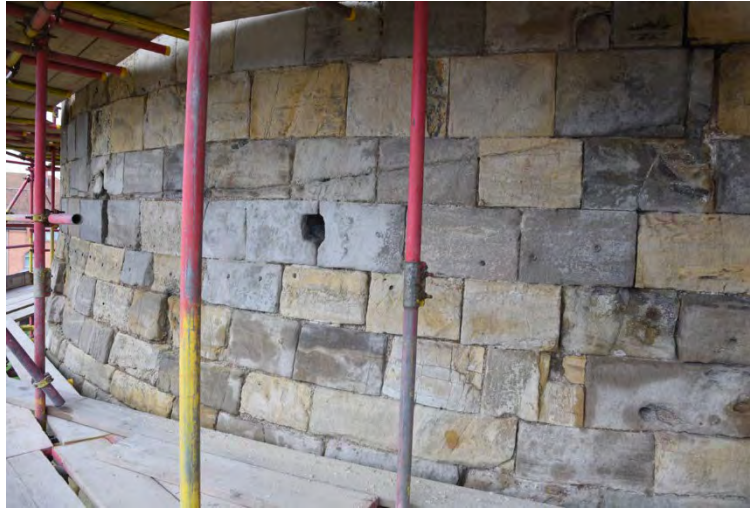
Plate 62 Roof scar and sockets on the exterior of the west lobe

The ground floor also retains evidence for a structure being built against the elevation in the form of a pattern of sockets, roof scar and holes with timber plugs (Plate 62). The roof scar is a thin chase, no more c.0.02m high, and c.4m in length. Rather than being straight or pitched raising to the centre, the scar is slightly curved and may have a slightly raised pitch to either end. This suggests that the roof sloped down or that it was important to have the roof of the building raised towards its outer walls. Beneath the roof scar there are three irregular sockets which presumably took timbers, probably purlins, to support the roof. A fourth socket, towards the southern end of the vanished structure, would be expected but evidence for this has likely removed through some stone replacement.

Further rows of sockets are positioned c.0.25m and c.1.4m above the current ground level. The sockets are c.0.06m x c.0.06m, too small for joists or similar structural elements and more likely to be for timber grounds to fix panels or similar finishes to the wall of the tower.

The remaining evidence for the vanished building, constructed against the tower, suggests that it was single storey and of light-weight construction. The absence for any substantial evidence for

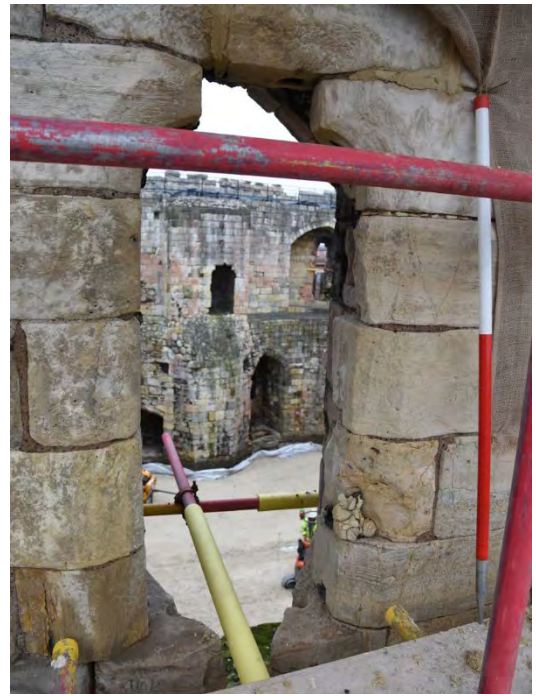
Plate 63 Upper part of first floor window on the west lobe (Scale 1.0m)

At first-floor level there are two openings of identical form, consisting of a shouldered opening above a narrow slit (Plate 63). The design appears to be deliberate, rather than an alteration, and provides for a very tall opening c.2.5m in height. The slit, which is c.0.09m wide, features a round termination, known as an oilet, at its bottom. The upper shouldered opening, which is c.0.5m wide maximum and has circular holes in its sill for securing bolts, iron grille work or window glazing bars. (Plate 64).

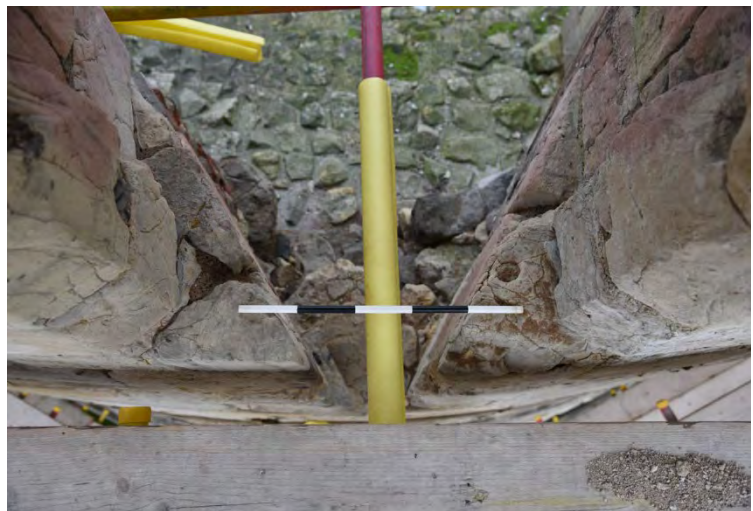
Plate 64 Sill detail of the upper part of first floor window on the west lobe (Scale 0.5m)

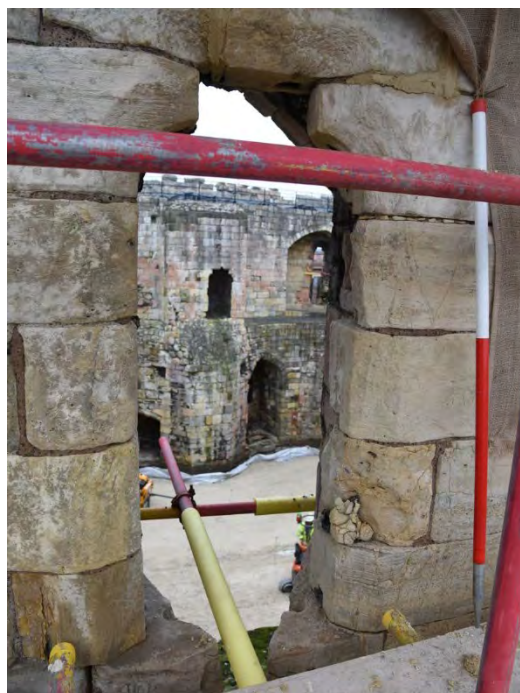
Plate 65 Rainwater spout on the west lobe

The wall head retains the bases of two arrow slits of fish-tail form and identical to that seen on the south lobe. Between the two arrow slit bases is a rainwater spout which, although decayed, is evidently in the form of a lion's head (Plate 65 and Plate 66). The spout is located approximately midway around the radius of the west lobe; further rainwater spouts would have been located similarly on the other lobes but have been lost. The position of the spout provides a little more certainty regarding the height of the parapet walk which it would have assisted in draining of rainwater.

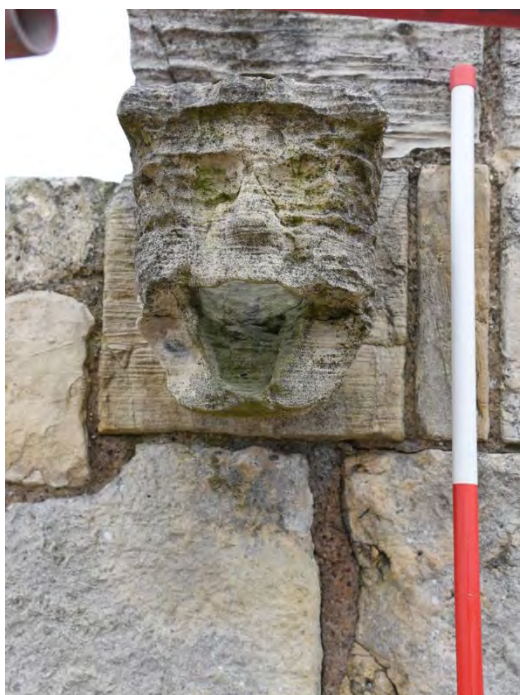
Plate 66 Detail of rainwater spout on the west lobe

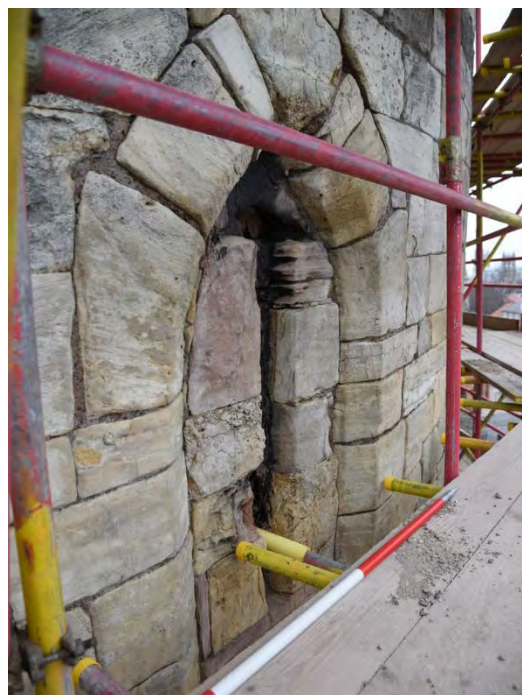
Plate 67 First floor window on the east lobe (Scale 1.0m)

The first floor also mirrors the south lobe with two openings, one with a two-centre head but with secondary narrowing, the other having shouldered opening above a narrow slit. The two-centre headed window would originally have been c.1m wide and c.2m high externally (Plate 67). The partial filling consists of a similar collection of material used in the south opening with the exclusion of any sandstone. The narrowed opening is c.1.28m tall and less than c.0.07m wide. In contrast to the south

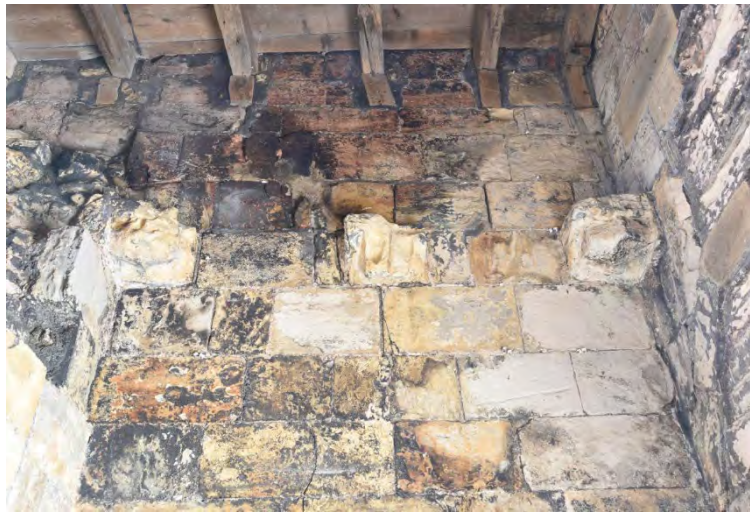
Plate 68 Stone corbels on the northeast wall of the outer lobby of the forebuilding (Scale 0.5m)

The upper part of the wall features three moulded sandstone corbels, although only one retains its form fully intact, but of regular size being the stones being c.0.25m high and c.0.40m wide. The moulded form is the same to that seen employed elsewhere in the tower, notably the stairs, and all are likely to be a primary feature (Plate 68). The corbels are located c.1m below the current modern floor of the chapel, but judging from the sockets and disrupted masonry

evident below the modern floor, the original floor structure was slightly lower. These corbels are likely to have supported short wall posts which, in turn, would have supported the main bridging beams spanning the lobby passage; a timber brace is likely to have been employed between post and bridging beam. The size of the corbels and the way they have been employed are of particular relevance in understanding the floor arrangement within the main body of the tower (discussed below).

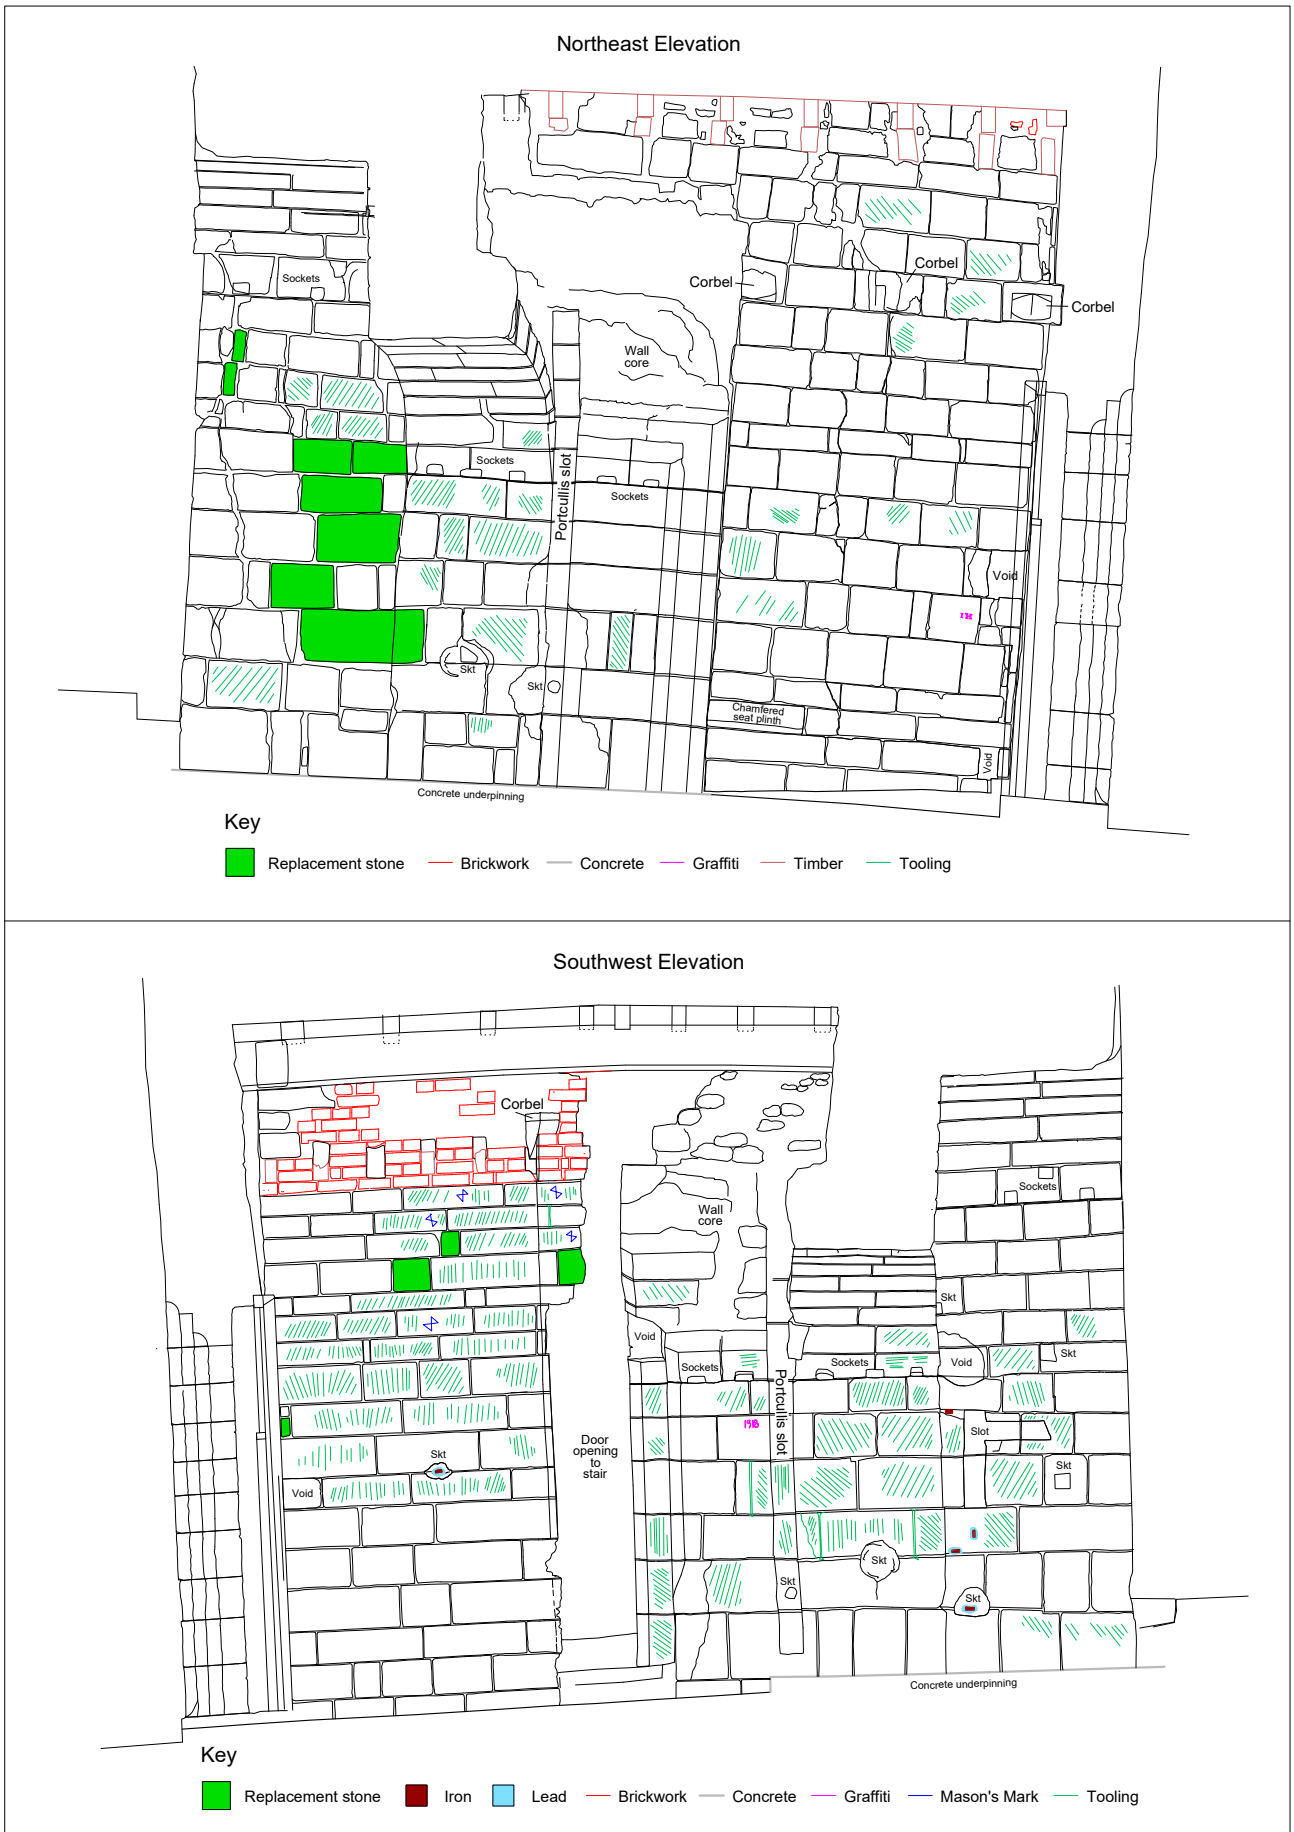
Figure 29

Northeast and southwest internal elevations of the ground floor of the forebuilding

The northeast wall of the outer lobby retains the socket, c.0.24m wide by c.0.32m high, that would have received the drawbar that secured the outer door (Figure 29). The lower part of the elevation has a bench seat, now surviving to maximum of c.0.62m above the most recent passage floor surface, with only one section of the bench to surviving at the northwest end. The bench seat arrangement would have presumably been mirrored on the opposite (southwest) side of the passage; a fragment of the recess survives that housed the bench but incorporated into the 17th-century reconstruction.

The opposite, southwest, wall was largely reconstructed in the 17th century and contains the remains of a newel stair, accessed by a narrow doorway that faces north. The section of wall that encloses the stair is largely of regularly coursed stone, with the upper part of brick (see Figure 29). The ends of timbers remain set within the brickwork, c.0.75m below the current floor; these are either joists or other structural timbers that served to support the floor of the chapel.

The northwest wall of the outer lobby is dominated by the fractured two-centre headed archway, and intact vaulted section beyond, that provides access to the inner passage. The passage walls retain a slot for a portcullis and, further into the passage (northwest), a shallow rebate which would have housed an inner, single leaf, door; traces for the location for the pintle fixings and a chase for securing bar remain on the southwest side (see Figure 29).

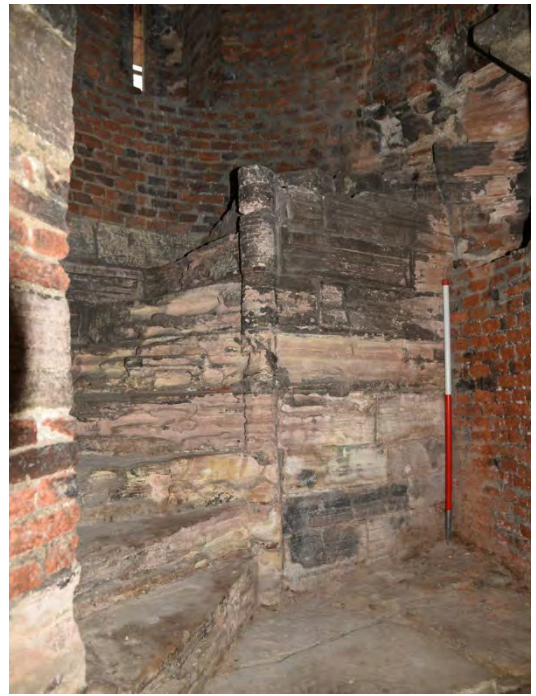
Plate 69 Newel staircase in the forebuilding (Scale 1.0m)

Only the lower part of the newel stair remains intact, although the position of vanished risers can be seen higher up the stair drum. The remaining stair risers have been constructed out of reused pieces of masonry (Plate 69 and Plate 70), while the stair drum is a mix of masonry and brick.

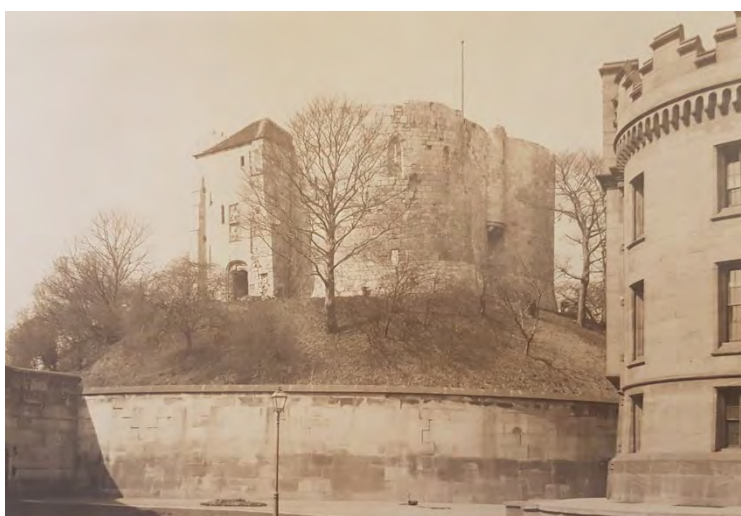
Plate 93 Late 19th-century view of the tower with gaslight in the foreground

of the development of the prison, to provide a level base for subsequently surfacing. C1128 produced a graffito stone of 1827 which would suggest material deriving from structures demolished or altered during the construction of the prison. A series of service trenches provided drainage, with stone collars and metal grilles over square brick shafts. These were observed within Intervention 12 (F78 and F79) and Intervention 7 (F16), where a cobbled surface was associated. Together, these indicate that ground level in the early 19th century in the castle yard was lower than today. It is possible that the narrower pipe identified in the trench may have served one of the gas lights shown on early photographs (Plate 93).

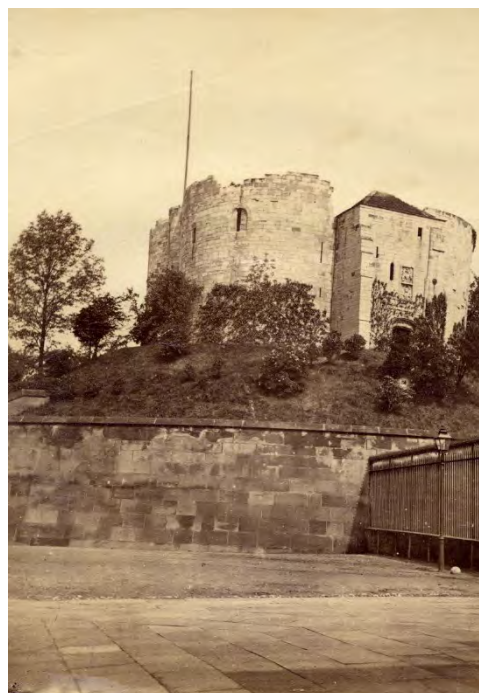
Plate 94 View of the tower showing flagpole attached to southwest bartizan turret

Within the tower, the role as a garden appears to have continued, but more public in character. Contemporary sources describe the picturesque character of the tower interior, including the presence of a central walnut tree; interestingly, the 1852 Ordnance Survey edition shows a central tree in the tower. At this time, photographs show that a flagpole appears to have been mounted on the wall, adjacent to the west and south lobes, and a straight wall and gate connected the motte retaining wall and the court (Plate 94).

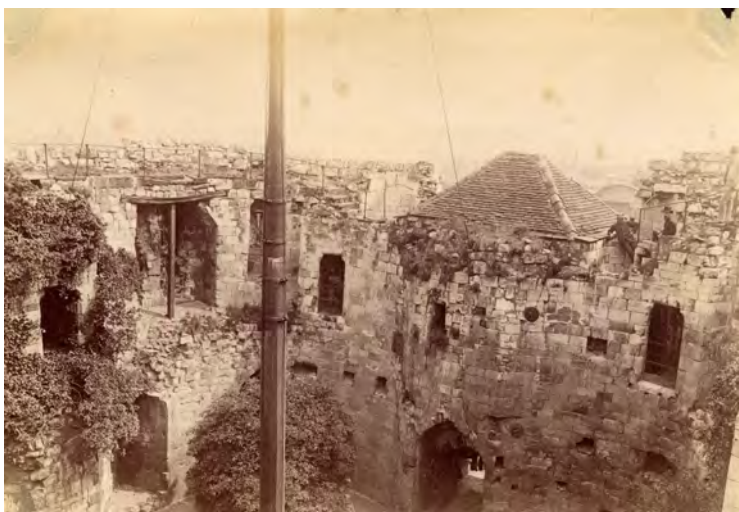
Plate 95 View of the large central flagpole and cable system

At first-floor level a door provides access to the bartizan stair. Some sockets adjacent to the door would have related to a partition, while above the door is a section of iron chain; this relates to the central flagpole that was installed in the second half of the 19th century (see Plate 95).

Between 1852 and 1889, paths were laid out around the exterior of the tower, and a central flagpole had been erected. Investigations in Intervention 6 shows that flagpole (F16) was a substantial feature, well-secured at the base; photographs show that it was supported by a series of cables attached to the tower walls, evidence for which was encountered during the historic building recording (Plate 95). The formality of the paths suggests a phase of levelling and removal of trees; the heavily disturbed deposit of C1039 may have originated in this period, with rubble-filled channels created to provide drainage of the surfaces.

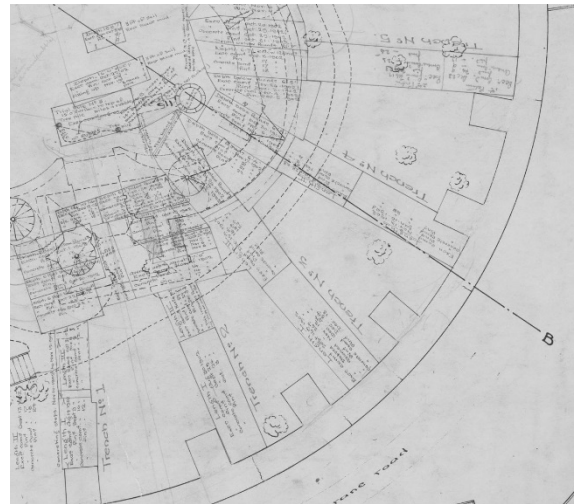
Plate 97 Mott drawing of underpinning locations, dated 1902

The takeover of the prison by the military was followed by surveys confirming the poor condition of Clifford's Tower. At the time this was blamed on the curtailment of the motte, but it is interesting to note that the decision was made to rescue the tower rather than demolish it. Works to underpin the elevation with the insertion of massive concrete ribs is well documented and corresponds accurately with what was identified during fieldwork. The concrete underpinning was contacted in Interventions 6, 10 and 11, with the cuts for inserting these works corresponding well with the documented interventions recorded on plans of 1902 (Plate 97). Mott's drawings show that the concrete was poured in sections, consistent with the mixed nature of the deposits over.

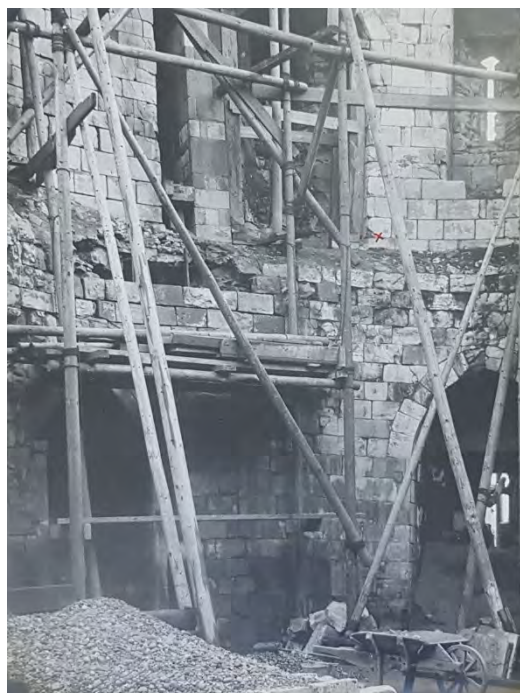
Plate 98 View of scaffold system erected in the tower in the 1920s

Clifford's Tower was taken into guardianship on the 30th March 1915 and five years later a further phase of restoration was begun. During the 1920s, the reinforced concrete ring beam was inserted at first-floor level, and work to the wall walk was undertaken. This work saw the erection of a scaffold within the tower, shown on contemporary photographs (Plate 98). The series of postholes containing large fragments of rubble and concrete are interpreted as the base supports for this scaffolding. A penny of 1928, recovered from C1164, would represent activity in the tower in the subsequent years.

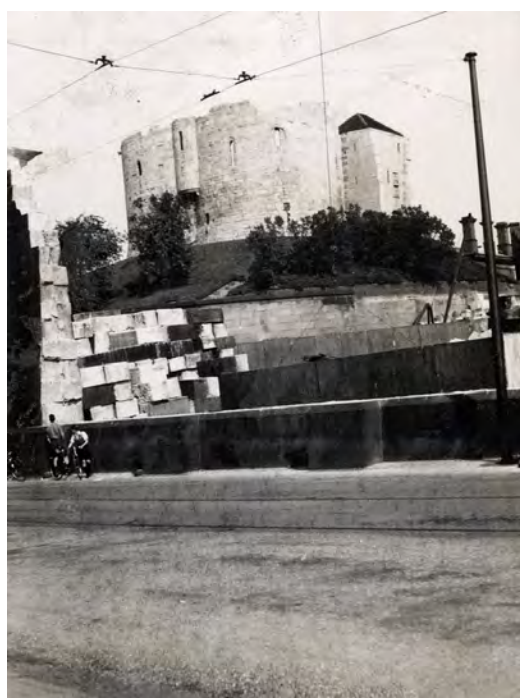
Plate 99 View of prison wall during demolition, the likely source of stone now buried in the motte

The prison was demolished c.1935, and contemporary photographs show the level of groundworks that this involved. The demolition of wall (F77) and subsequent levelling belongs to this period (Plate 99). Many of the drainage features would have been disused, and new services required.
