HERITAGE STATEMENT

Refurbishment Works – 46,48 & 50 Stonegate, York

May 2024

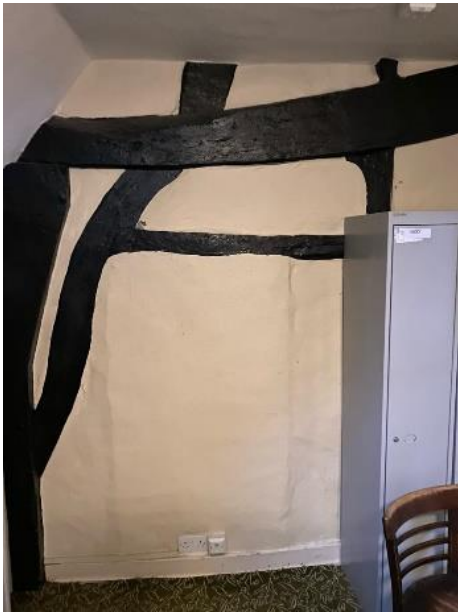
Figure 7 Timber posts and braces visible on second floor

No.46. Staircase from ground floor to attic has close string, turned balusters, square newels with attached half balusters and moulded ramped handrail. Some timber-framing visible on second floor, mainly the posts, tie-beams and wall plates. An investigation from a structural engineer discovered that the stud infill panels have previously been removed and replaced with masonry. The first floor front room has fireplace with moulded jambs and frieze, angle roundels and hob grate with fluted side pieces; reeded door architraves with angle roundels. Second floor front room has blocked C18 fireplace with cornice shelf; cupboard door of run-through panelling on H-hinges.

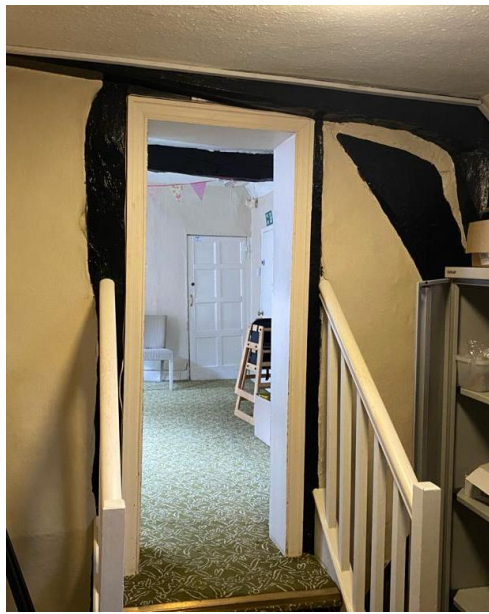
Figure 6 Existing doorway inserted in between 46 and 48 to connect the two buildings.

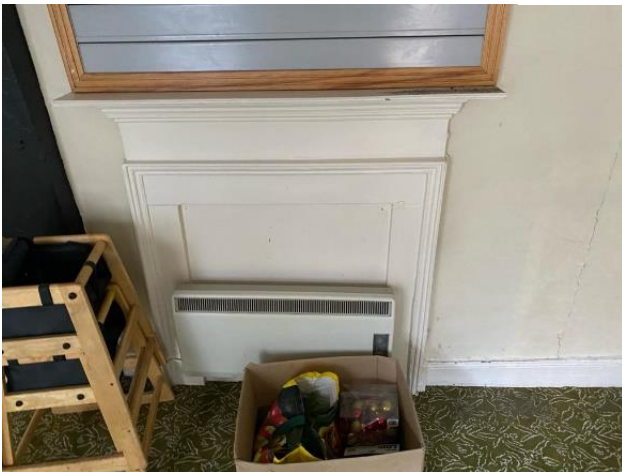
Figure 5 Blocked 18th century fireplace on the second floor of 46

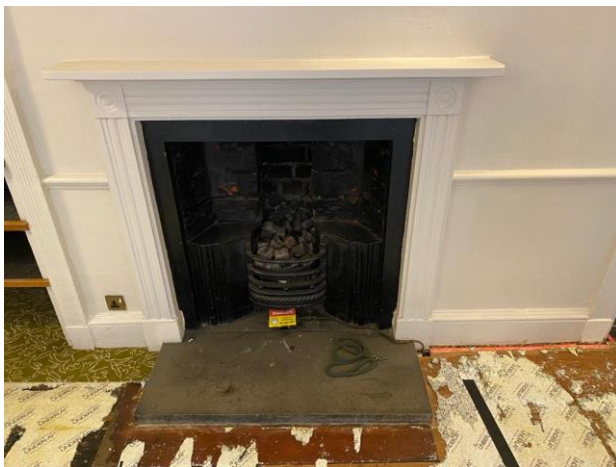
Figure 4 Fireplace on the first floor front room of 46

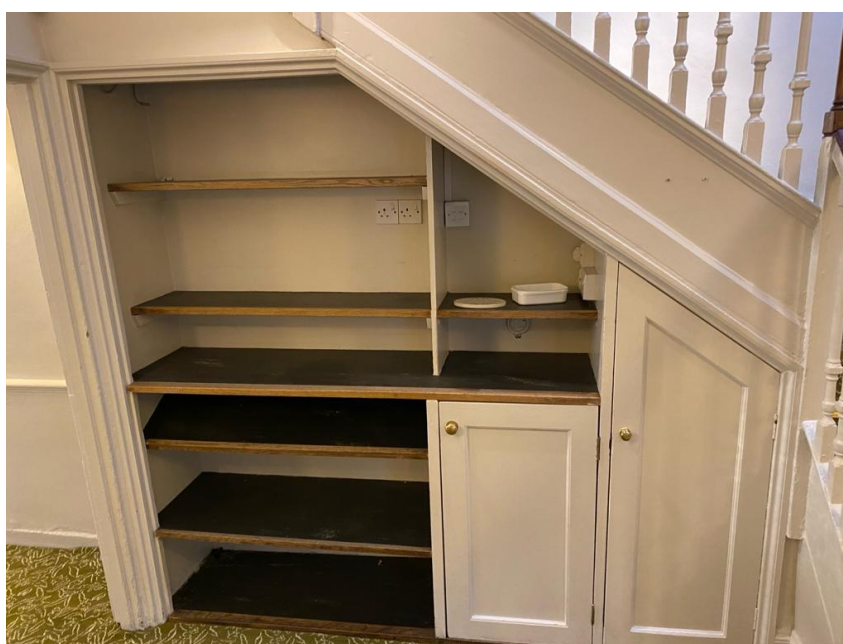
Figure 8 Modern shelving beneath staircase

- A - Corridor
 - Lift carpet, remove asphalt floor covering to reveal stone flagstones. Repair and repoint with lime mortar.
 - Remove modern shelving from beneath historic staircase.

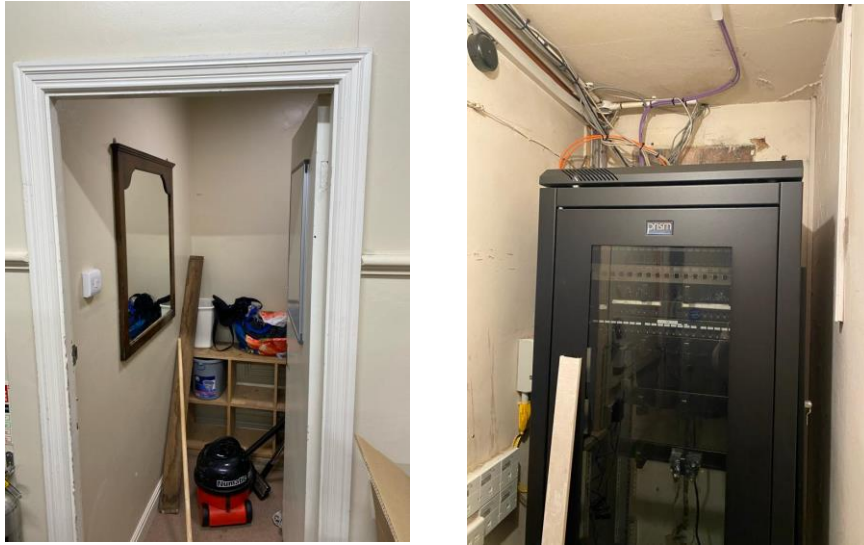
Figure 9 Ground floor store cupboard and landing IT room used for beer pythons

- B - Beer Store
 - Clad walls with wipeable plastic sheets.
 - Run 2 beer pythons from cellar to 1st floor proposed bar, in locations shown on drawings.
 - Install heat dump unit within the external yard for a keg line cooler, with pipes feeding through wall. Existing openings created by mechanical and electrical equipment to be used where possible. Refer to drawings for details of location and dimensions.
 - Install air conditioning unit on the external wall to maintain required internal air quality and temperature. Existing openings created by mechanical and electrical equipment to be used where possible. Refer to drawings for details of location and dimensions.

- C - Services – Beer pythons use existing service runs where possible to serve first floor bar.

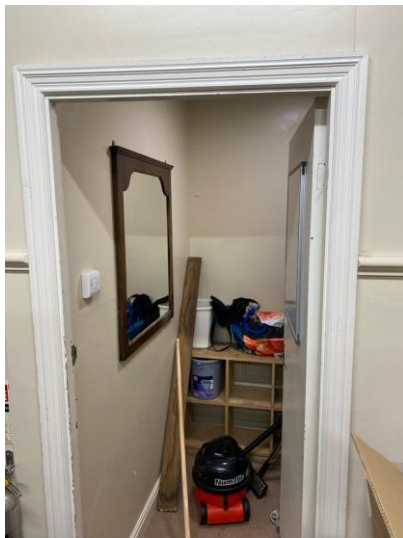
Figure 10 Store area to form new mens WC

- D - Mens toilet – install new mens toilet in store area between ladies toilets and beer store.

D	The installation of a new gents toilet in the existing store area will have neutral impact on the building. The store room is next to the existing ladies toilet so can connect into existing hot and cold water supplies and drainage for waste. The space is already vented with a metal grill so this can be replaced with a mechanical vent, using the existing opening on the external wall.	Neutral
E	Replacing the modern carpet with reclaimed timber floor boards will enhance the character of the space.	Minor Beneficial
	Remove modern suspended ceilings to reveal joists, to enhance character of space. The timber paneling applied to the walls can be removed in future. The bar will be a free standing piece of furniture, designed to be in keeping with the space but can be removed in future without harm to the building.	Neutral
F	This space was previously the kitchen for the Bettys café. There are no historic features within this space, and it is possibly the room which has had the most modern interventions. The proposal is to remove the modern stainless steel wall coverings, the vinyl floor covering and all the cooking equipment. The space will then be subdivide by a glazed partition and will form a tasting room. The removal of modern detracting commercial kitchen equipment and conversion of the space into a tasting room will enhance the character of the space.	Minor Beneficial

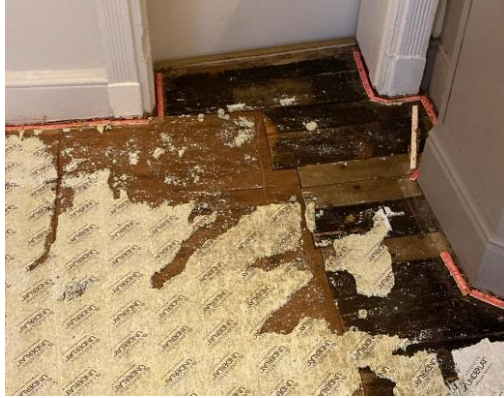
Figure 11 Chipboard and pine boards beneath carpet on first floor

- E - Bars 01,02 and 03 –
 - Remove modern plywood floor covering and replace with reclaimed tongue and groove timber floor. Floor boards to have natural oiled finished applied.

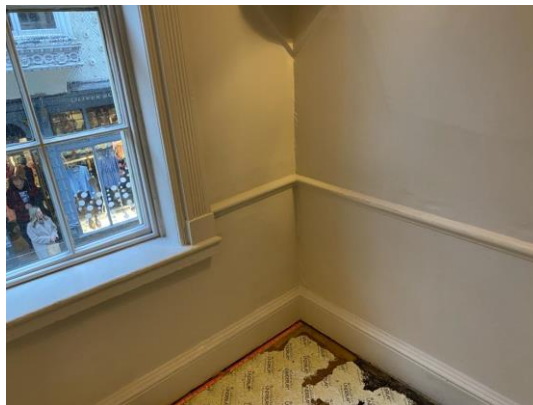
Figure 12 Reeded window architrave on first floor of 46

- Remove modern suspended ceilings to expose joists in the first floor front rooms of 46, 48 and 50.
- Apply timber paneling to walls in areas shown on drawings. Refer to drawings for paneling design.
- Install a free standing bar and back bar within the first floor of 46 stonegate.
- Back bar to be offset from front elevation wall to avoid reeded window architrave.

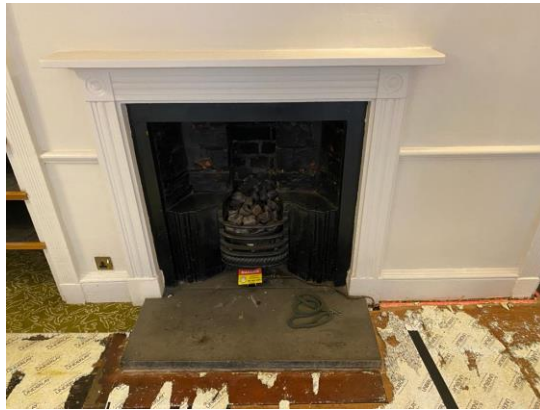
Figure 13 Fire place on first floor of 46

- Remove hearth in bar, historic fire surround to be retained.

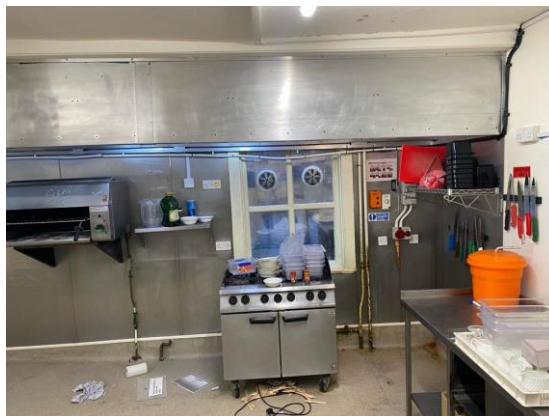
Figure 14 Existing kitchen on first floor, to be converted into tasting room

- Remove modern shelving in alcoves to left of fireplace.
- F - Tasting Room
 - Install glazed partition to form tasting room.
 - Remove internal partition to connect store to tasting room.

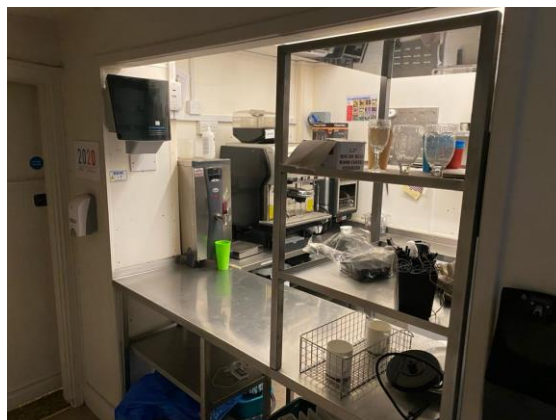
Figure 15 Existing prep kitchen on first floor, infill opening

- G - Prep Room – reinstate timber stud partition wall and fit door to existing opening.

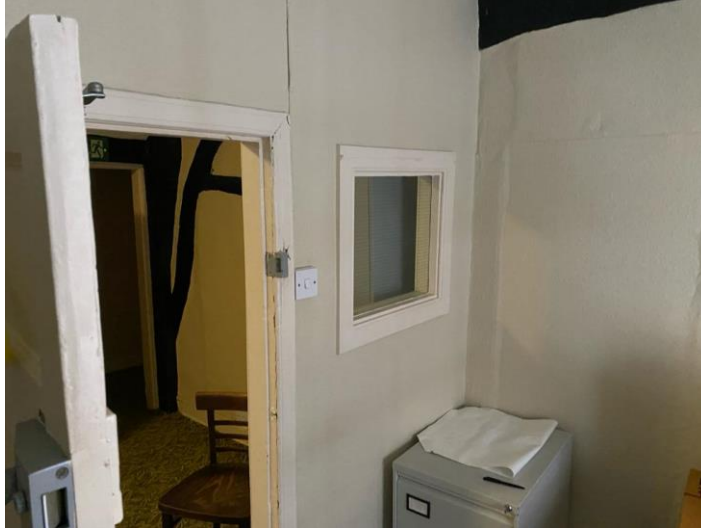
Figure 16 Partition dividing the room on the second floor of 48

- H - Remove modern plywood floor covering and replace with reclaimed tongue and groove timber floor. Floor boards to have natural oiled finish applied.
- I - Remove infill panels to partition and expose timber studs.

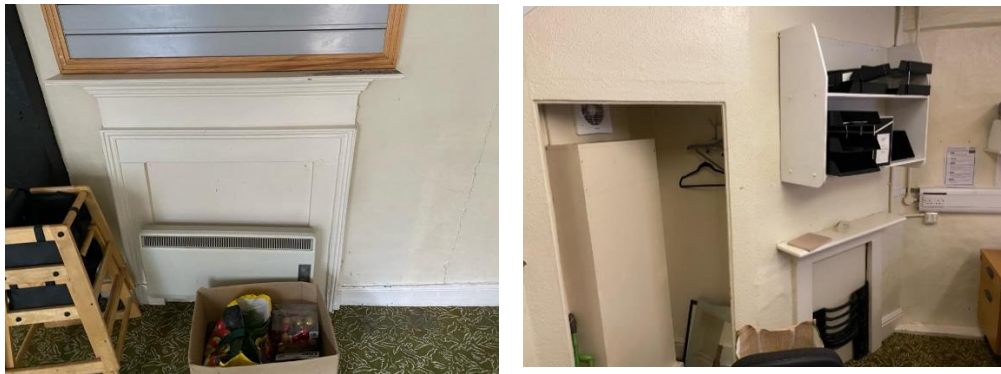
Figure 17 Blocked up fireplace on the second floor of 46 and 50.

- J - Reinststate historic doorway between proposed bar 5 and 6.
- K - Reinststate existing fire place and install gas fire in proposed bar 7 and bar 5.

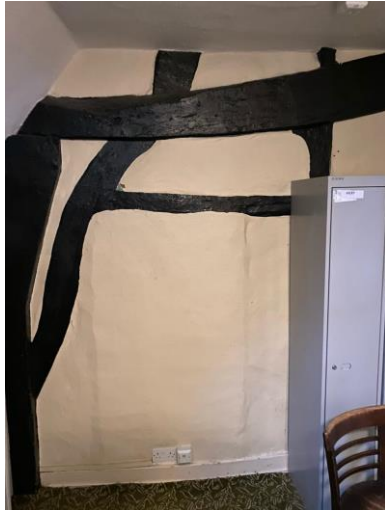
Figure 18 Timber posts and braces visible on the second floor between 46 and 48

- L - Apply timber paneling to walls in areas shown on drawings. Refer to drawings for paneling design.
- M - Expose timber posts and braces to wall between 46 and 48 Stonegate and remove infill panels. Following a structural engineers report it is understood that the original wattle and daub infill panels have been removed and replaced with masonry. Once the wallpaper has been stripped the make up of the wall can be fully understood.

- N - Remove modern layers of paint to all beams using a gentle non chemical system such as Soda blasting and low pressure chemical free blasting. Such methods are a non-harmful processes to clean and strip oak & wooden beams and timbers.
