Photographic Recording Report
Relating to Structural Timber and Render Repairs at
72 Goodramgate, York, YO1 7LF

ON BEHALF OF:
North Country Properties Ltd c/o Vine Property Management

Reference: WACBLD272

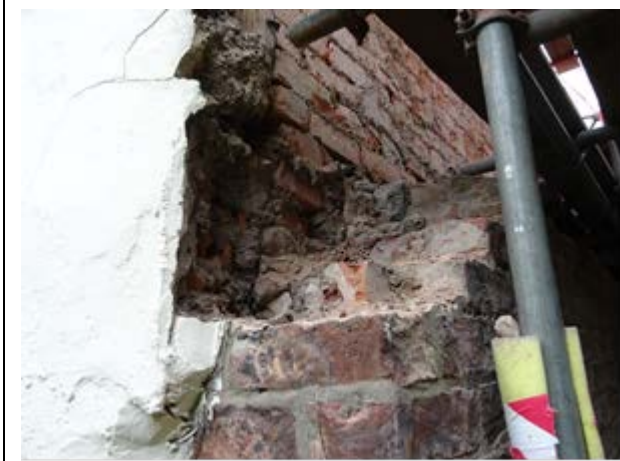
19 - LHS elevation (LHS)

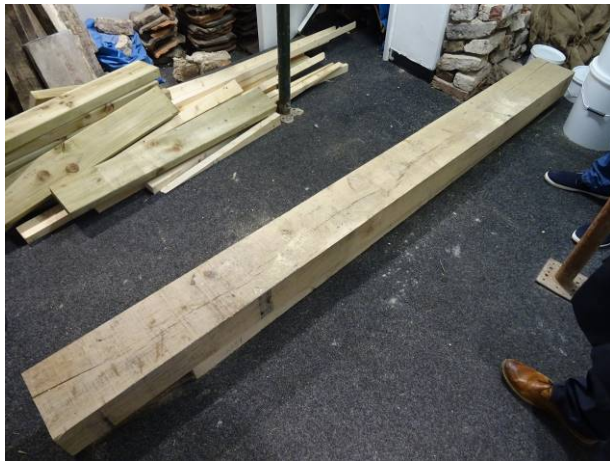
146 - New timber

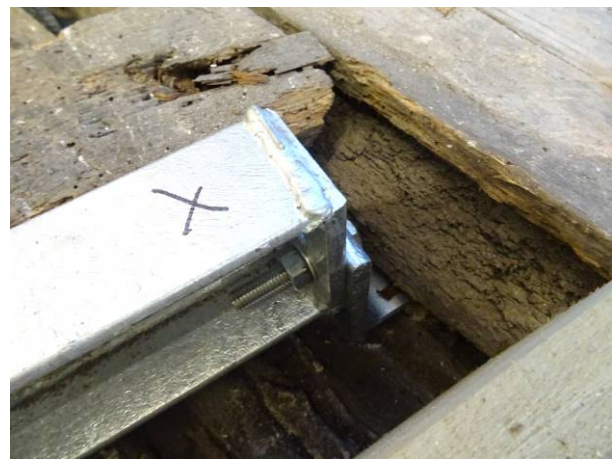
157 - Structural channels connected to the front elevation sole plate.

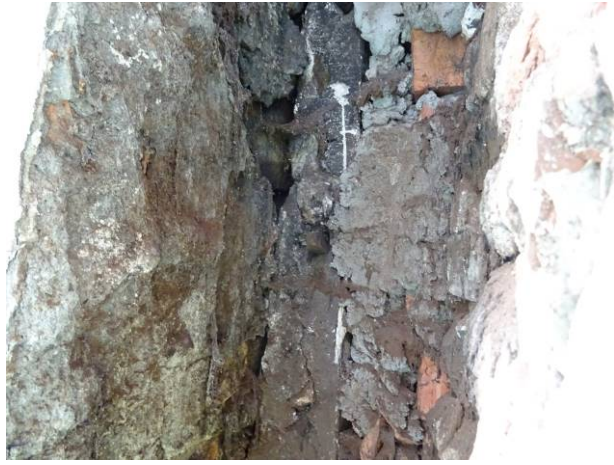
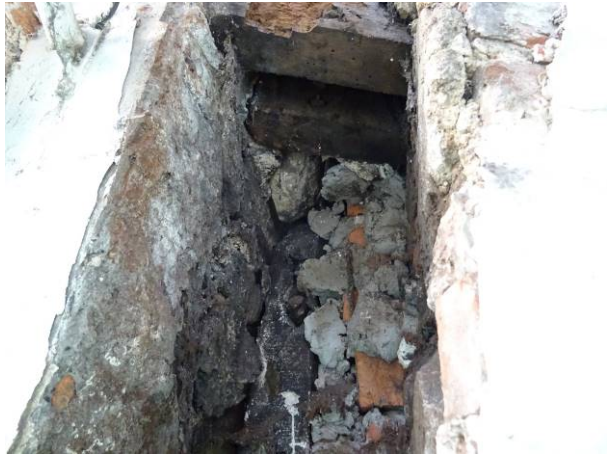
<p>166 - Void remaining following the removal of the corner post at front LHS corner</p>	<p>167 - Void remaining following the removal of the corner post at front LHS corner</p>

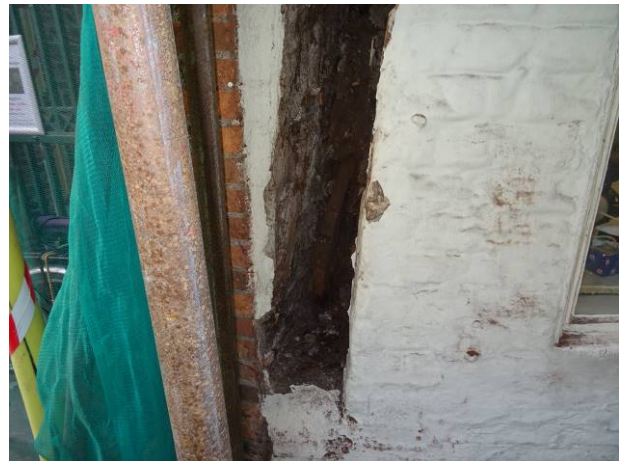
182 - Void remaining following the removal of the corner post at front LHS corner and underside of the jetty structure

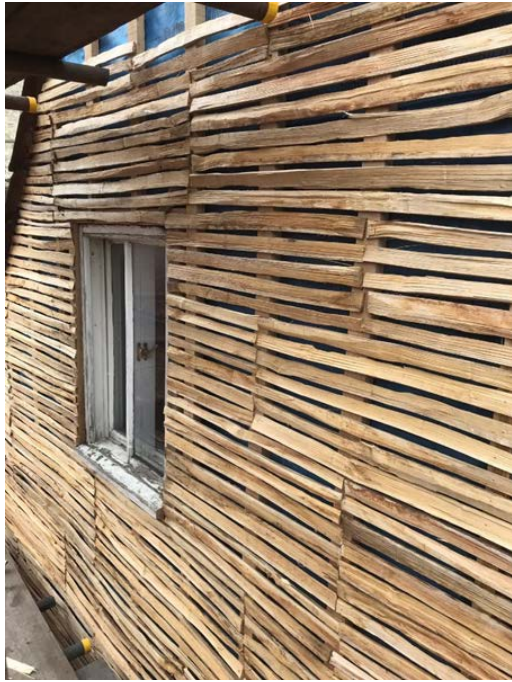
195 - New chestnut battens to LHS elevation

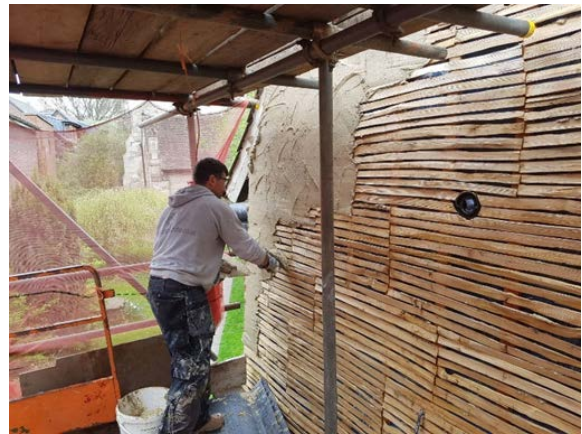
198 - Render being applied at the LHS elevation.

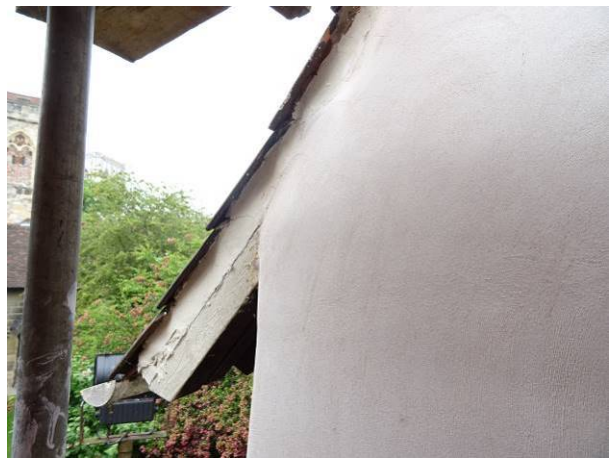
212 - Render at LHS elevation

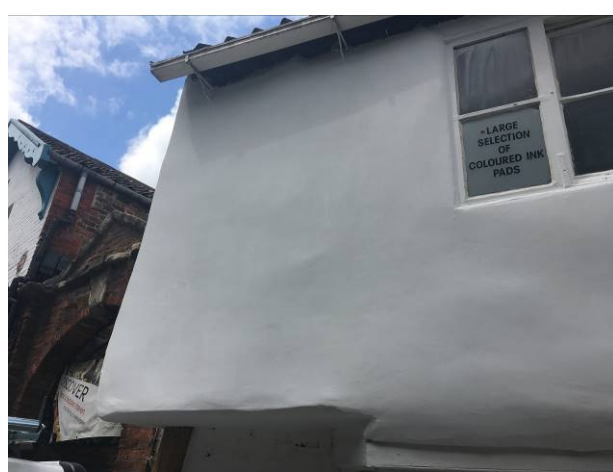
215 - Finished render at front elevation

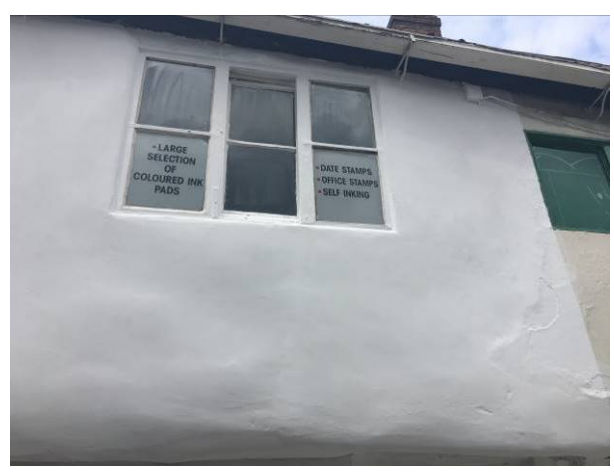
216 - Finished render at front elevation

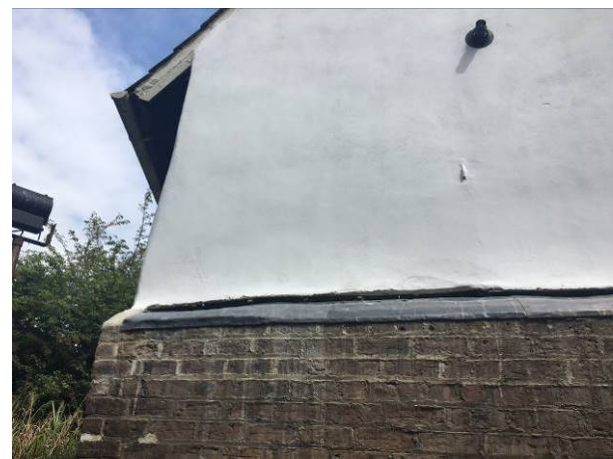
219 - Finished render at LHS elevation

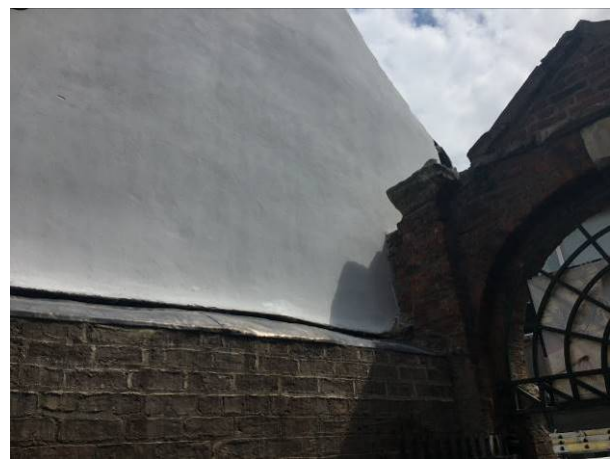
220 - Finished render at LHS elevation
